Hazard Mapping of the Philippines Using LIDAR ( Phil-LIDAR 1 )

# **LiDAR Surveys and Flood Mapping of Malbag River**

University of the Philippines Training Center  
for Applied Geodesy and Photogrammetry  
Ateneo de Naga University

APRIL 2017

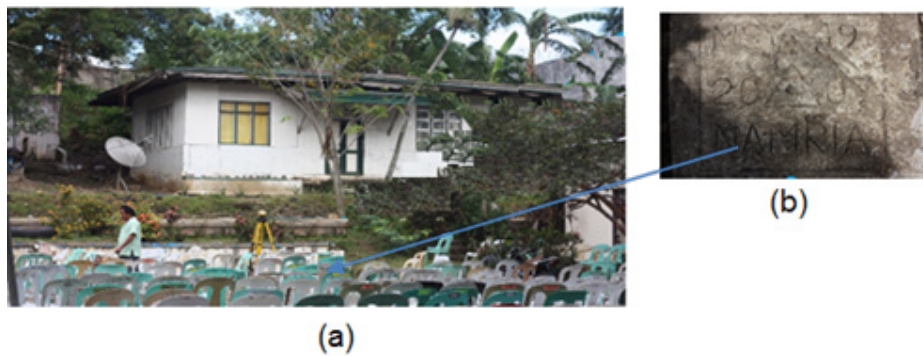
Figure 7. a) GPS set-up over MST-49 as recovered in front of the Cataingan Municipal Hall, municipality of Cataingan, Masbate b) NAMRIA reference point MST-49 as recovered by the field team.

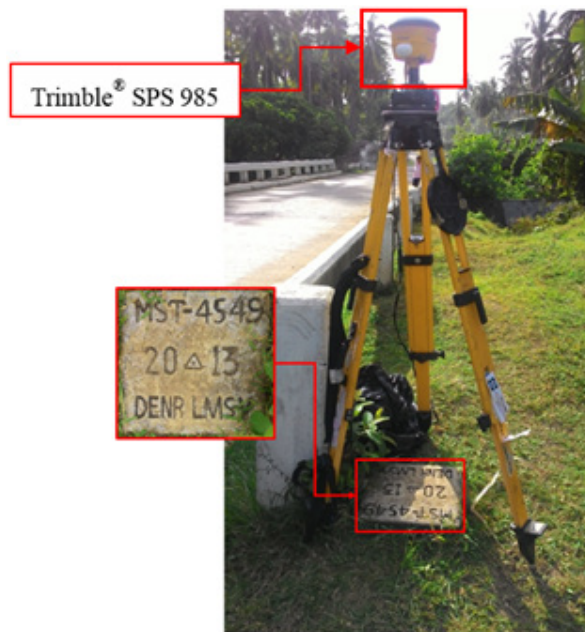
Figure 35. GNSS base set up, Trimble® SPS 985, at MST-4549, located in Brgy. Canjunday, Municipality of Baleno, Masbate.

The GNSS set-ups on recovered reference points and established control points in Malbag River are shown in Figure 35 to Figure 40.

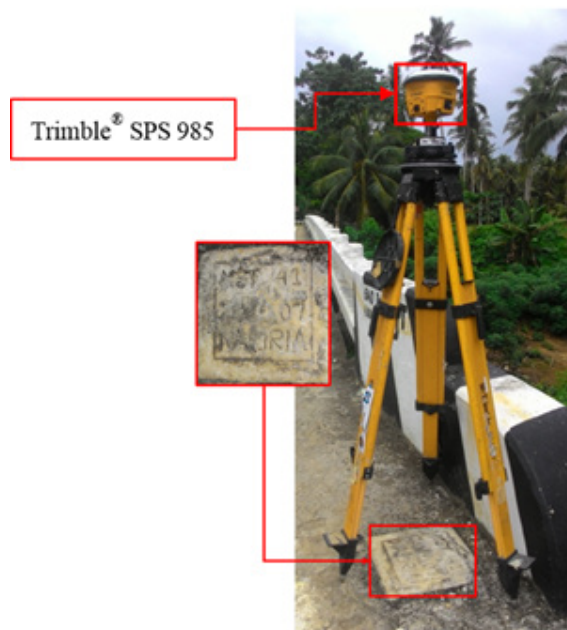
Figure 36. GNSS receiver setup, Trimble® SPS 985, at MST-41, located in Brgy. Gaid, Municipality of Dimasalang, Masbate

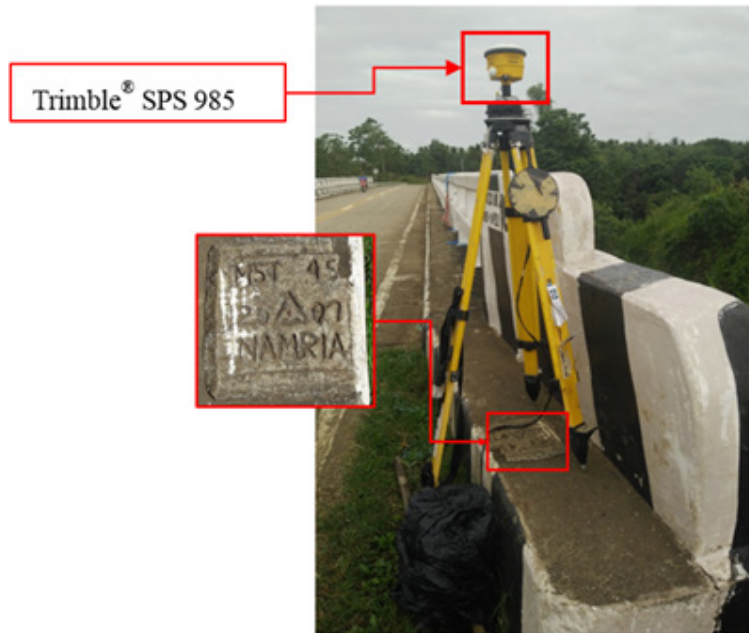
Figure 37. GNSS receiver setup, Trimble® SPS 985, at MST-45, located in Brgy. Villahermosa, Municipality of Cawayan, Masbate

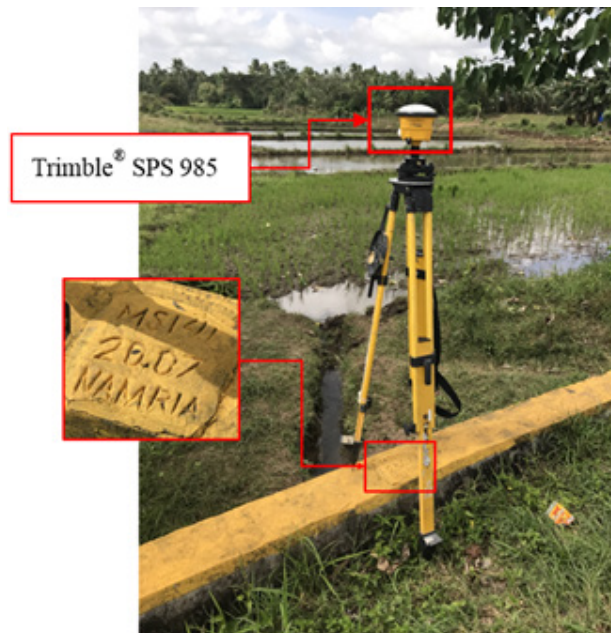
Figure 38. GNSS receiver setup, Trimble® SPS 985, at MS-141, located in Brgy. San Vicente, Municipality of Cawayan, Masbate

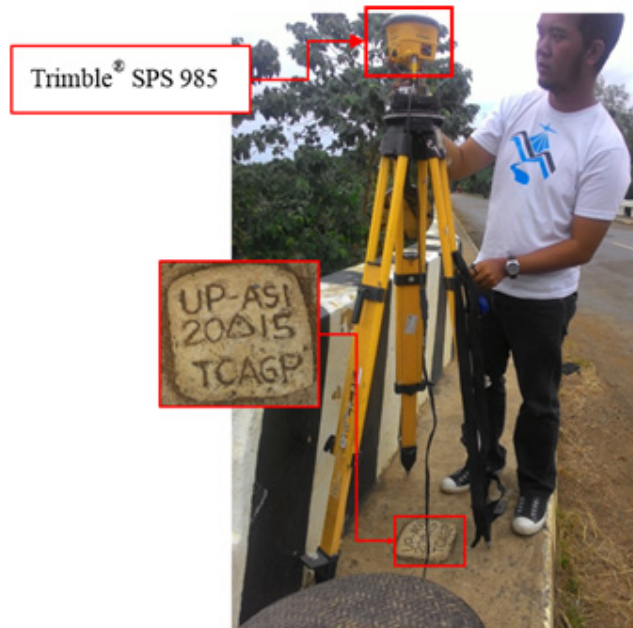
Figure 39. GNSS receiver setup, Trimble® SPS 985, at UP-ASI, located Brgy. Cayabon, Municipality of Milagros, Masbate

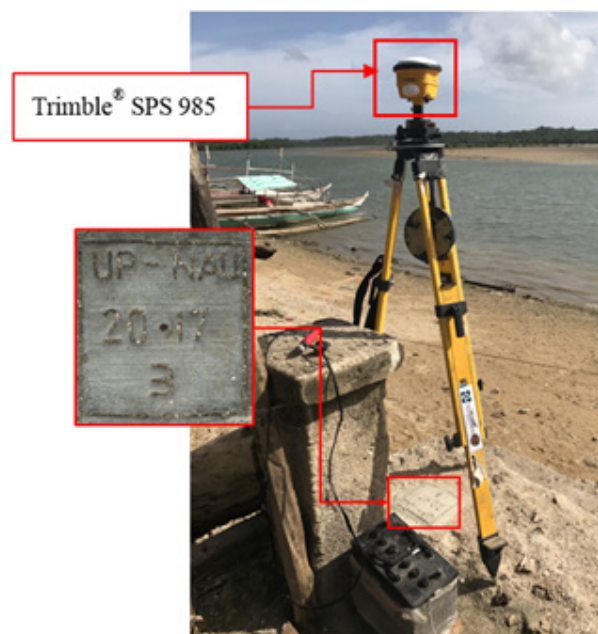
Figure 40. GNSS receiver setup, Trimble® SPS 985, at UP-NAU3, located in Brgy. Taboc, Municipality of Placer, Masbate

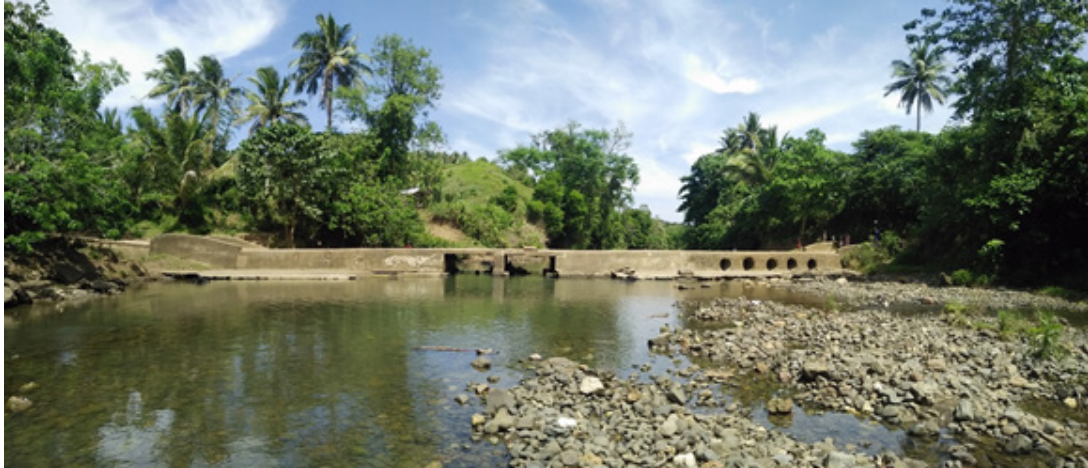
Figure 41. Malbag Culvert facing upstream

Cross-section and as-built survey were conducted on February 10, 2017 at the downstream side of Malbag Culvert in Brgy. San Vicente, Municipality of Cawayan, Masbate as shown in Figure 41. A Trimble® SPS 882 GNSS in PPK survey technique was used as shown in Figure 42.

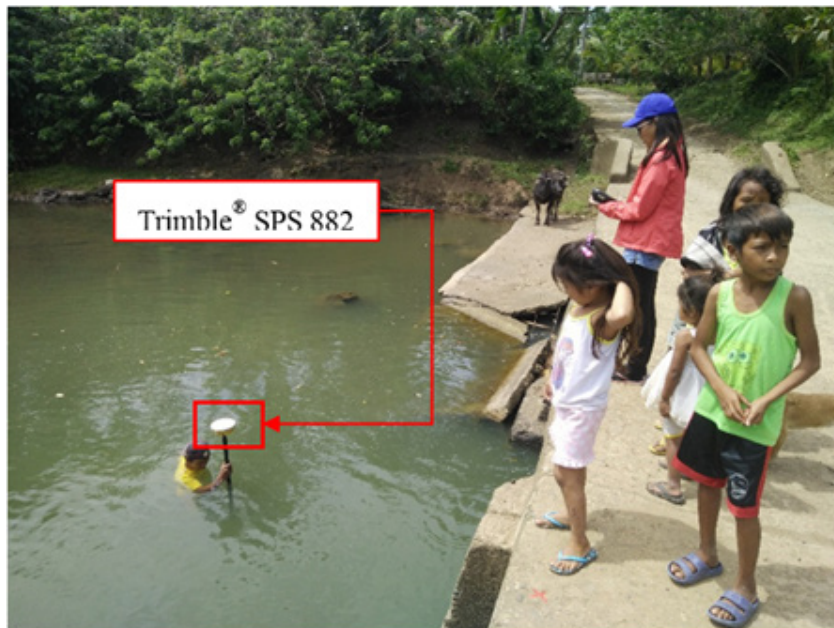
Figure 42. Bridge As-Built Survey using PPK Technique

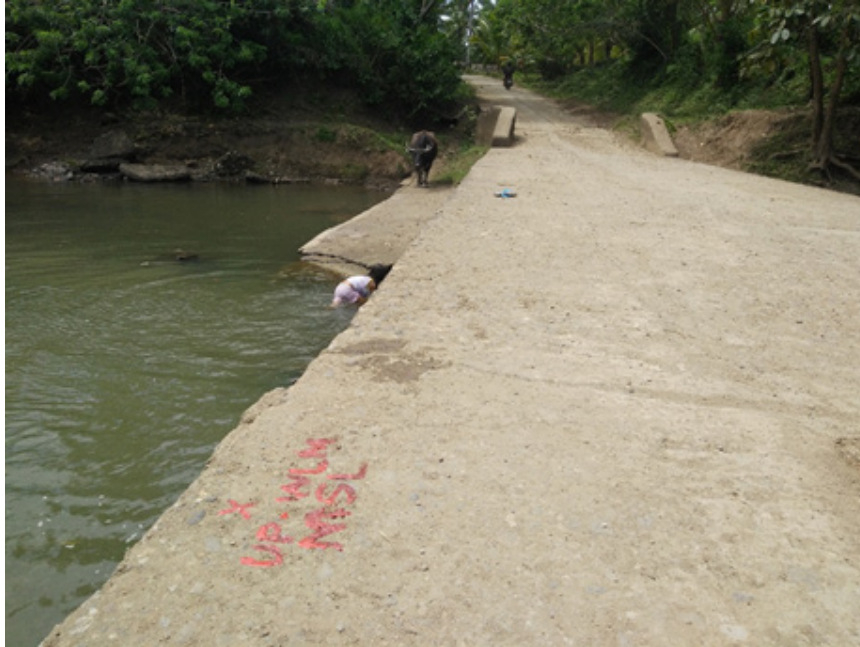
Figure 46. Water-level markings on Malbag Culvert

Water surface elevation of Malbag River was determined using a survey grade GNSS receiver Trimble® SPS 882 in PPK survey technique on February 10, 2017 at 11:58 AM with a value of 12.743 m in MSL as shown in Figure 43. This was translated into marking on the Malbag Culvert's deck using the same technique as shown in Figure 46. This will serve as reference for flow data gathering and depth gauge deployment of partner HEI responsible for Malbag river, the Ateneo de Naga University.

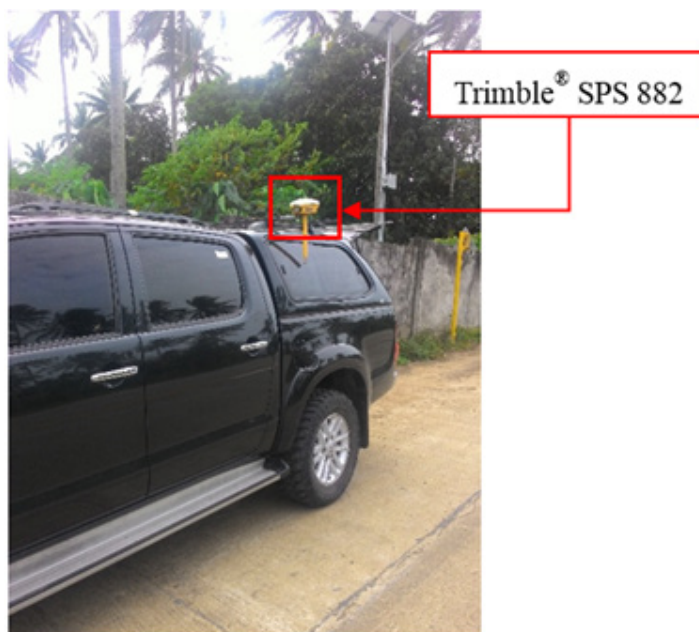
Figure 47. Validation points acquisition survey set up along Malbug River Basin

Validation points acquisition survey was conducted on January 28, February 7 and 13, 2017 using a survey-grade GNSS Rover receiver, Trimble® SPS 882, mounted on top of a vehicle as shown in Figure 47. It was secured with a nylon rope to ensure that it was horizontally and vertically balanced. The antenna height was 1.884 m and measured from the ground up to the bottom of notch of the GNSS Rover receiver. The PPK technique utilized for the conduct of the survey was set to continuous topo mode with UP-NAU3, MST-41, and UP-ASI occupied as the GNSS base stations.

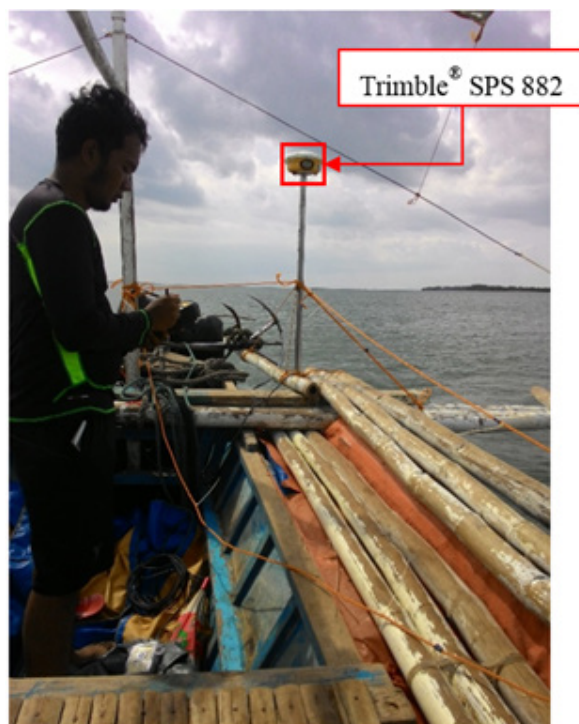
Figure 49. Bathymetric survey using Ohmex™ single beam echo sounder in Malbag River

Bathymetric survey was executed on February 9, 10, and 11, 2017 using an Ohmex™ single beam echo sounder and Trimble® SPS 882 in GNSS PPK survey technique in continuous topo mode as illustrated in Figure 49. The survey started in the upstream part of the river in Brgy. Lague-Lague, Municipality of Cawayan with coordinates 12°04'30.66113"N, 123°42'59.60994"E, and ended at the mouth of the river in Brgy. Malbag, in the same Municipality with coordinates 12°04'30.66113"N, 123°38'10.22429"E. The control MST-45 was used as GNSS base station all throughout the entire survey.

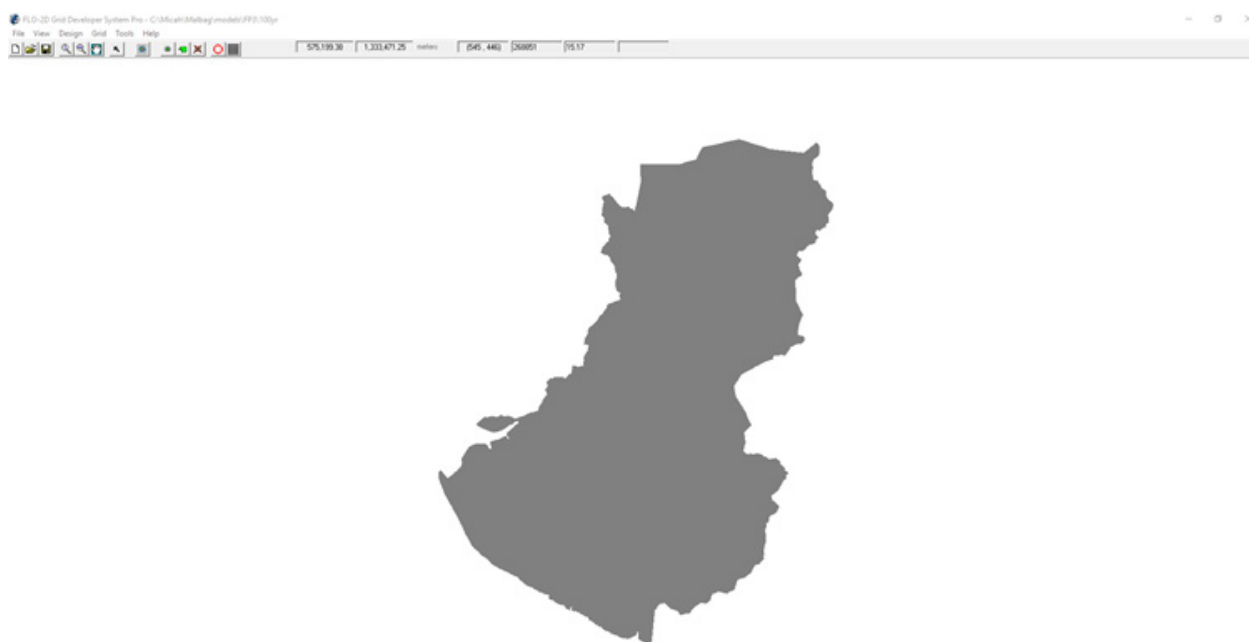
Figure 63. Screenshot of subcatchment with the computational area to be modeled in FLO-2D Grid Developer System Pro (FLO-2D GDS Pro)

The automated modelling process allows for the creation of a model with boundaries that are almost exactly coincidental with that of the catchment area. As such, they have approximately the same land area and location. The entire area is divided into square grid elements, 10 meter by 10 meter in size. Each element is assigned a unique grid element number which serves as its identifier, then attributed with the parameters required for modelling such as x-and y-coordinate of centroid, names of adjacent grid elements, Manning coefficient of roughness, infiltration, and elevation value. The elements are arranged spatially to form the model, allowing the software to simulate the flow of water across the grid elements and in eight directions (north, south, east, west, northeast, northwest, southeast, southwest).

Based on the elevation and flow direction, it is seen that the water will generally flow from the north of the model to the southwest, following the main channel. As such, boundary elements in those particular regions of the model are assigned as inflow and outflow elements respectively.

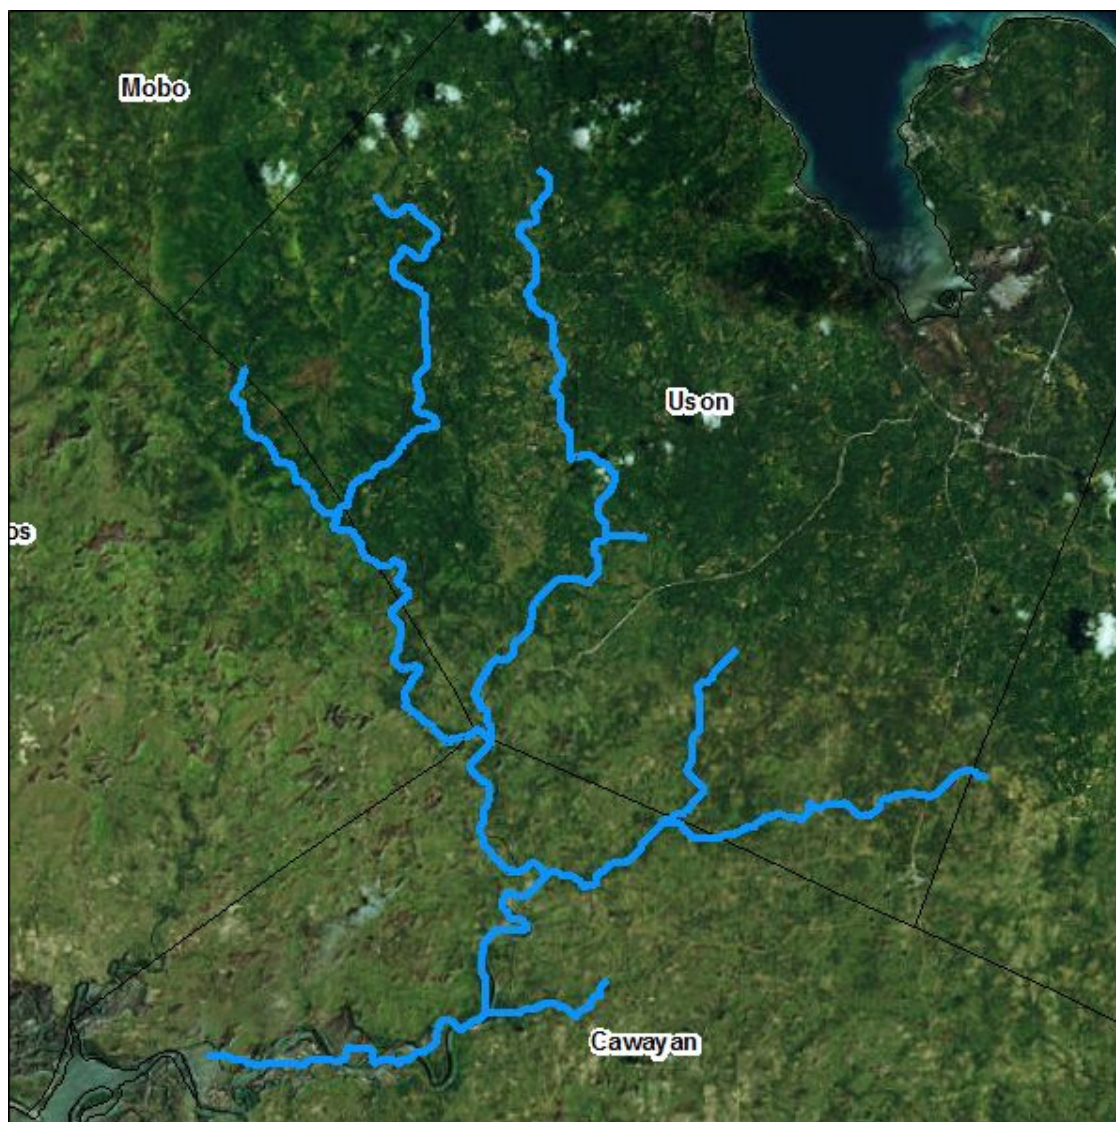
Figure 66. The sample output map of the Malbag RAS Model

The HEC-RAS Flood Model produced a simulated water level at every cross-section for every time step for every flood simulation created. The resulting model will be used in determining the flooded areas within the model. The simulated model will be an integral part in determining real-time flood inundation extent of the river after it has been automated and uploaded on the DREAM website. For this publication, only a sample output map river was to be shown, since only the ADNU-DVC base flow was calibrated. Figure 66 shows a generated sample map of the Malbag River using the calibrated HMS base flow.

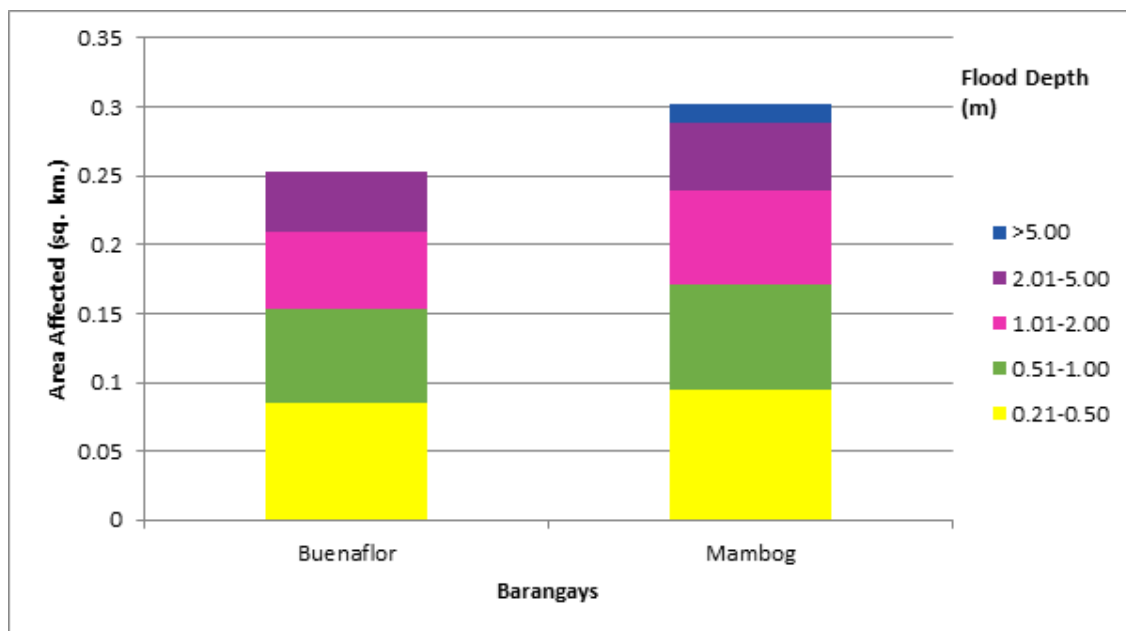
Figure 80. Affected Areas in Dimasalang, Masbate during the 25-Year Rainfall Return Period

For the municipality of Dimasalang with an area of 100.44 sq. km., 5.94% will experience flood levels of less than 0.20 meters. 0.18% of the area will experience flood levels of 0.21 to 0.50 meters, while 0.14%, 0.12%, 0.09%, and 0.01% of the area will experience flood depths of 0.51 to 1 meter, 1.01 to 2 meters, 2.01 to 5 meters, and greater than 5 meters, respectively. Table 41 depicts the areas affected in Dimasalang in square kilometers by flood depth per barangay.

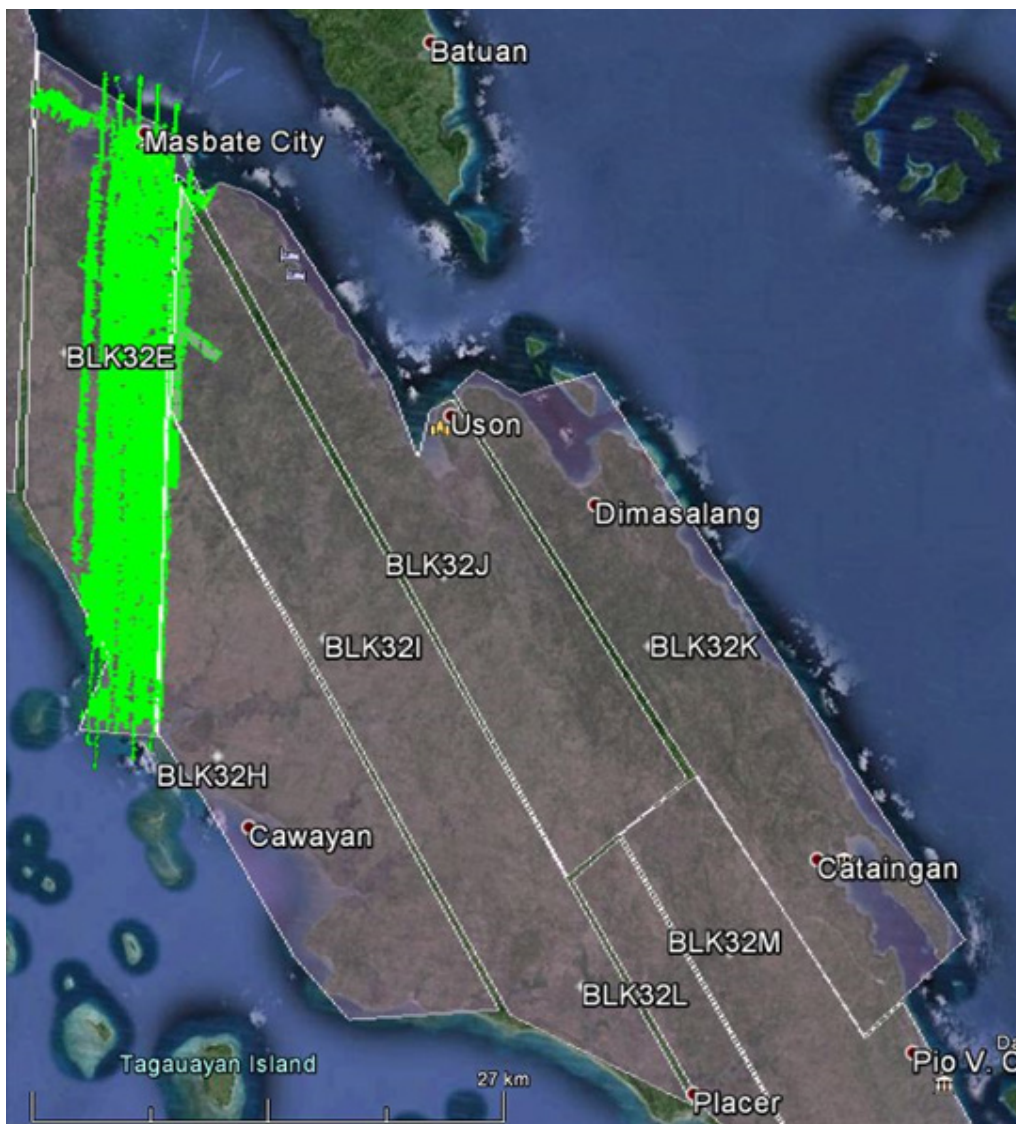
Altitude: 1000m  
PRF: 200 kHzSCF: 30 Hz  
Lidar FOV: 50 deg Sidelap:25%

Figure A.7.1. Swath for Flight No. 1241P

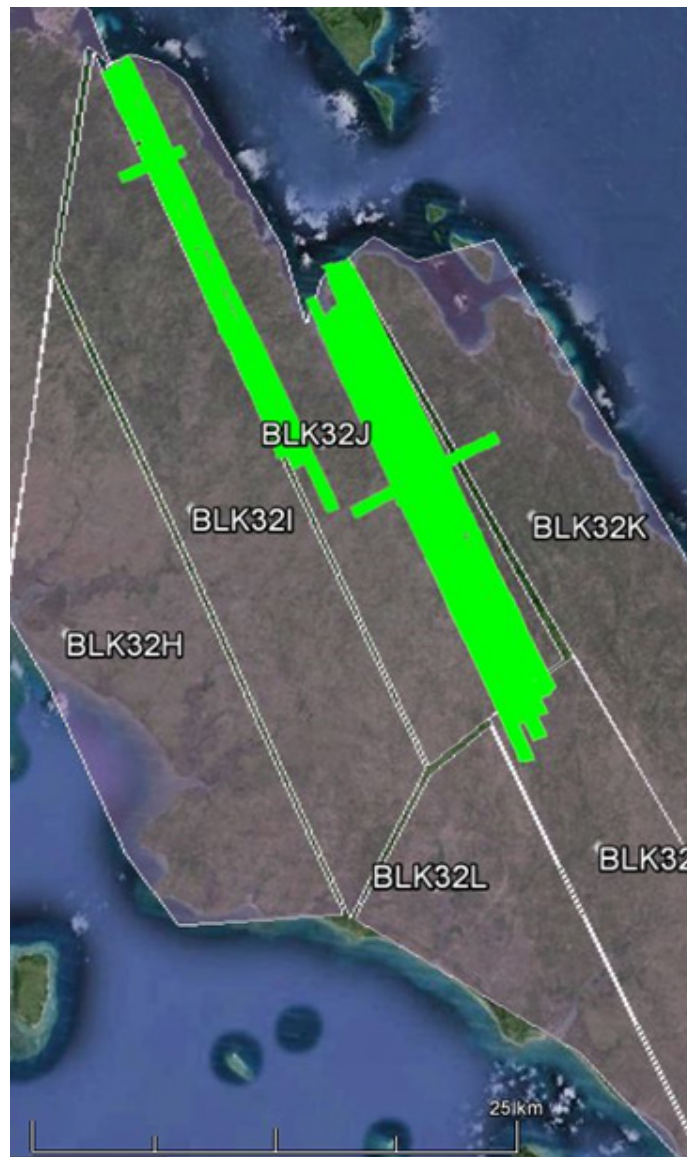
Flight No. : 1245P  
Area: BLK32J  
Mission Name: 1BLK32J079B  
Area Surveyed: 145.344 sq.km.

Altitude: 800m  
PRF: 200 kHzSCF: 30 Hz  
Lidar FOV: 50 deg Sidelap: 25%

Figure A.7.3. Swath for Flight No. 1245P

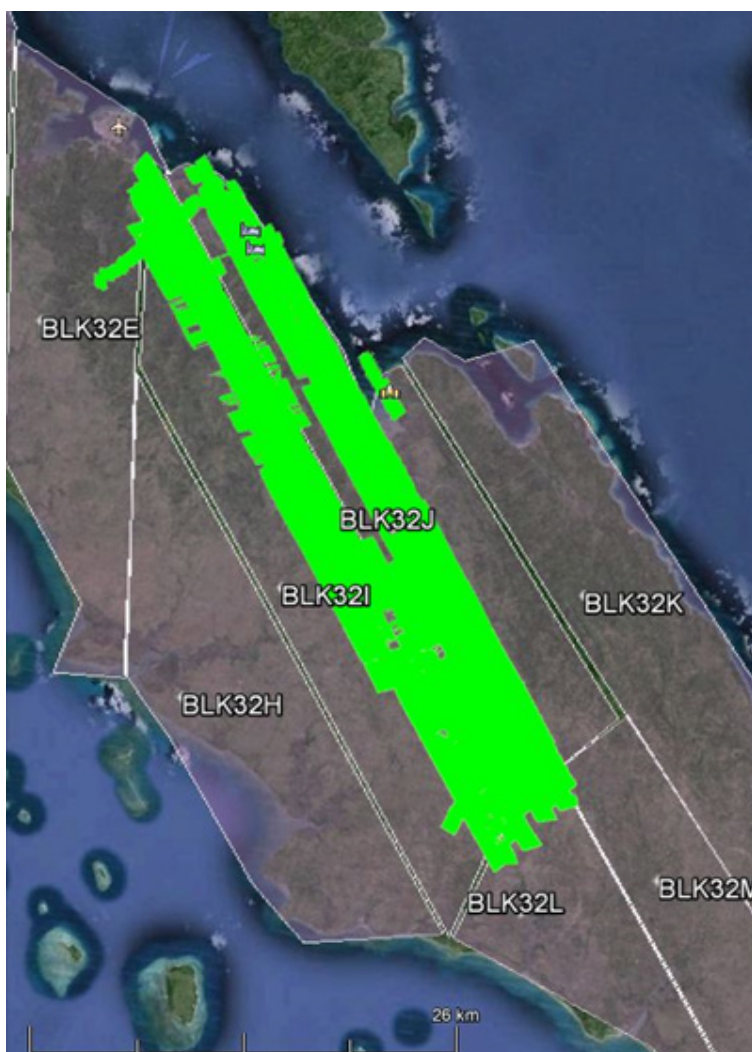
Flight No. : 1247P  
Area: BLK32J  
Mission Name: 1BLK32IJ080A  
Area Surveyed: 333.843 sq.km.

Altitude: 1000m  
PRF: 200 kHz SCF: 30 Hz  
Lidar FOV: 50 deg Sidelap: 25%

Altitude: 1200m  
PRF: 300 kHz SCF: 30 Hz  
Lidar FOV: 50 deg Sidelap: 25%

Figure A.7.4. Swath for Flight No. 1247P

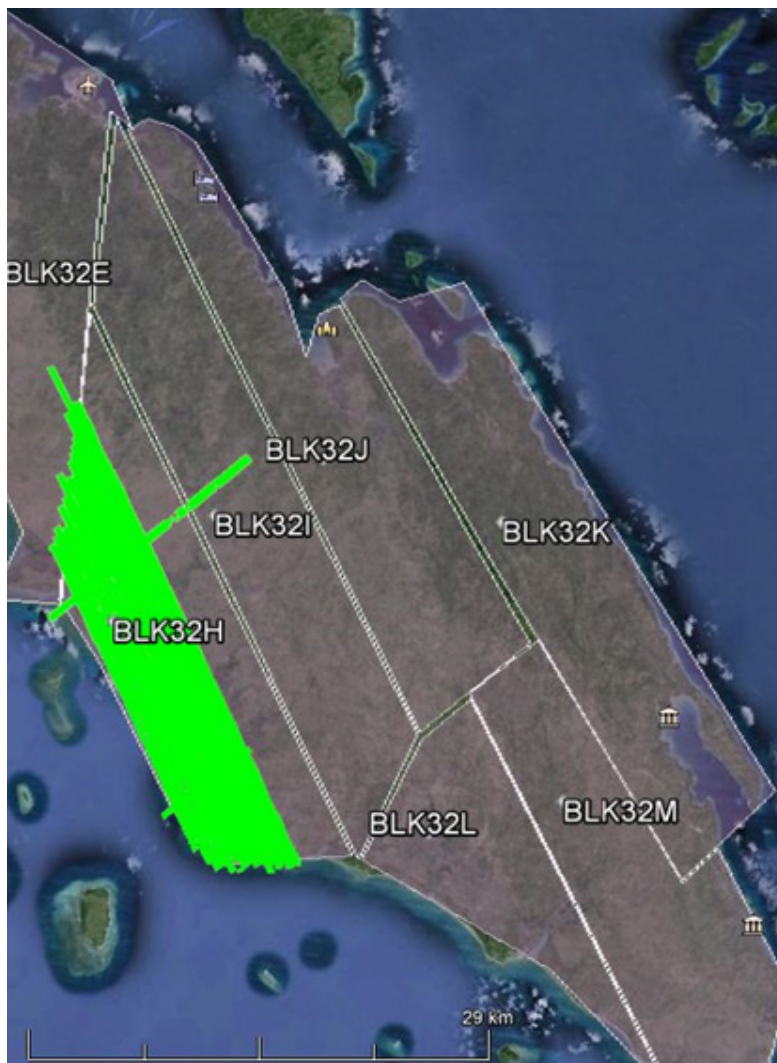
Flight No. : 1271P  
Area: BLK32H  
Mission Name: 1BLK32H086A  
Area Surveyed: 173.31 sq.km.

Altitude: 800m  
PRF: 200 kHzSCF: 30 Hz  
Lidar FOV: 50 deg Sidelap:25%

Altitude: 600m  
PRF: 200 kHzSCF: 30 Hz  
Lidar FOV: 50 deg Sidelap:30%

Figure A.7.5. Swath for Flight No. 1271P
