Hazard Mapping of the Philippines Using LIDAR (Phil-LIDAR 1)

LiDAR Surveys and Flood Mapping of Calumpang River

University of the Philippines Training Center
for Applied Geodesy and Photogrammetry
Mapua Institute of University (MIT)

APRIL 2017

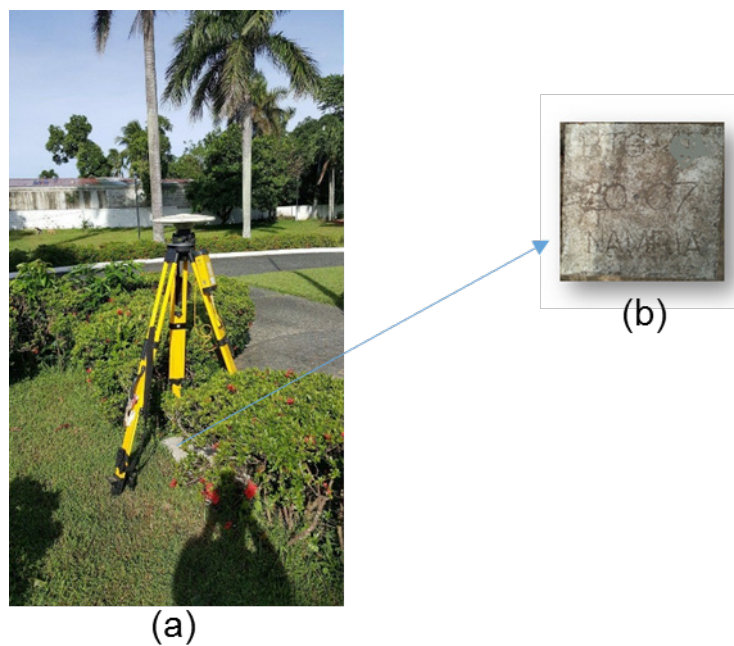
Figure 3. GPS set-up over BTG-51 inside the vicinity of Mabini Shrine in Brgy, Talaga, Tanuan City, Batangas (a) NAMRIA reference point BTG-51 (b) as recovered by the field team

Figure 3 to Figure 5 show the recovered NAMRIA reference points within the area. In addition, Table 3 to Table 7 show the details about the following NAMRIA reference points and established points, while Table 8 shows the list of all ground control points occupied during the acquisition together with the dates they are utilized during the survey.

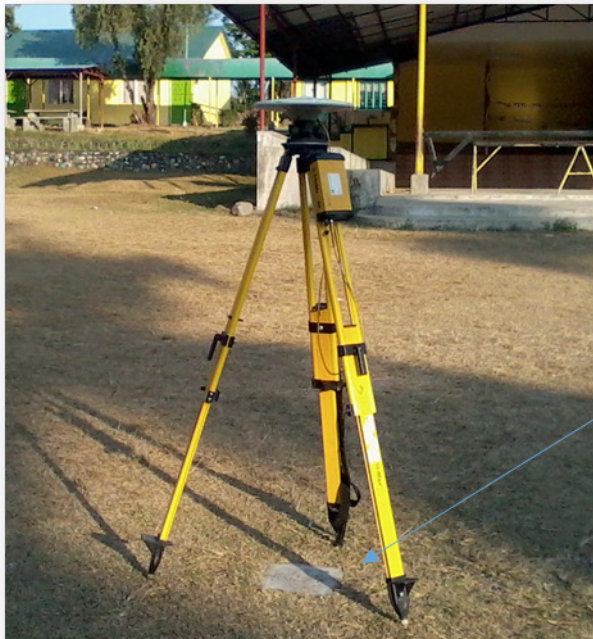
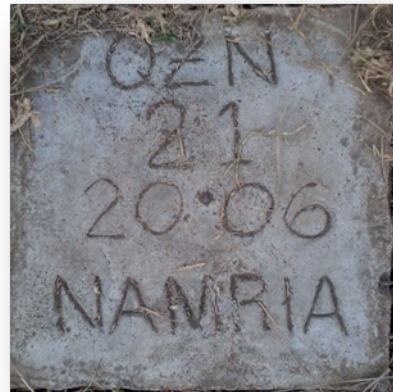
Figure 4. GPS set-up over QZN-21 inside Paaralang Elementarya ng Silangang Tiaong of Brgy. Poblacion III, Tiaong, Quezon Province (a) and NAMRIA reference point QZN-21 (b) as recovered by the field team

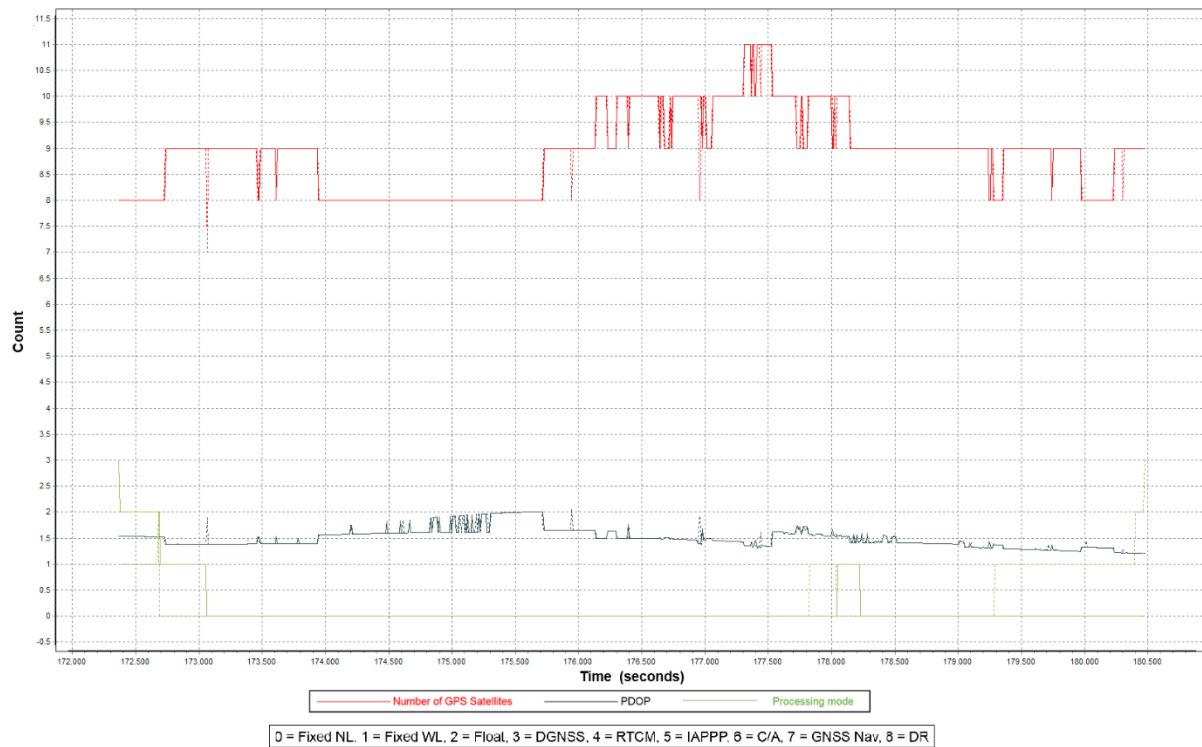
Figure 9. Solution Status Parameters of Calumpang Flight 3669G.

The Solution Status parameters of flight 3669G, one of the Calumpang flights, which are the number of GPS satellites, Positional Dilution of Precision (PDOP), and the GPS processing mode used, are shown in Figure 9. The graphs indicate that the number of satellites during the acquisition did not go down to 6. Majority of the time, the number of satellites tracked was between 6 and 10. The PDOP value also did not go above the value of 3, which indicates optimal GPS geometry. The processing mode stayed at the value of 0 for majority of the survey with some peaks up to 1 attributed to the turns performed by the aircraft. The value of 0 corresponds to a Fixed, Narrow-Lane mode, which is the optimum carrier-cycle integer ambiguity resolution technique available for POSPAC MMS. All of the parameters adhered to the accuracy requirements for optimal trajectory solutions, as indicated in the methodology. The computed best estimated trajectory for all Calumpang flights is shown in Figure 10.

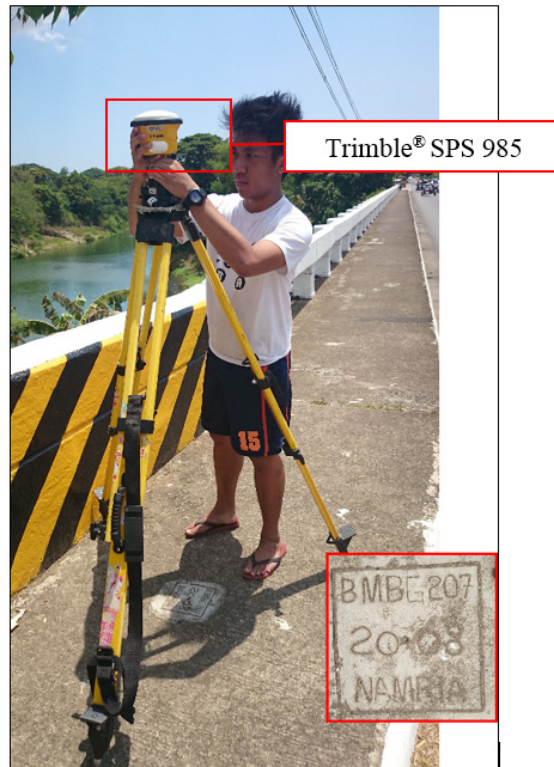
Figure 31. GNSS receiver, Trimble® SPS 985, set-up at BG-207 at Palico Bridge, Brgy. Luntal, Nasugbu, Batangas

The GNSS set-up on reference and established control points in Batangas are shown on Figure 31 to Figure 37.

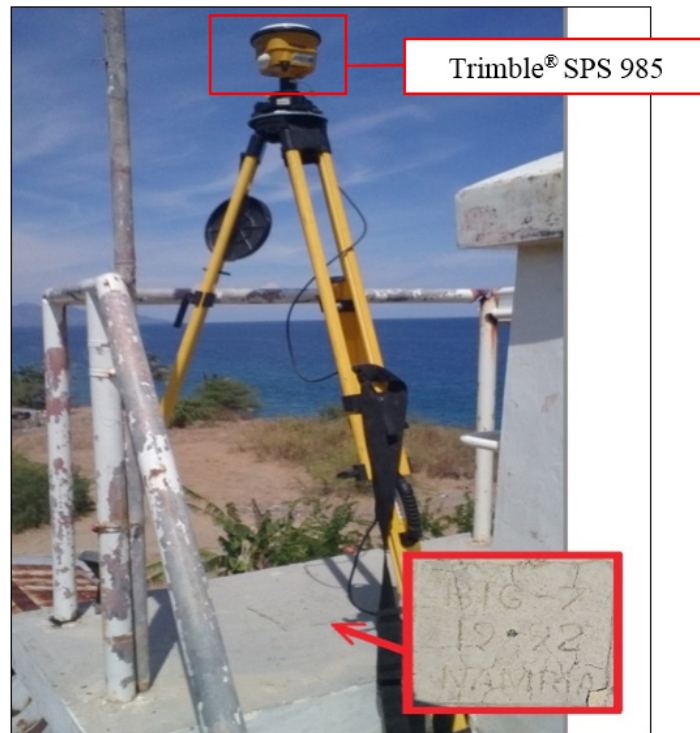
Figure 32. GNSS receiver, Trimble® SPS 985, set-up at BTG-7 in Dela Paz Lighthouse in Brgy. Dela Paz, Batangas City, Batangas

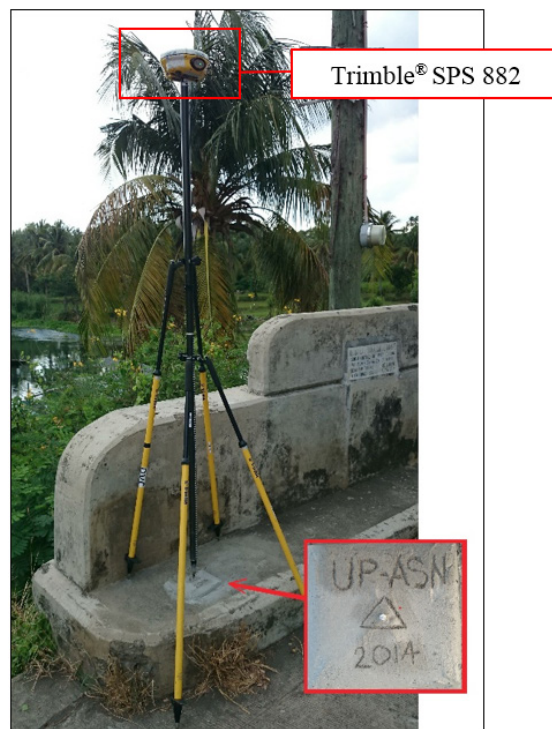
Figure 33. GNSS receiver, Trimble® SPS 882, set-up at UP-ASN at San Nicholas Bridge, Brgy. Poblacion, San Nicholas, Batangas

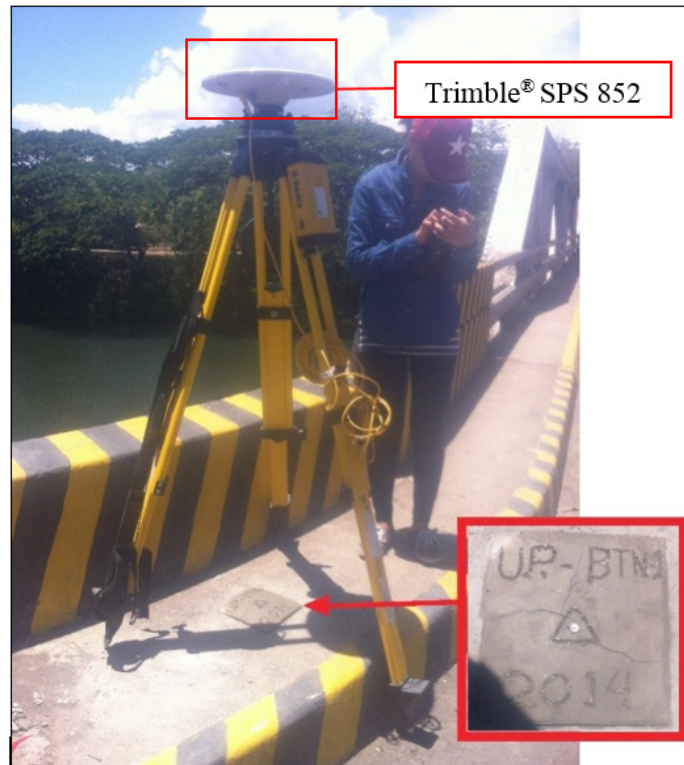
Figure 34. GNSS base receiver, Trimble® SPS 852, set-up at UP-BTN at Bantilan Bridge, Brgy. Manggalang Banitilan, Sariaya, Quezon

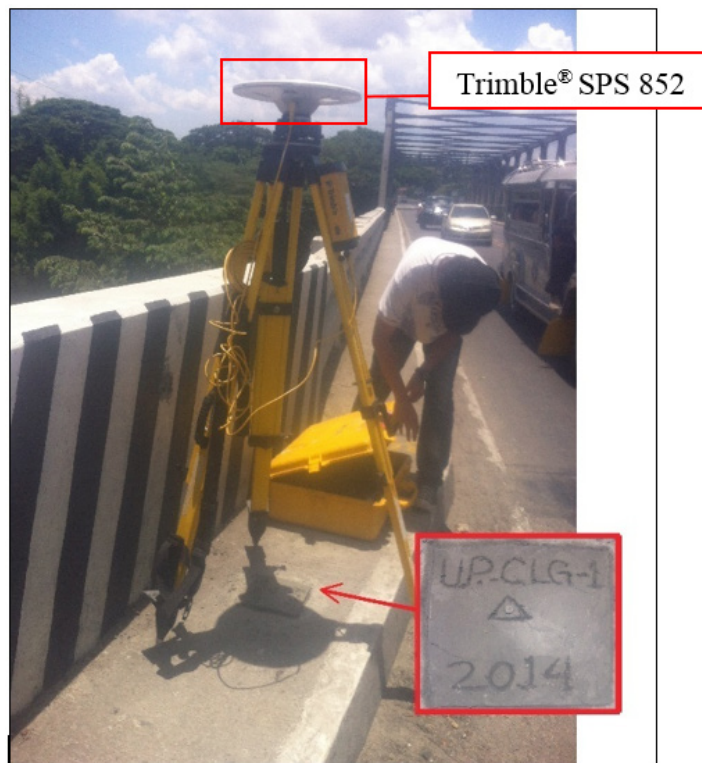
Figure 35. GNSS base receiver, Trimble® SPS 852, set-up at UP-CLG1 in Calumpang Bridge, Brgy. Cumintang Ibaba, Batangas City, Batangas

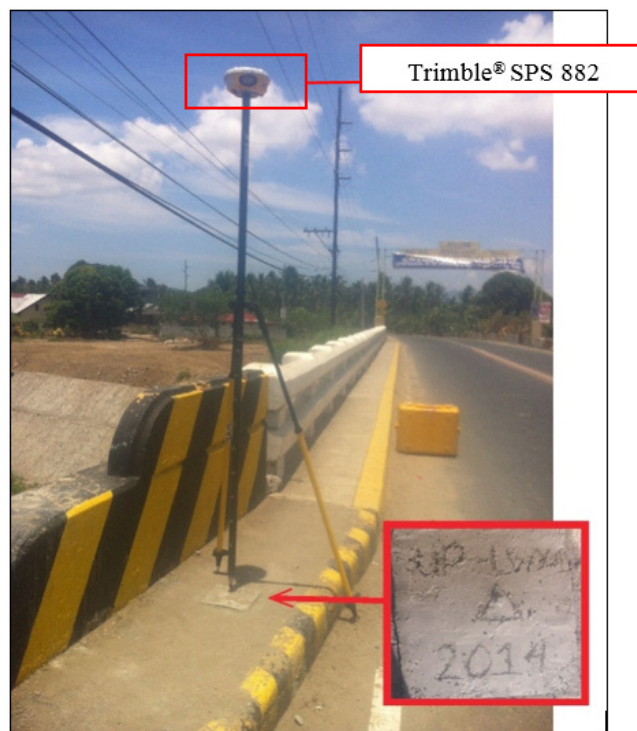
Figure 37. GNSS receiver, Trimble® SPS 882, set-up at UP-LWY1 at Lawaye Bridge, Brgy. Calitcalit-Mabalanoy, San Juan, Batangas

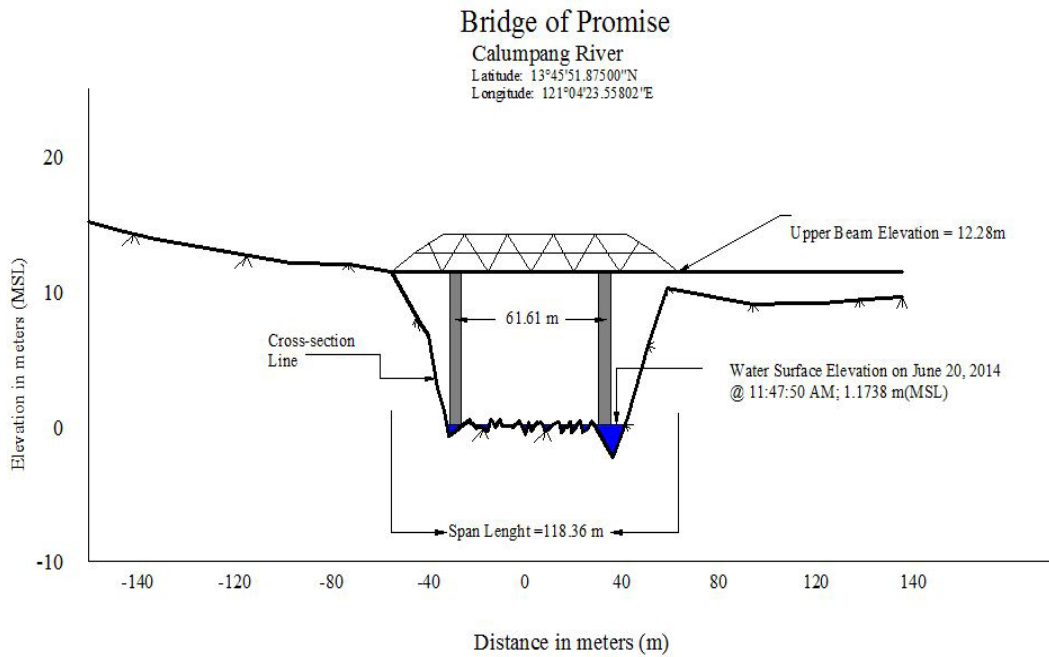
Figure 40. Bridge of Promise cross-section diagram

A total of 72 points with an approximate length of 335.59 m were gathered for Bridge of Promise using the control point UP-CLG as the GNSS base station. The planimetric map, cross-sectional diagram, and bridge as-built form are shown in Figure 39 to Figure 41.

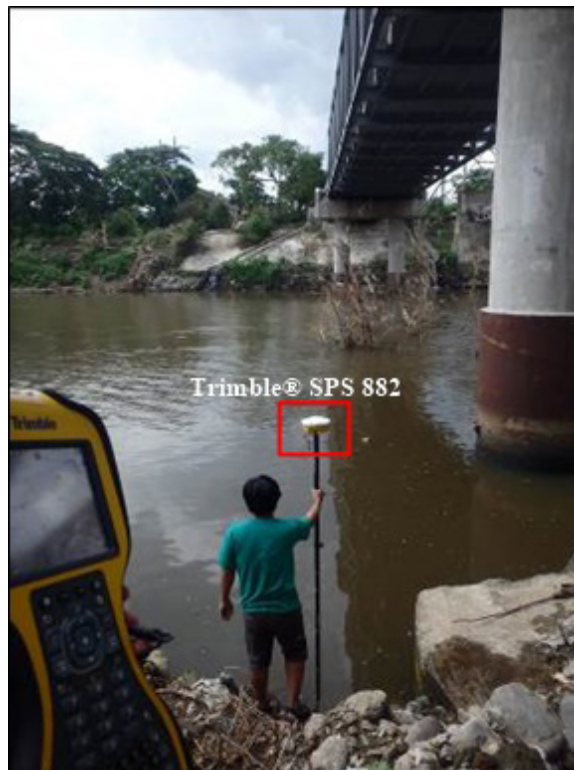
Figure 42. Determination of water surface elevation at the river banks of the Bridge of Promise

The water marking was done on the pier of the Bridge of Promise in Brgy. Kumintang Ibaba, Batangas City using a Trimble® SPS 882 PPK survey technique GNSS point observation. The water surface elevation of Calumpang River was acquired on August 27, 2014 at 2:49 PM. The resulting water surface elevation data is 0.541 m in MSL. This value was translated onto the bridge's pier which would serve as reference for the partner HEI, MIT.

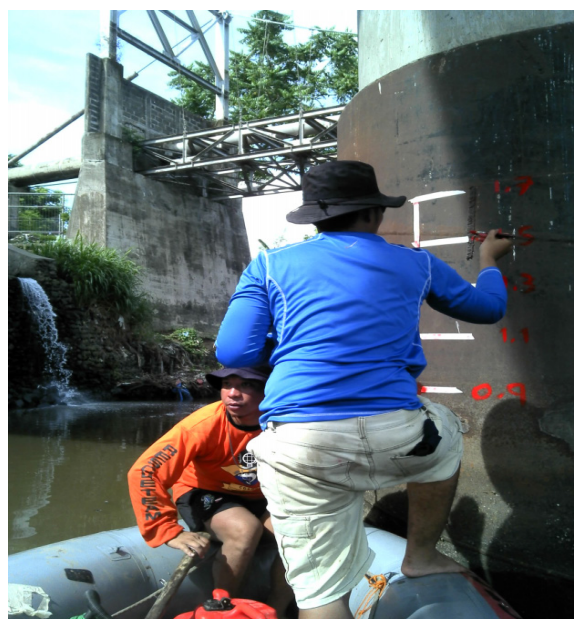
Figure 43. Marking of MSL-based elevation on the right side of a pier in Bridge of Promise

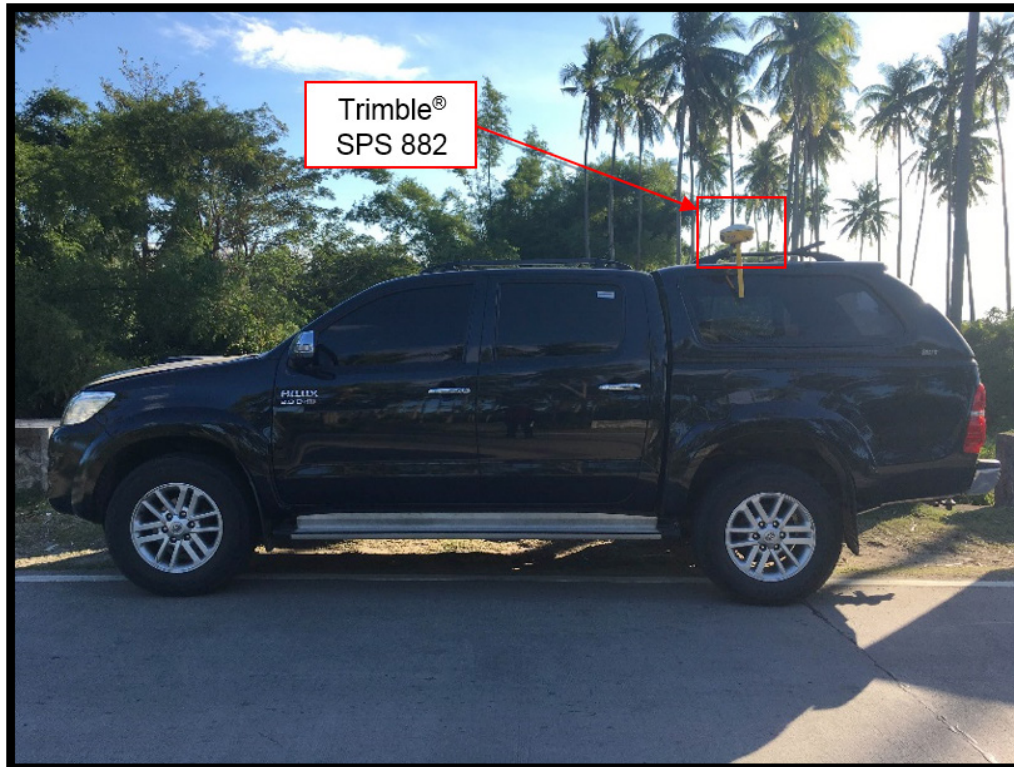
Figure 44. Ground Validation set up in Calumpang Survey

Validation points acquisition survey was conducted on November 8, 2014 using a survey-grade GNSS rover receiver, Trimble® SPS 882, mounted on a pole which was attached to the top of the vehicle as shown in Figure 44. It was secured with cable ties to ensure that it was horizontally and vertically balanced. The antenna height was 2.09 m measured from the ground up to the bottom of notch of the GNSS rover receiver. The PPK technique utilized for the conduct of the survey was set to continuous topo mode with UP-CLG occupied as the GNSS base station all throughout the conduct of the survey.

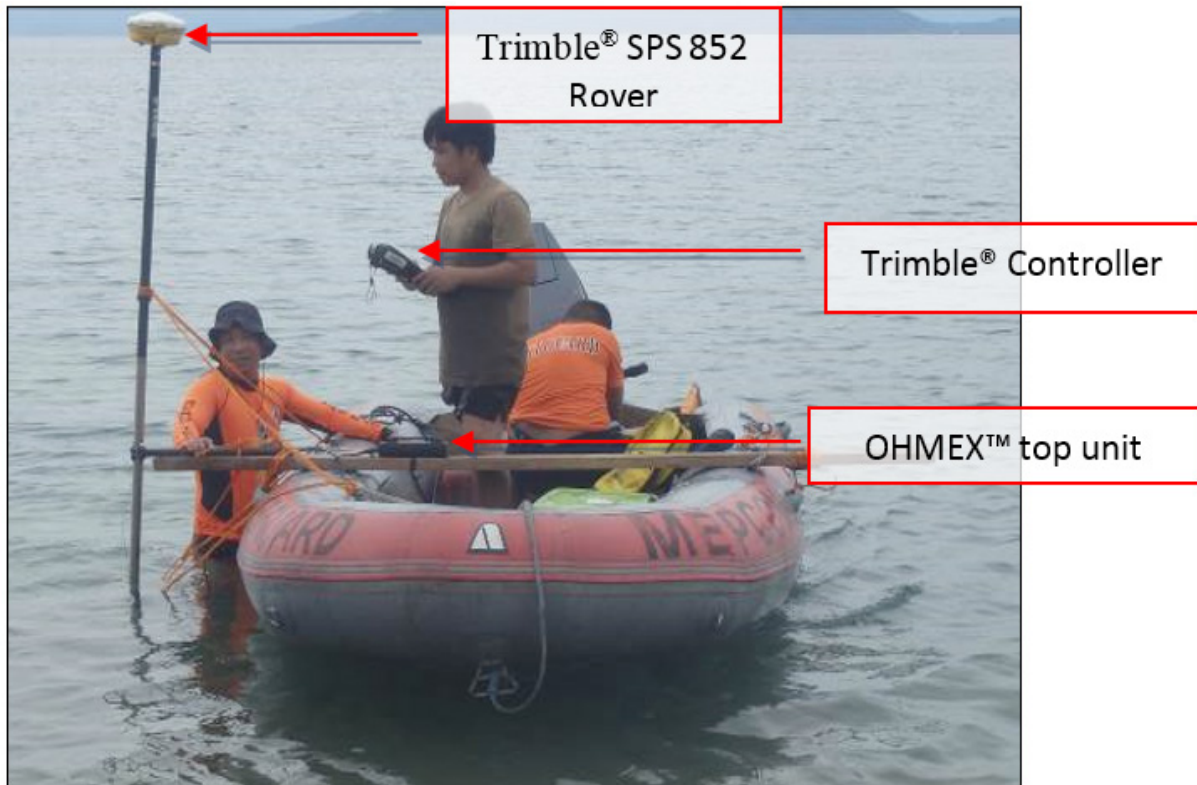
Figure 46. OHMEX™ single-beam echo sounder set-up on a rubber for the Calumpang River bathymetric survey

The bathymetric survey was conducted on August 27, 2014 using an Ohmex™ single-beam echo sounder and Trimble® SPS 882 in GNSS PPK survey technique as shown in Figure 46. The survey started from Brgy. Tinga Itaas, Batangas City with coordinates 13°47'18.44423"121°05'45.18162", down to the mouth of the river in Brgy. Wawa, Batangas City with coordinates 13°44'27.26237"121°03'01.09411".

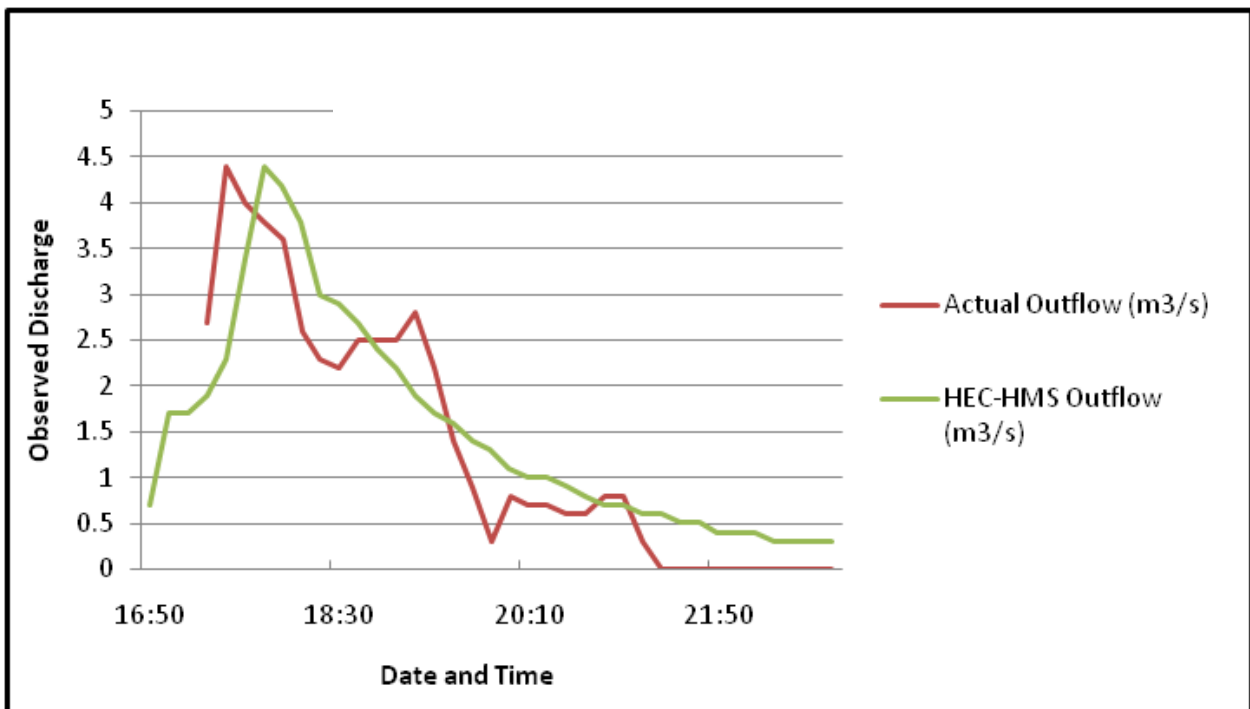
After calibrating the Calumpang HEC-HMS river basin model, its accuracy was measured against the observed values. Figure 64 shows the comparison between the two discharge data.

Figure 64. Outflow hydrograph of Calumpang produced by the HEC-HMS model compared with observed outflow

The Pearson correlation coefficient (r²) assesses the strength of the linear relationship between the observations and the model. This value being close to 1 corresponds to an almost perfect match of the observed discharge and the resulting discharge from the HEC HMS model. Here, it measured 0.7622.

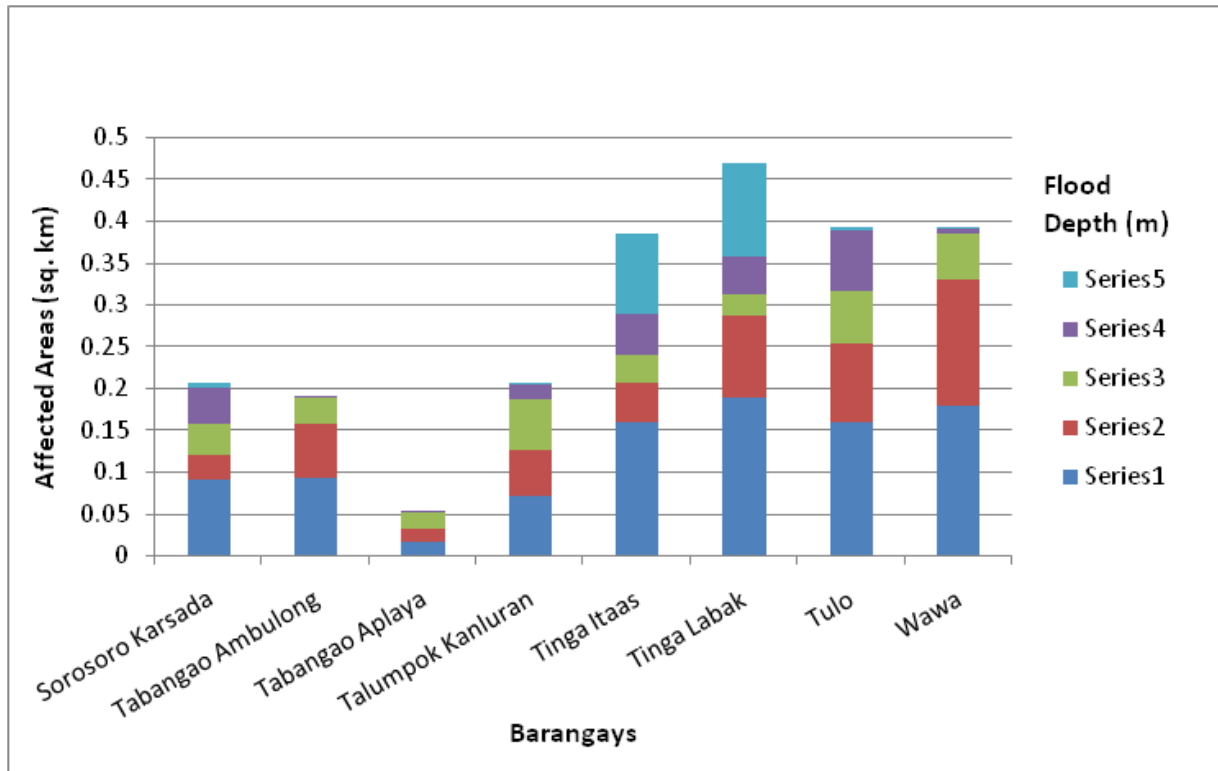
Figure 73. Affected areas in Batangas City, Batangas during a 5-year rainfall return period

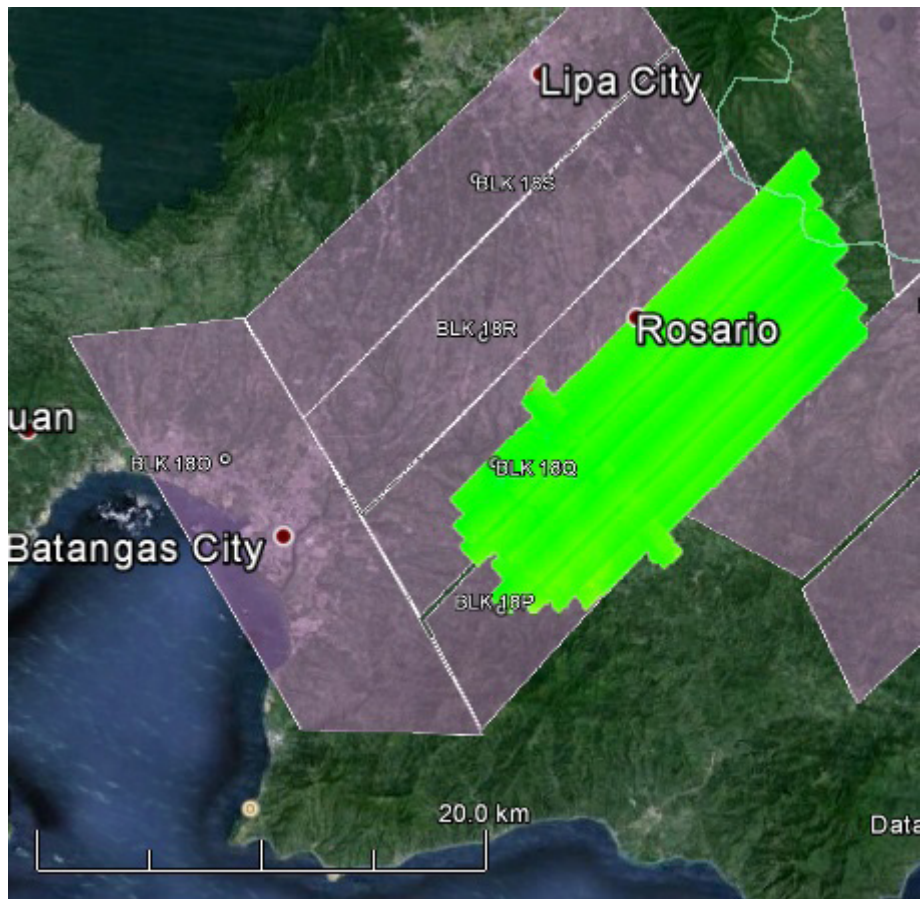
Flight No. : 1111P
Area: BLK 18RS AND BLK 18ES
Mission Name: 1BLK18RS46A
Parameters: PRF 200 SF 30 FOV 50

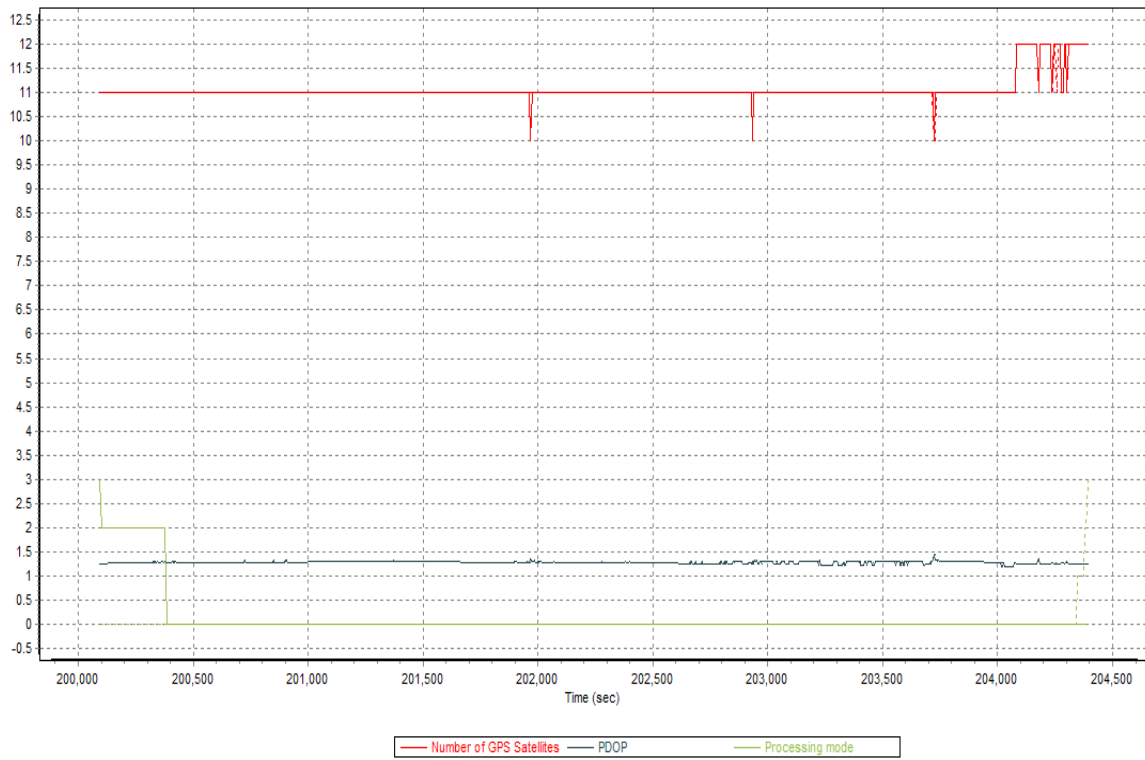
Figure 1.6.1. Solution Status

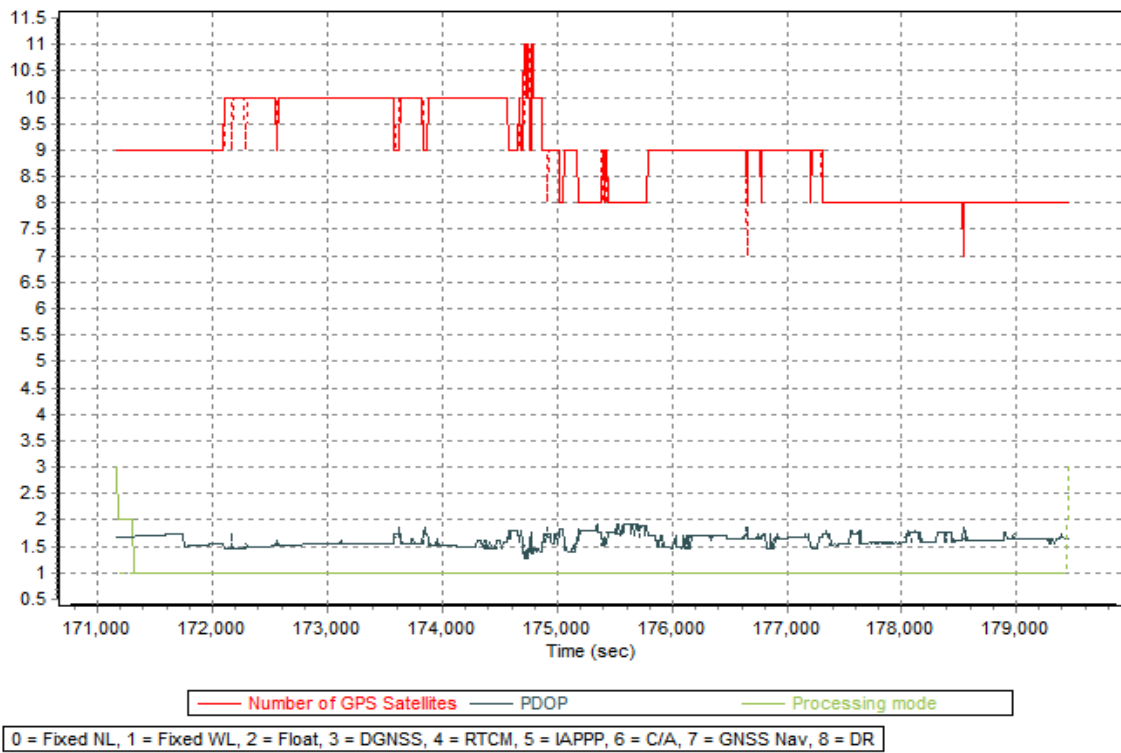
Figure 1.9.1. Solution Status

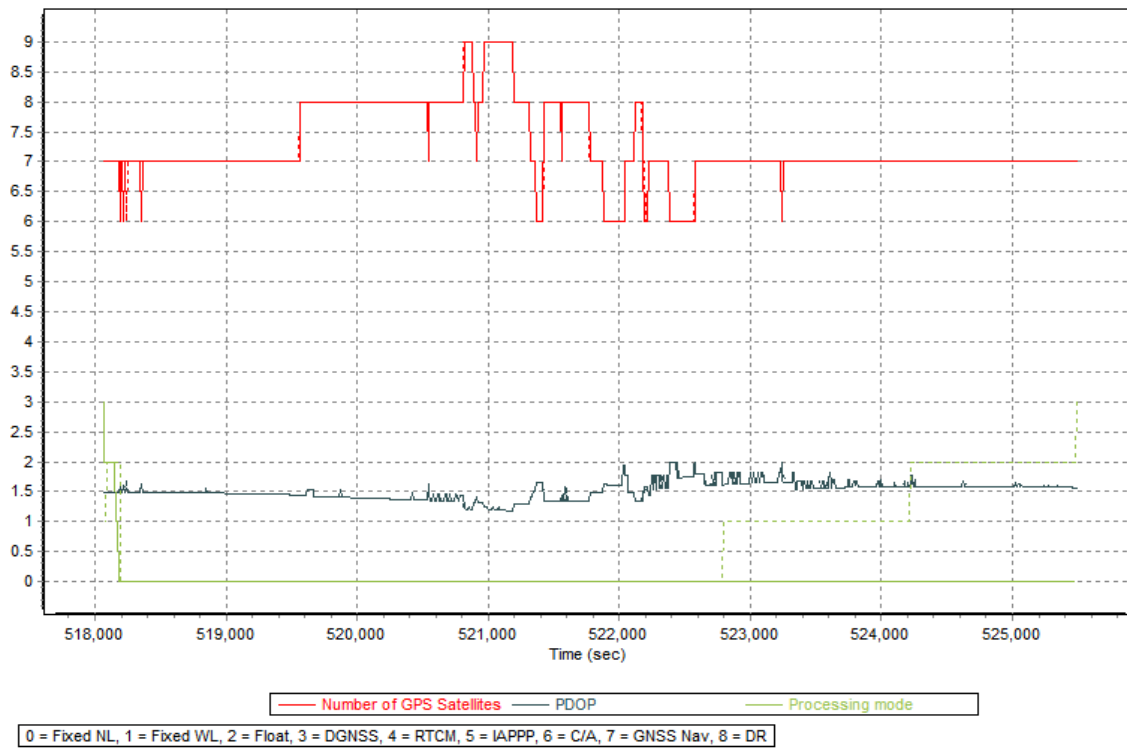
Figure 1.11.1. Solution Status
