HAZARD MAPPING OF THE PHILIPPINES USING LIDAR (PHIL-LIDAR I)

LiDAR Surveys and Flood Mapping of Buaya River

University of the Philippines Training Center
for Applied Geodesy and Photogrammetry
University of the Philippines Baguio

APRIL 2017

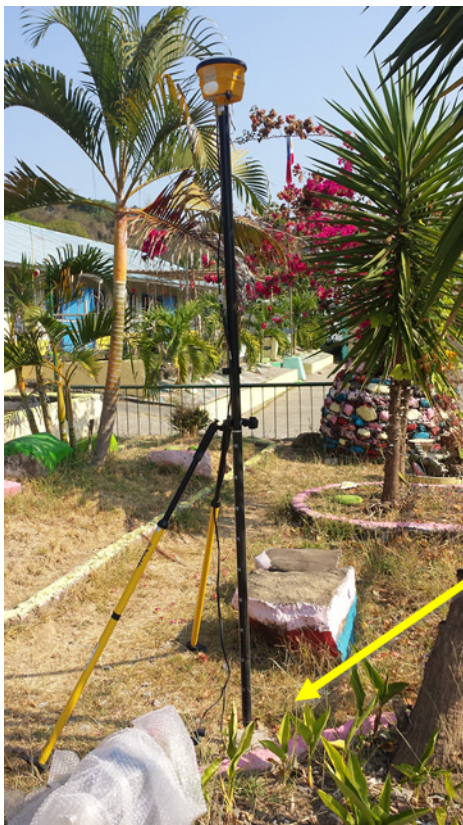
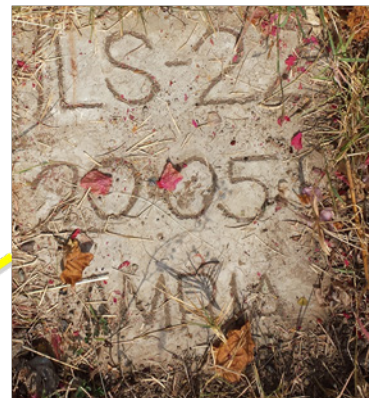
Figure 4. GPS set-up over ILS-22 inside Lidlidda North Central School in Lidlidda, Ilocos Sur (a) and NAMRIA reference point ILS-22 (b) as recovered by the field team.

Figure 3 to Figure 5 show the recovered NAMRIA reference points within the area. In addition, Table 3 to Table 5 show the details about the following NAMRIA control stations and established points while Table 5 shows the list of all ground control points occupied during the acquisition with the corresponding dates of utilization.

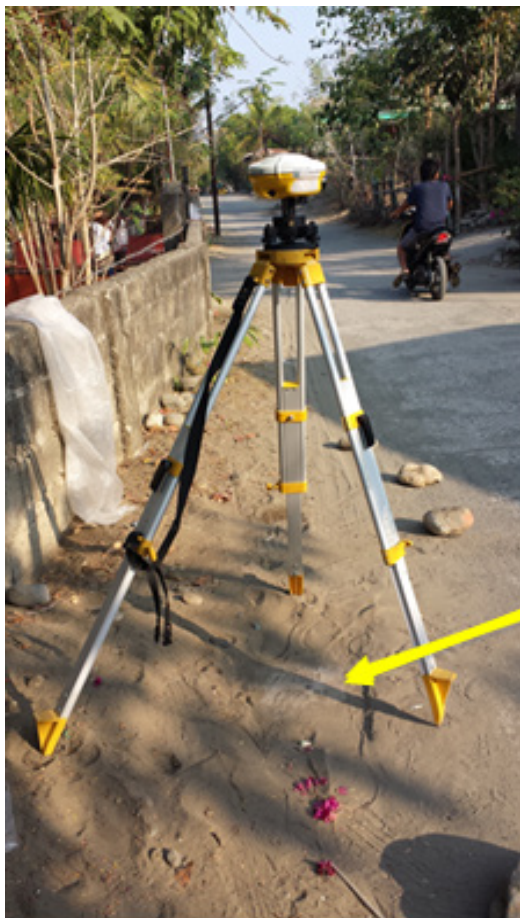
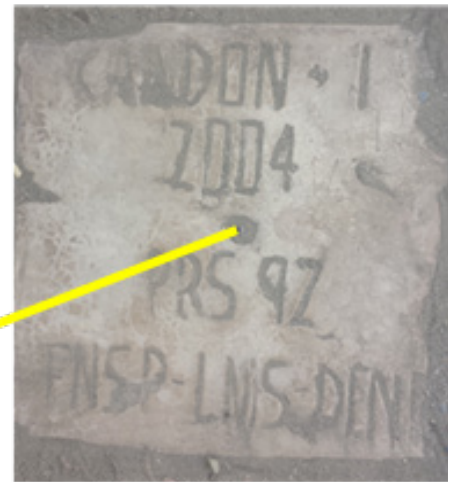
Figure 5. GPS set-up over ILS-24 beside the University of Northern Philippines Annex in Barangay Darapidap, Ilocos Sur (a) and NAMRIA reference point ILS-24 (b) as recovered by the field team.

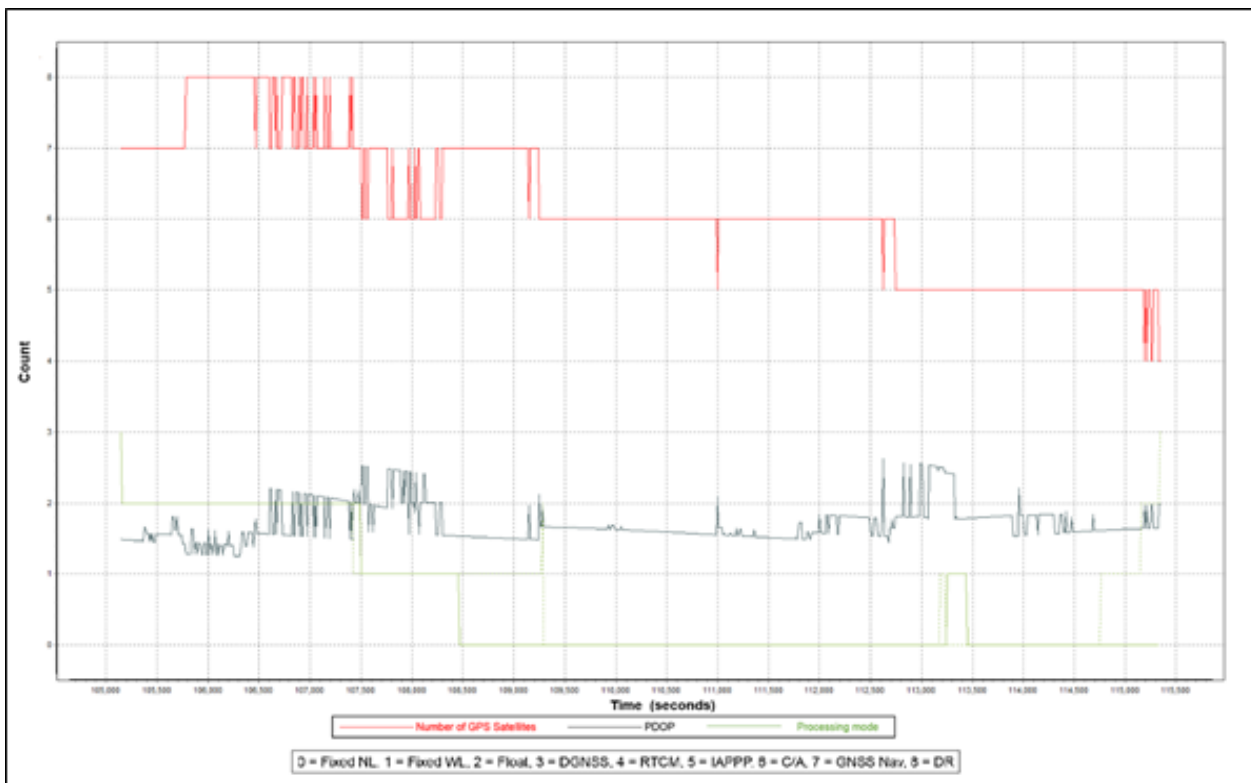
Figure 9. Solution Status Parameters of Buaya Flight 7119G.

The Solution Status parameters of flight 7119G, one of the Buaya flights, which are the number of GPS satellites, Positional Dilution of Precision, and the GPS processing mode used are shown in Figure 9. The graphs indicate that majority of the number of satellites during the acquisition did not go down to 6. Majority of the time, the number of satellites tracked was between 6 and 10. The PDOP value also did not go above the value of 3, which indicates optimal GPS geometry. The processing mode stayed at the value of 0 for majority of the survey with some peaks up to 1 and 2 attributed to the turns performed by the aircraft. The value of 0 corresponds to a Fixed, Narrow-Lane mode, which is the optimum carrier-cycle integer ambiguity resolution technique available for POSPAC MMS. All of the parameters adhered to the accuracy requirements for optimal trajectory solutions, as indicated in the methodology. The computed best estimated trajectory for all Buaya flights is shown in Figure 10.

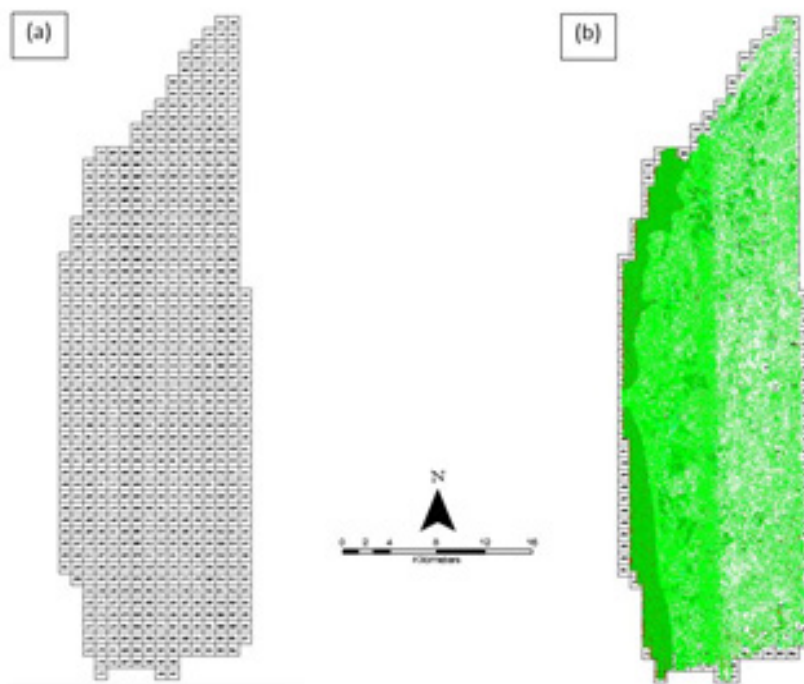
The tile system that TerraScan employed for the LiDAR data and the final classification image for a block in Buaya floodplain is shown in Figure 16. A total of 744 1km by 1km tiles were produced. The number of points classified to the pertinent categories is illustrated in Table 12. The point cloud has a maximum and minimum height of 859.24 meters and 37.49 meters respectively.

Figure 16. Tiles for Buaya floodplain (a) and classification results (b) in TerraScan.

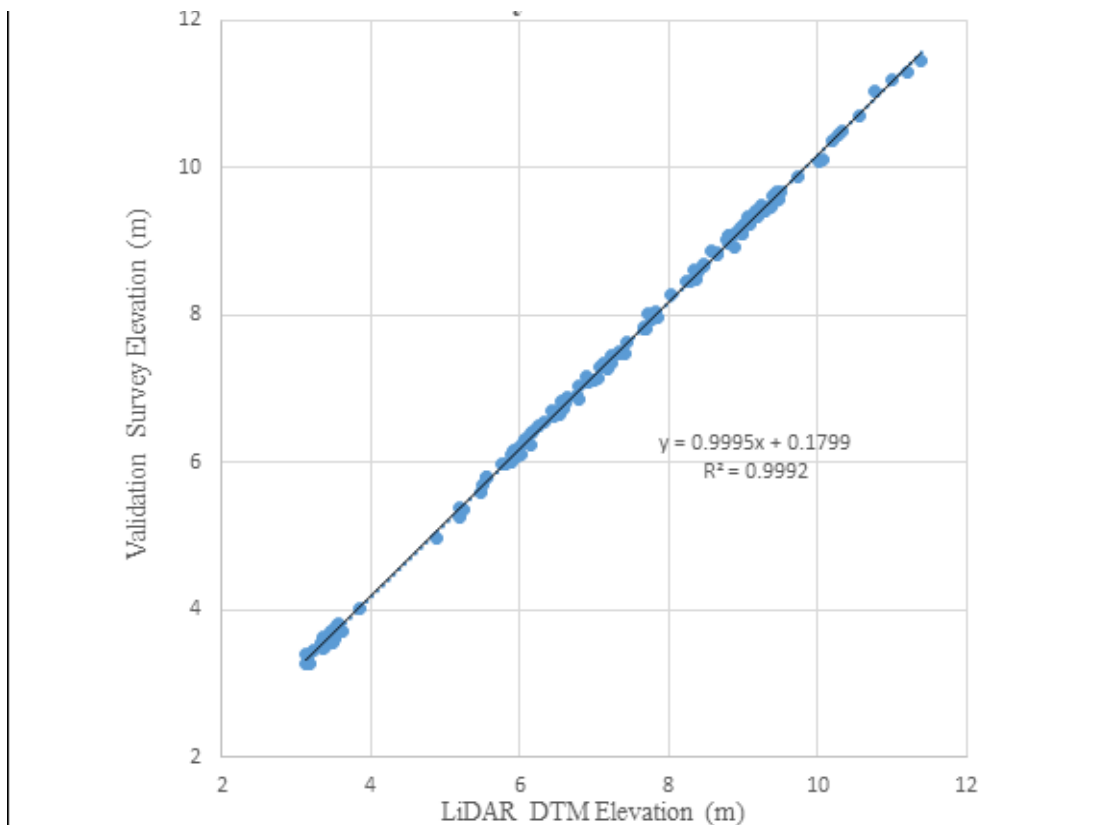
Figure 25. Correlation plot between validation survey points and LiDAR data.

Validation Statistical Measures	Value (meters)
RMSE	0.18
Standard Deviation	0.06
Average	-0.17
Minimum	-0.29
Maximum	-0.04

The remaining 20% of the total survey points, resulting to 135 points, were used for the validation of calibrated Buaya DTM. A good correlation between the calibrated mosaicked LiDAR elevation values and the ground survey elevation, which reflects the quality of the LiDAR DTM is shown in Figure 25. The computed RMSE between the calibrated LiDAR DTM and validation elevation values is 0.18 meters with a standard deviation of 0.06 meters, as shown in Table 16.

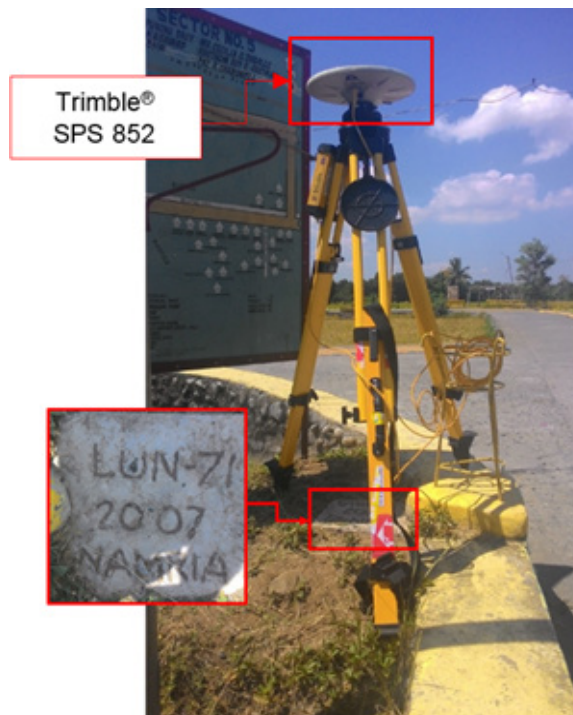
Figure 31. GNSS base set up, Trimble® SPS 852, at LUN-71, situated beside the irrigation canal at the right intersection of barangay roads, in Brgy. General Prim West, Municipality of Sudipen, La Union

The GNSS set-ups on recovered reference points and established control points in Buaya River are shown in Figure 31 to Figure 34.

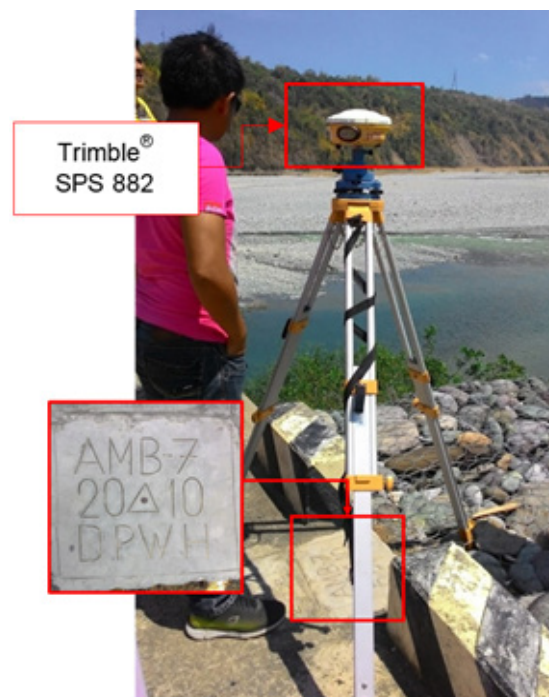
Figure 32. GNSS receiver setup, Trimble® SPS 882, at AMB-7, located at the approach of Alilem Bridge, in Brgy. Kiat, Municipality of Alilem, Ilocos Sur

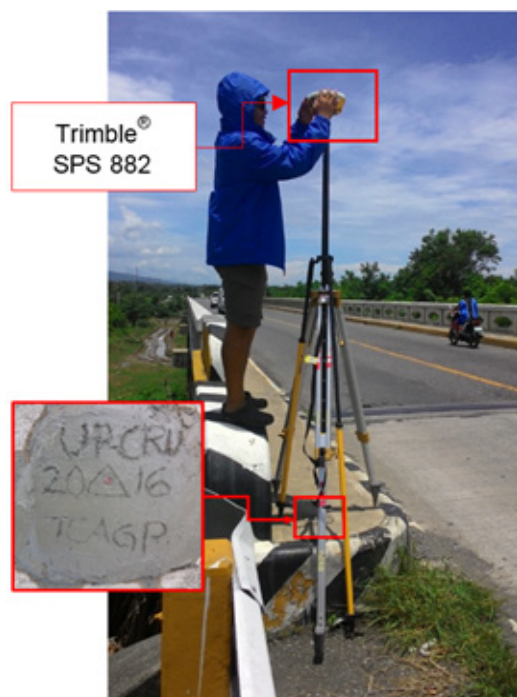
Figure 34. GNSS receiver setup, Trimble® SPS 882, at UP-CRU, located at the approach of Santa Cruz Bridge, in Brgy. Quinsoriano, Municipality of Santa Cruz, Ilocos Sur

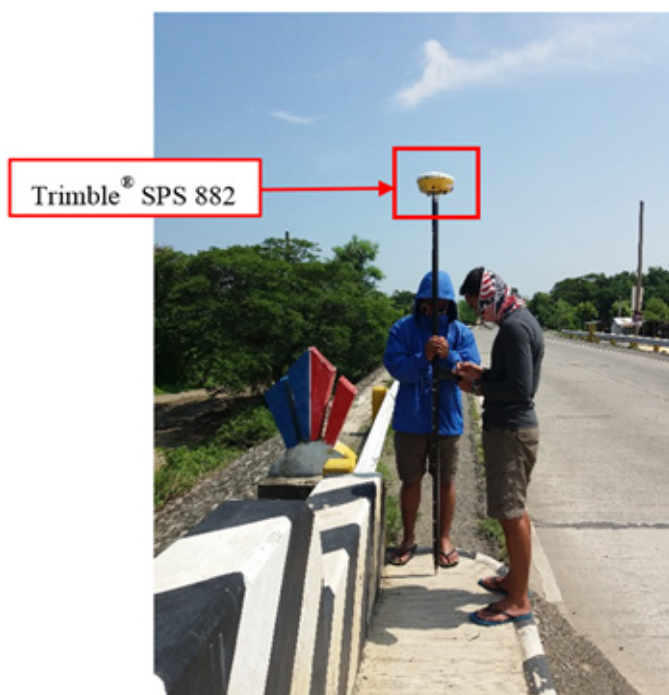
Figure 36. As-Built Survey of Santa Cruz Bridge

Cross-section and as-built survey were conducted on June 12, 2016 at the downstream side of Sta. Cruz Bridge in Brgy. Quinsoriano, Municipality of Santa Cruz, Ilocos Sur as shown in Figure 35. A survey grade GNSS receiver Trimble® SPS 882 in PPK survey technique was utilized for this survey as shown in Figure 36.

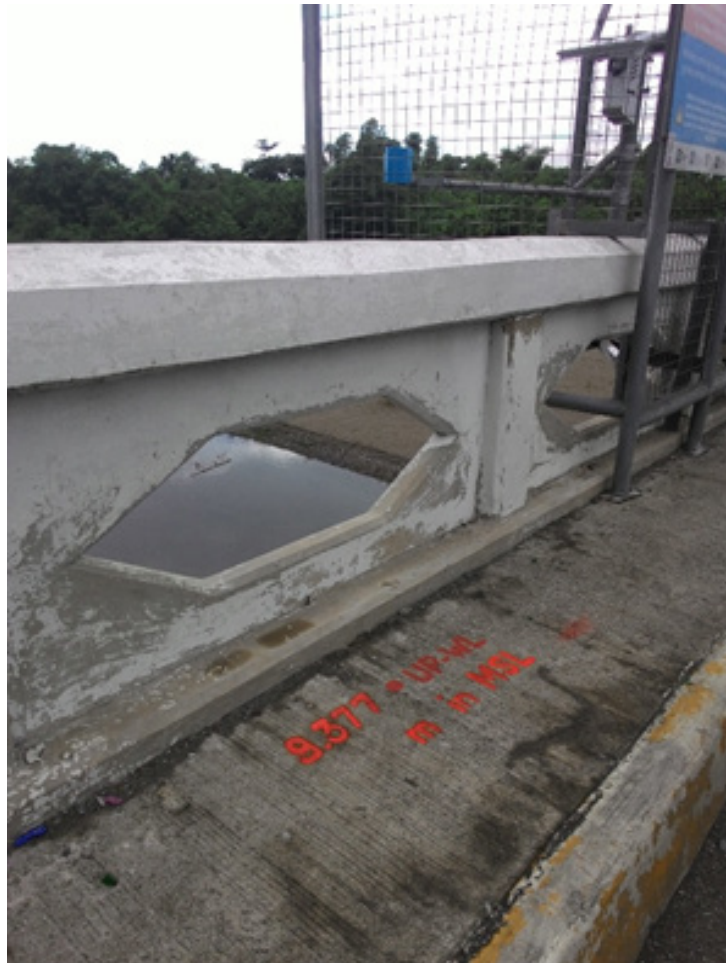
Figure 40. Water-level markings on the deck of Santa Cruz Bridge

Water surface elevation of Buaya River was determined a survey grade GNSS receiver Trimble® SPS 882 in PPK survey technique on June 12, 2016 at 11:38 AM with a value of 0.711 m in MSL as shown in Figure 38. This was translated into marking on the bridge's deck using the same technique with a value of 9.377 m in MSL. This will serve as reference for flow data gathering and depth gauge deployment of UPB for Buaya River.

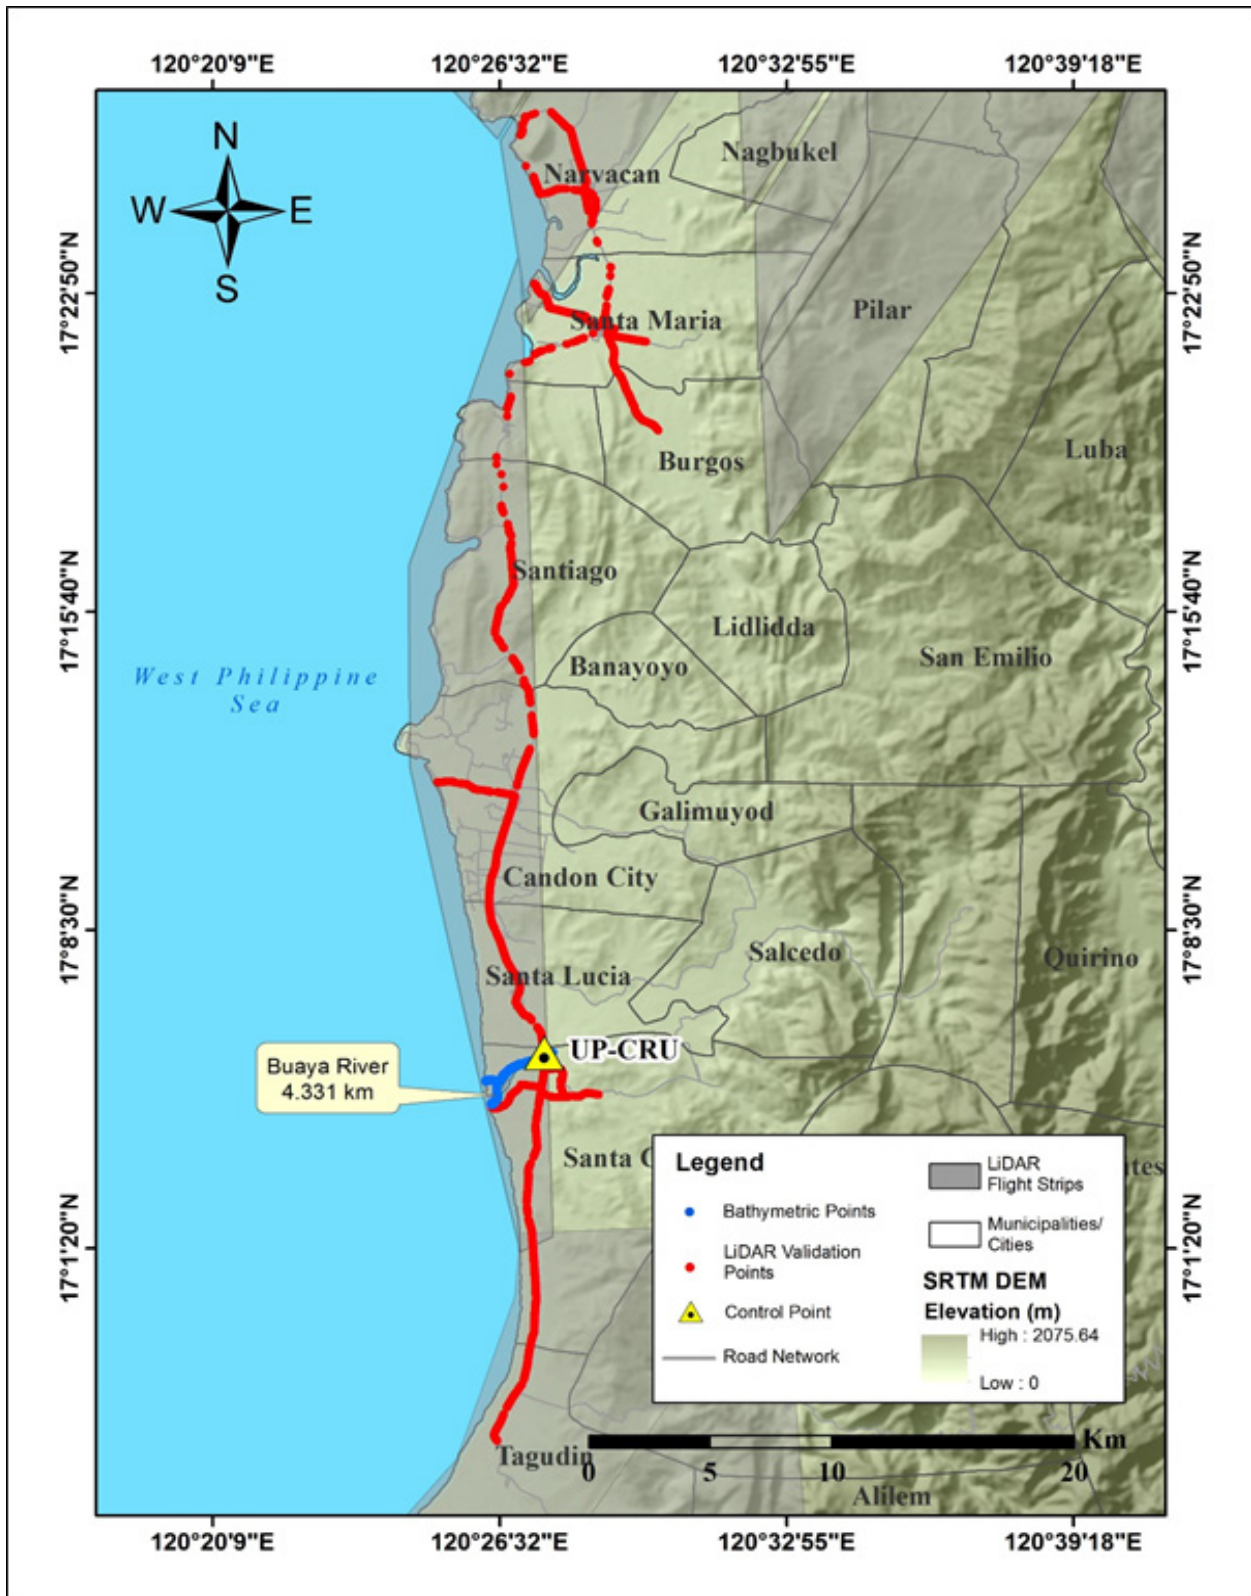
Figure 42. Validation point acquisition survey of Buaya River basin

The survey started from Brgy. Borono in the Municipality of Tagudin, going north covering seven (7) Municipalities of Ilocos Sur namely: Santa Lucia, Santiago, San Esteban, Burgos, Santa Maria and Narvacan; and Candon City. The survey gathered a total of 9,969 points with approximate length of 78.68 km using UP-CRU as GNSS base stations for the entire extent validation points acquisition survey as illustrated in the map in Figure 42.

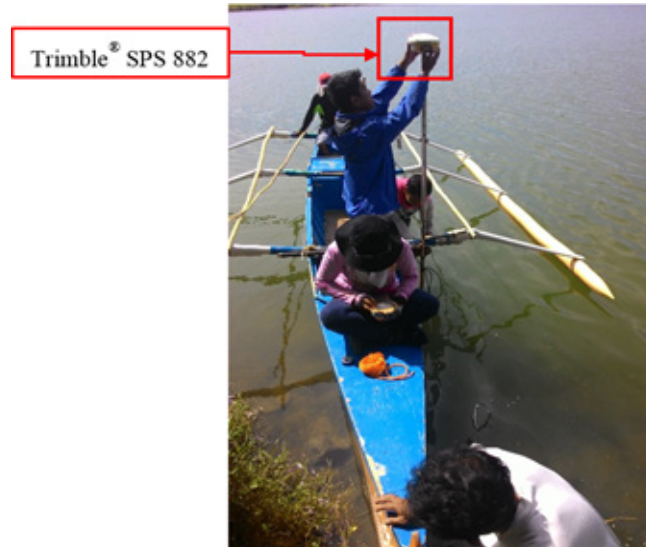
Figure 43. Bathymetric survey using Ohmex™ single beam echo sounder in Buaya River

Bathymetric survey was executed on June 14, 2016 using an Ohmex™ single beam echo sounder and Trimble® SPS 882 in GNSS PPK survey technique in continuous topo mode as illustrated in Figure 43. The survey started from in Brgy. Villa Hermosa, Municipality of Santa Cruz, with coordinates 17°5'30.12262"N, 120°26'59.90222"E, and ended at two different mouths of the river: in Brgy. Pilar with coordinates 17°4'34.72341"N, 120°26'21.36624"E; and in Brgy. Villa Hermosa with coordinates 17°5'6.76064"N,

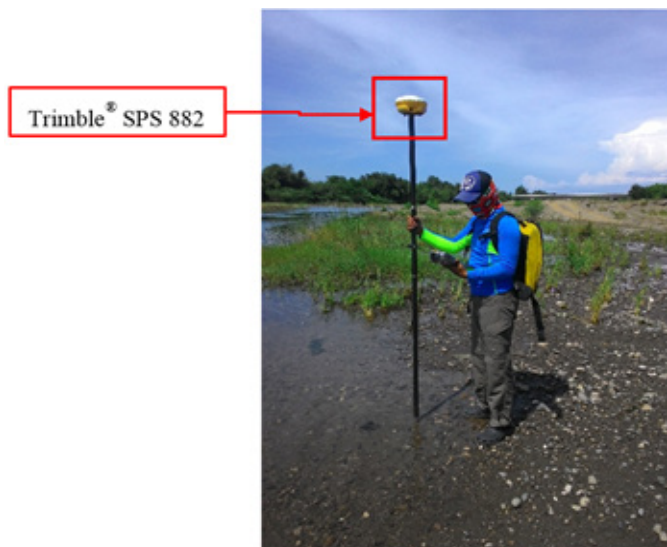
Figure 44. Manual bathymetric survey in Buaya River

Manual bathymetric survey, on the other hand, was conducted simultaneously on the same day using a Trimble® SPS 882 in GNSS PPK survey technique in continuous topo mode as shown in Figure 44. The survey started from the upstream of the river in Brgy. Quinsoriano, Municipality of Santa Cruz, with coordinates 17°5'45.03500"N, 120°27'43.96187"E, traversed down by foot, and ended at the starting point of bathymetric survey by boat. The control point UP-CRU was used as the GNSS base station all throughout the entire survey.

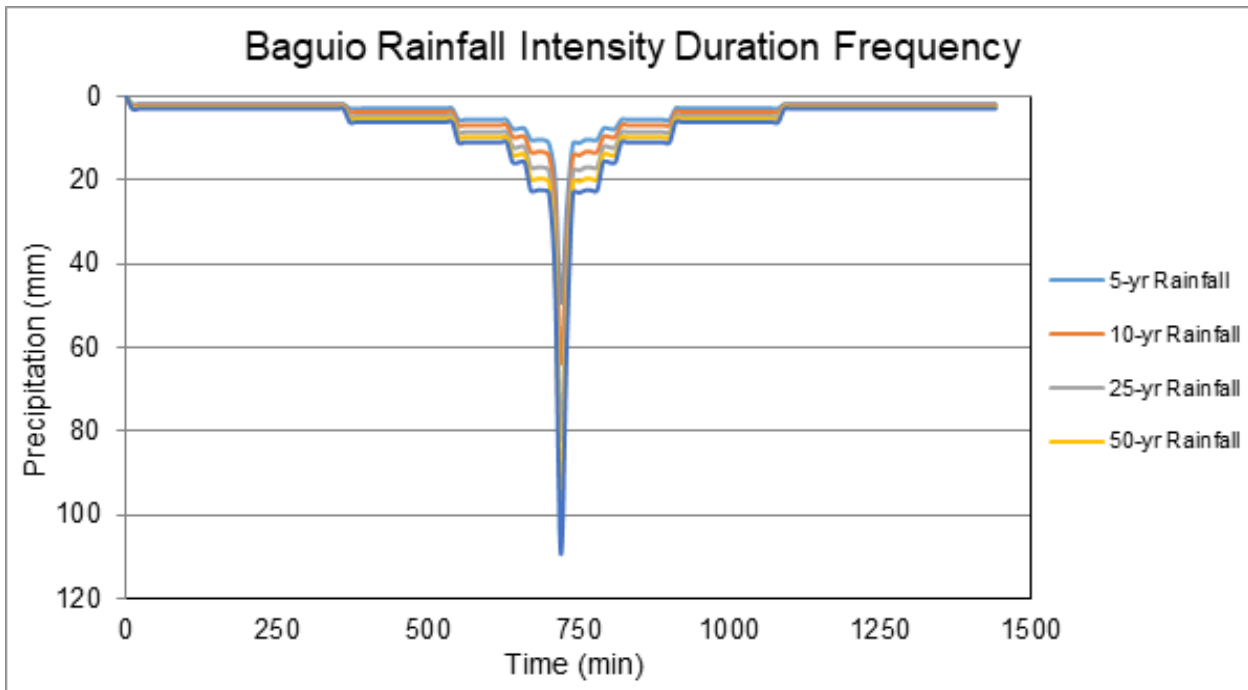
Figure 53. Synthetic storm generated for a 24-hr period rainfall for various return periods.

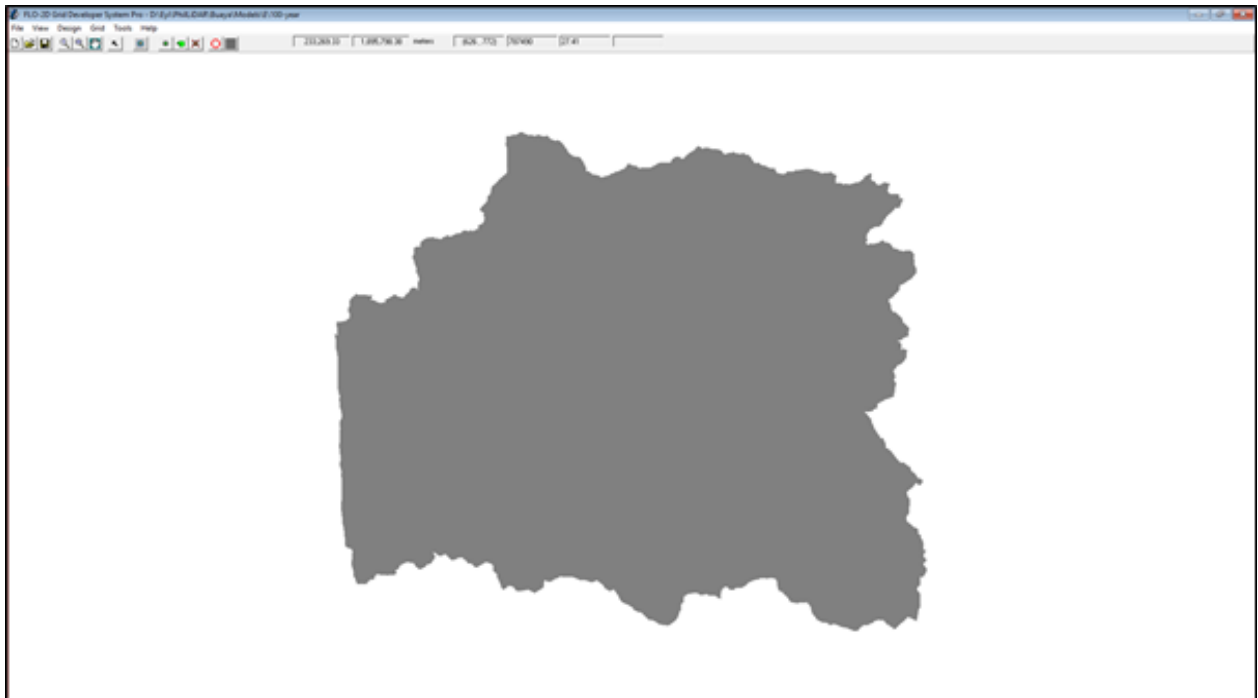
The automated modelling process allows for the creation of a model with boundaries that are almost exactly coincidental with that of the catchment area. As such, they have approximately the same land area and location. The entire area is divided into square grid elements, 10 meter by 10 meter in size. Each element is assigned a unique grid element number which serves as its identifier, then attributed with the parameters required for modelling such as x-and y-coordinate of centroid, names of adjacent grid elements, Manning coefficient of roughness, infiltration, and elevation value. The elements are arranged spatially to form the model, allowing the software to simulate the flow of water across the grid elements and in eight directions (north, south, east, west, northeast, northwest, southeast, southwest).

Based on the elevation and flow direction, it is seen that the water will generally flow from the east of the model to the west, following the main channel. As such, boundary elements northwest of the model are assigned as outflow elements.

Figure 60. A screenshot of the river subcatchment with the computational area to be modeled in FLO-2D Grid Developer System Pro (FLO-2D GDS Pro)

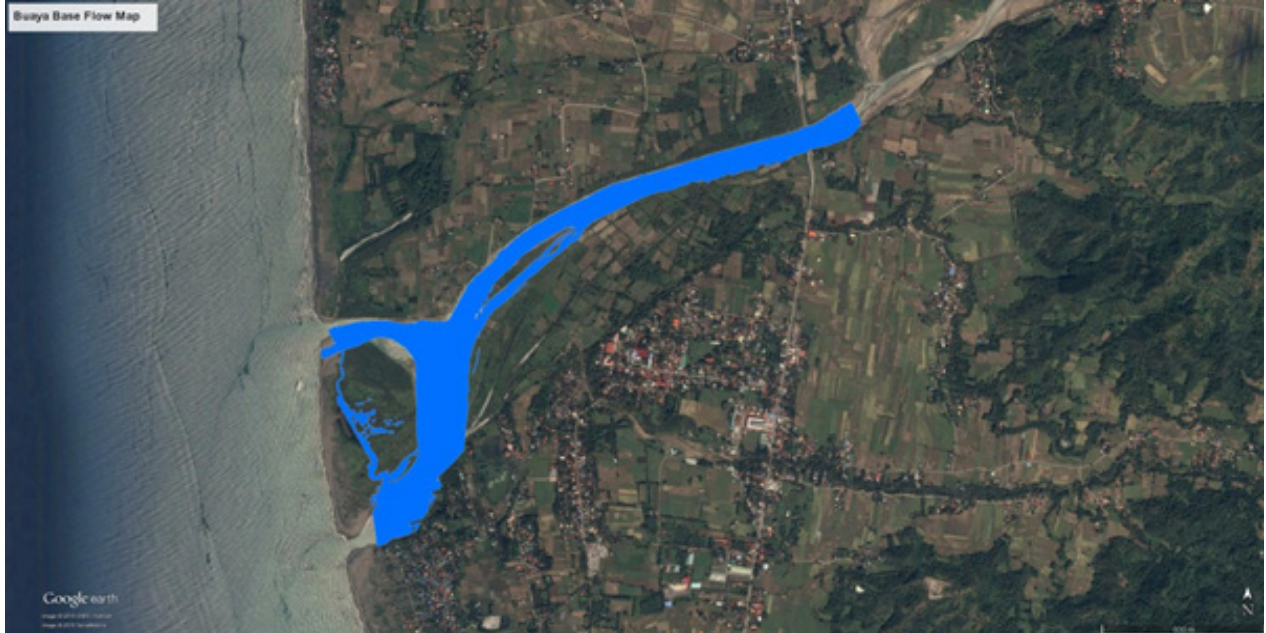
The HEC-RAS Flood Model produced a simulated water level at every cross-section for every time step for every flood simulation created. The resulting model will be used in determining the flooded areas within the model. The simulated model will be an integral part in determining real-time flood inundation extent of the river after it has been automated and uploaded on the DREAM website. For this publication, only a sample output map river was to be shown. The sample generated map of Buaya River using the calibrated HMS base flow is shown in Figure 63.

Figure 63. Sample output of Buaya RAS Model

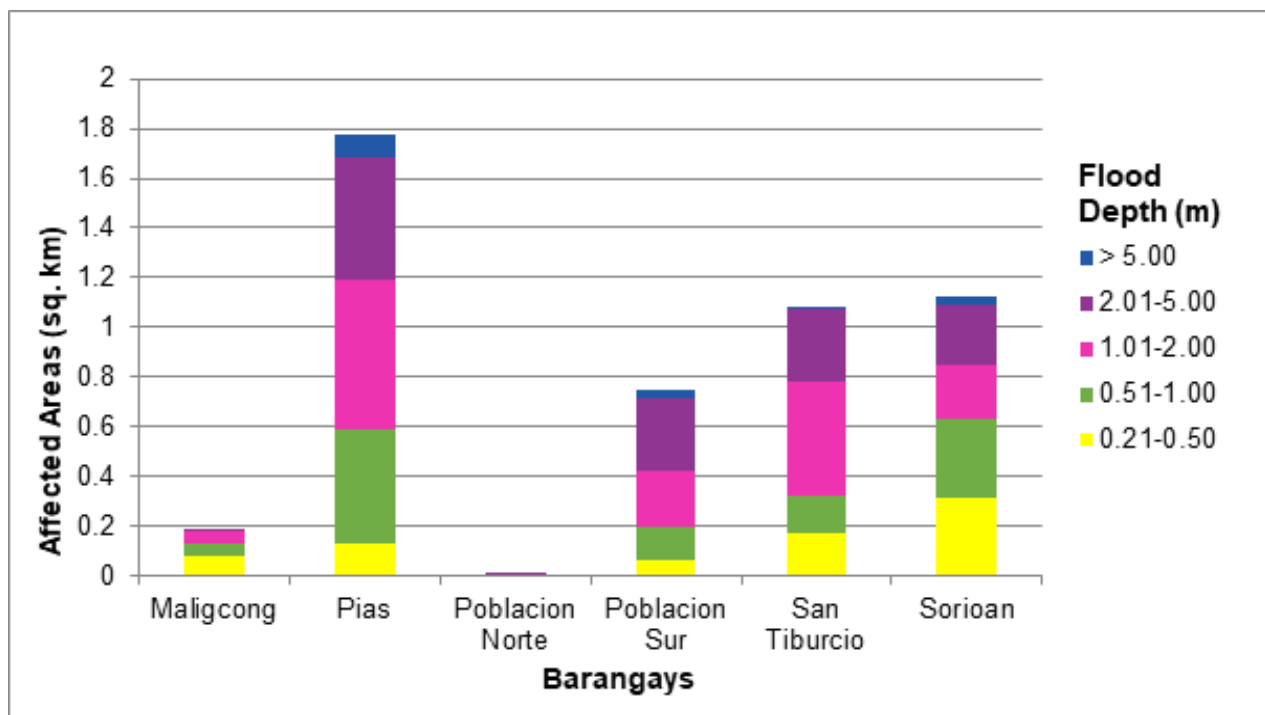
Figure 72. Affected Areas in Salcedo, Ilocos Sur during 5-Year Rainfall Return Period

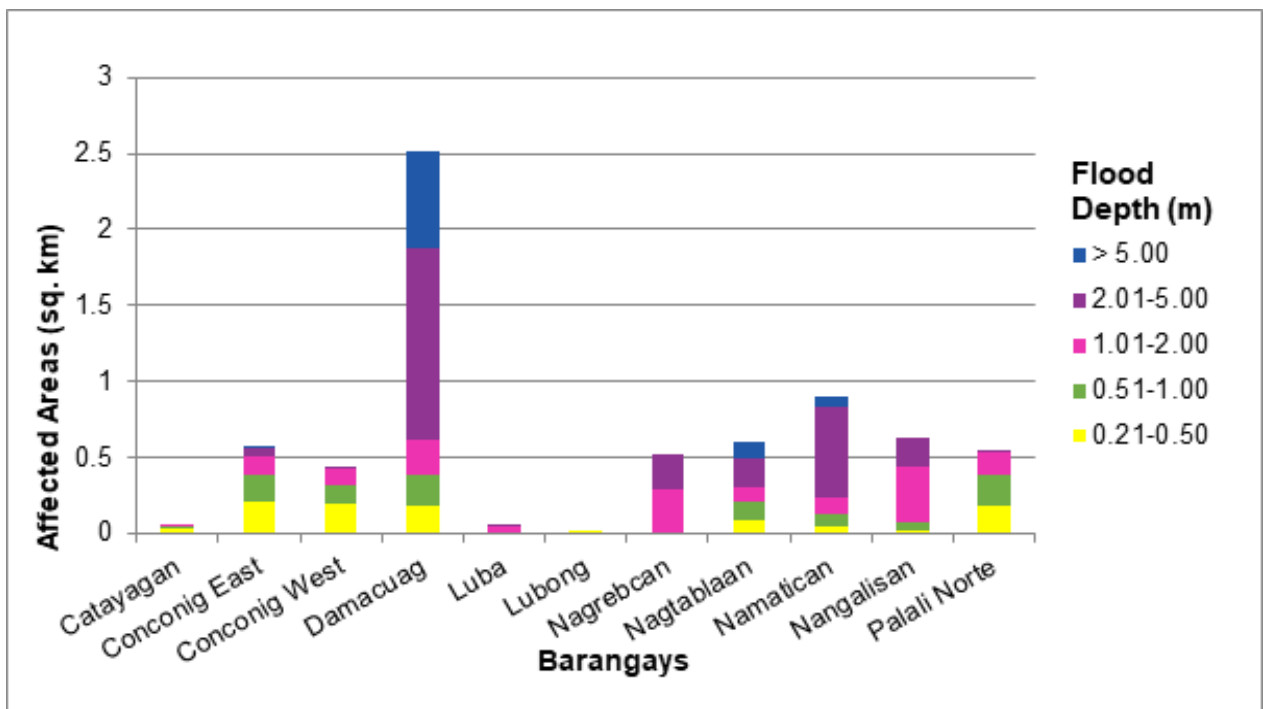
Figure 77. Affected Areas in Santa Lucia, Ilocos Sur during 5-Year Rainfall Return Period
