Hazard Mapping of the Philippines Using LIDAR (Phil-LIDAR 1)

LiDAR Surveys and Flood Mapping of Aklan River

University of the Philippines Training Center
for Applied Geodesy and Photogrammetry
University of the Philippines Cebu

APRIL 2017

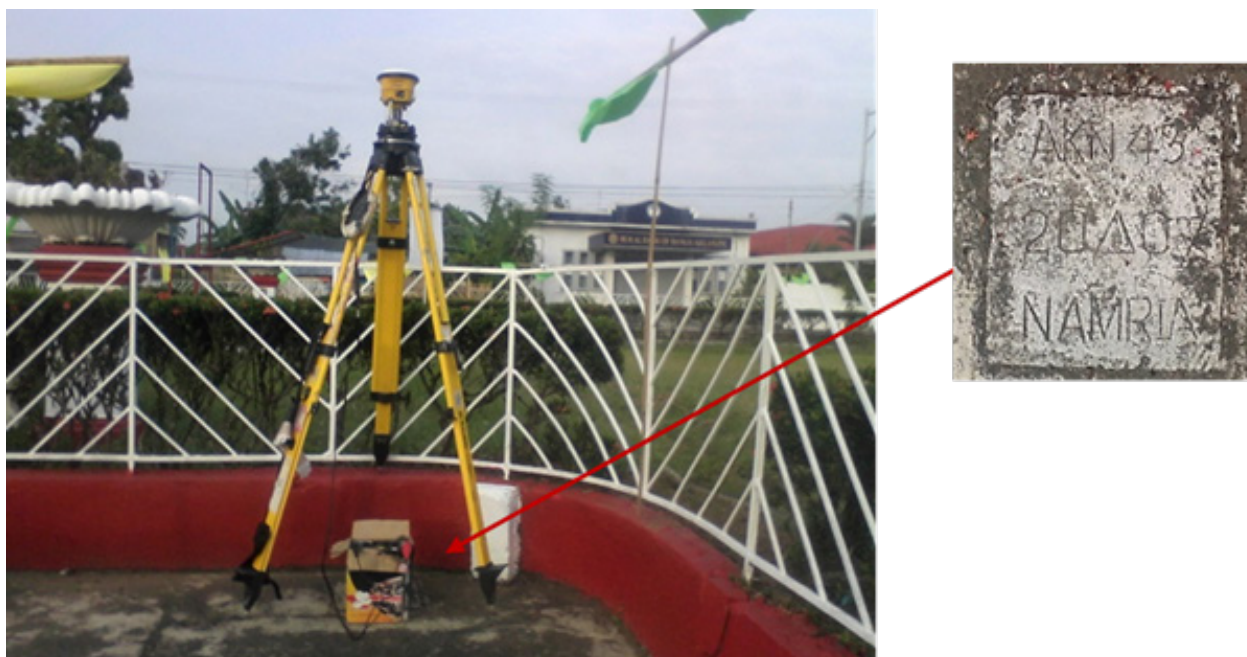
Figure 4. GPS set-up over AKN-43 located on the concrete sidewalk in front of the municipal hall of Banga, Aklan, and NAMRIA reference point AKN-43 (b) as recovered by the field team.

Figure 4 to Figure 8 show the recovered NAMRIA reference points within the area. Table 3 to Table 7 show the details about the following NAMRIA reference stations and established points, while 8 shows the list of all ground control points occupied during the acquisition with the corresponding dates of utilization.

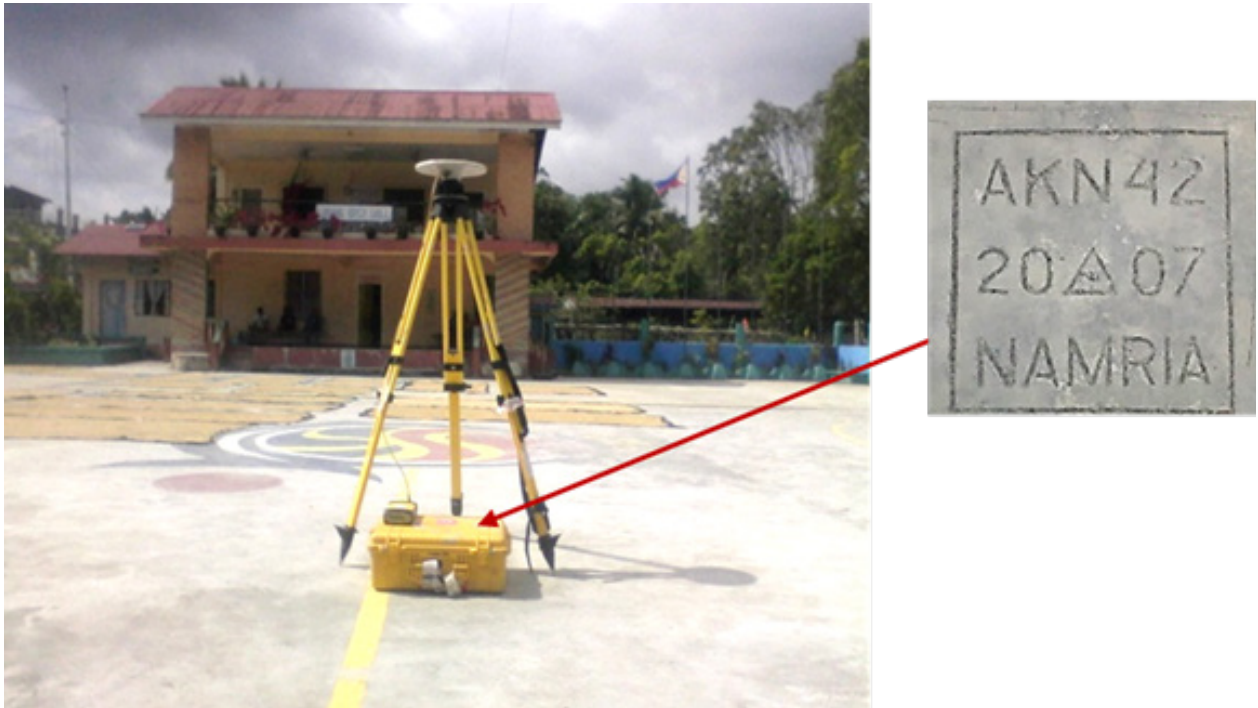
Figure 5. GPS set up over AKN-42 at the open court in Barangay Libang, Makato, Aklan (a) and NAMRIA reference point AKN-42 (b) as recovered by the field team.

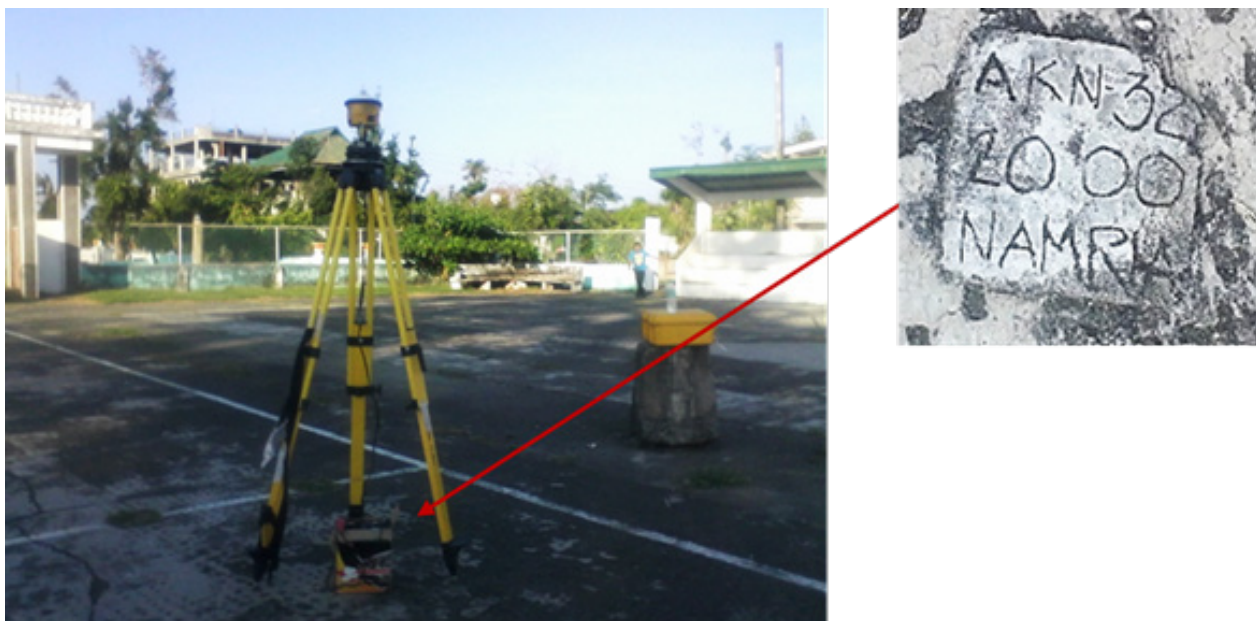
Figure 6. GPS set up over AKN-32 located at the centerpoint of Batan Multi-purpose Sports Center, (a) and NAMRIA reference point AKN-32 (b) as recovered by the field team.

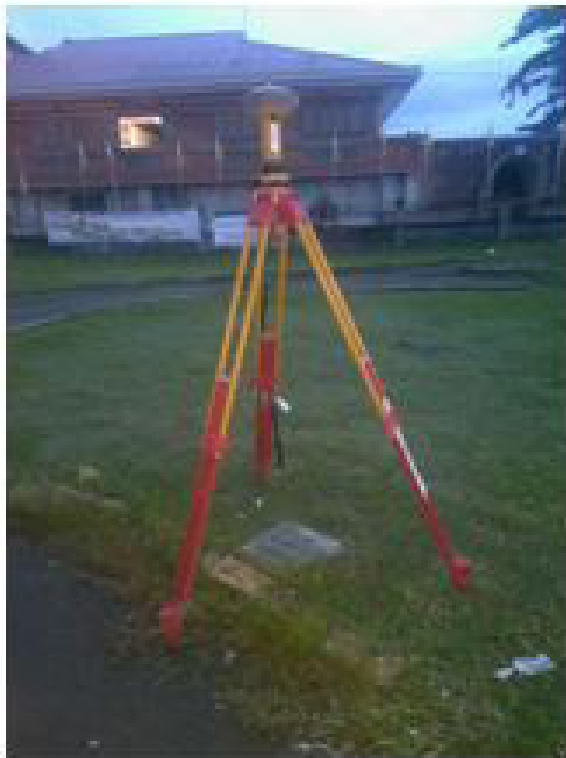
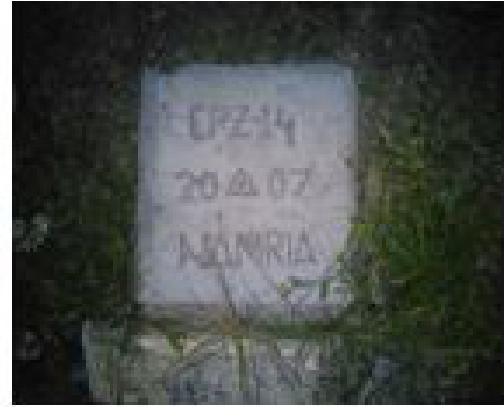
Figure 7. GPS set up over CPZ-14 located at the centerpoint of Batan Multi-purpose Sports Center, (a) and NAMRIA reference point CPZ-14 (b) as recovered by the field team

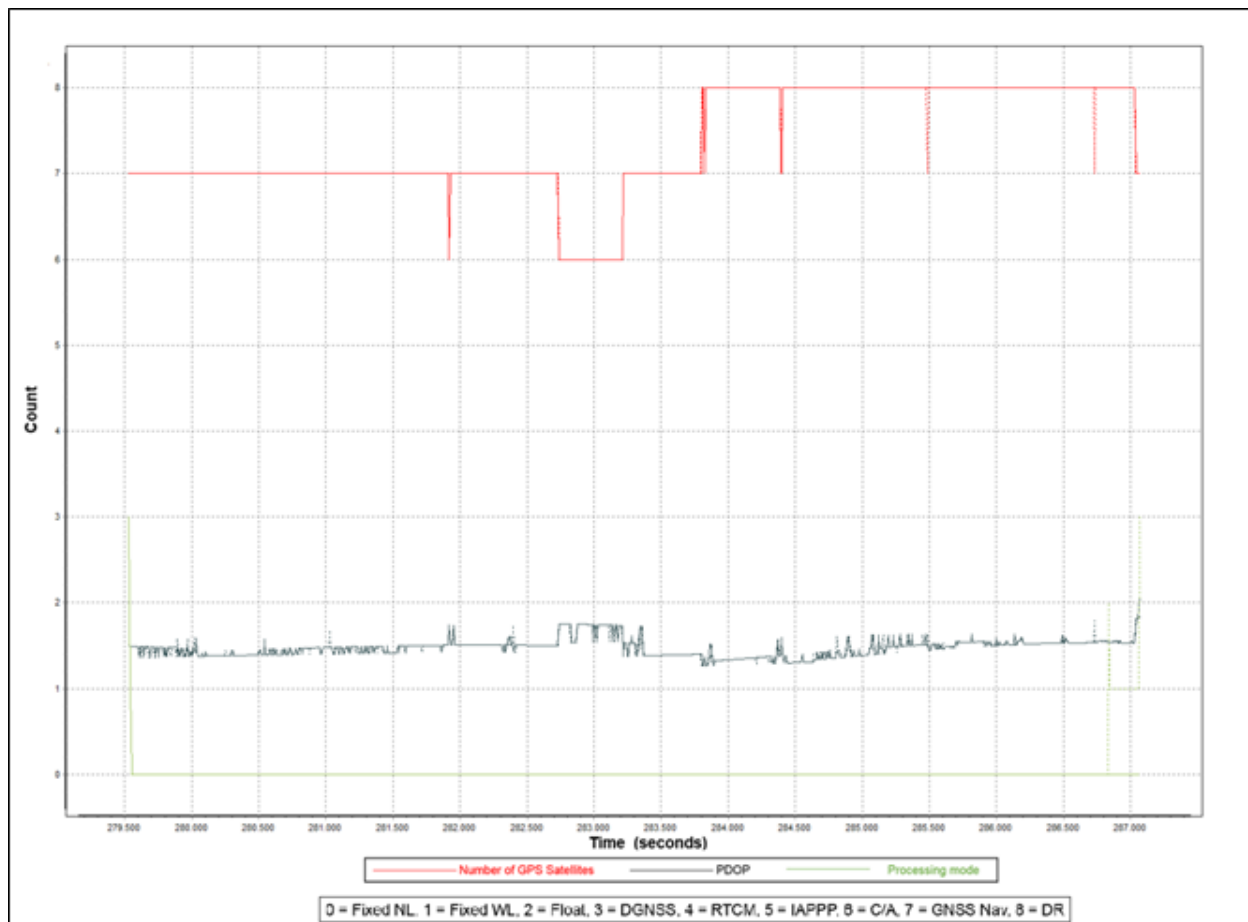
Figure 12. Solution Status Parameters of Aklan Flight 1232A.

The Solution Status parameters of flight 1232A, one of the Aklan flights, which are the number of GPS satellites, Positional Dilution of Precision, and the GPS processing mode used are shown in Figure 12. The graphs indicate that majority of the number of satellites during the acquisition did not go down to 6. Majority of the time, the number of satellites tracked was between 6 and 10. The PDOP value also did not go above the value of 3, which indicates optimal GPS geometry. The processing mode stayed at the value of 0 for majority of the survey with some peaks up to 1 and 2 attributed to the turns performed by the aircraft. The value of 0 corresponds to a Fixed, Narrow-Lane mode, which is the optimum carrier-cycle integer ambiguity resolution technique available for POSPAC MMS. All of the parameters adhered to the accuracy requirements for optimal trajectory solutions, as indicated in the methodology. The computed best estimated trajectory for all Aklan flights is shown in Figure 13.

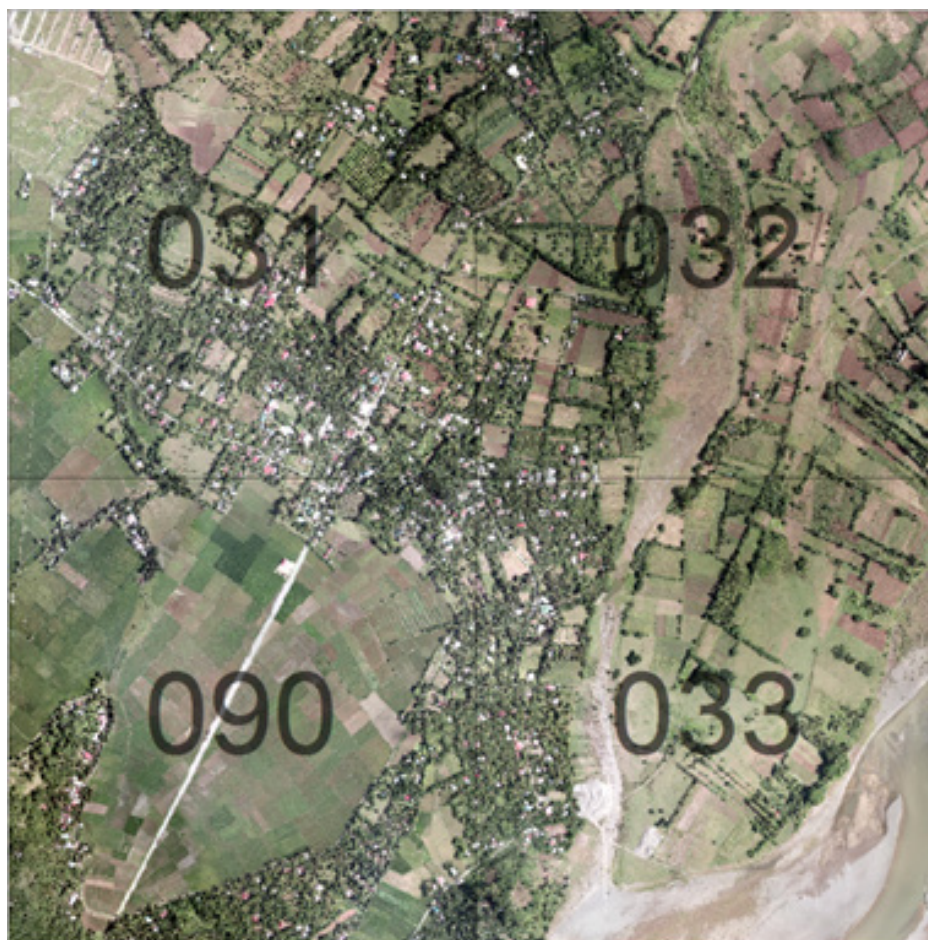
Figure 23. Sample orthophotograph tiles for Aklan Floodplain.

The 1,877 1km by 1km tiles area covered by Aklan floodplain is shown in Figure 22. After tie point selection to fix photo misalignments, color points were added to smoothen out visual inconsistencies along the seamlines where photos overlap. The Aklan floodplain has a total of 881.90 sq.km orthophotograph coverage comprised of 11,457 images. A zoomed in version of sample orthophotographs named in reference to its tile number is shown in Figure 23.

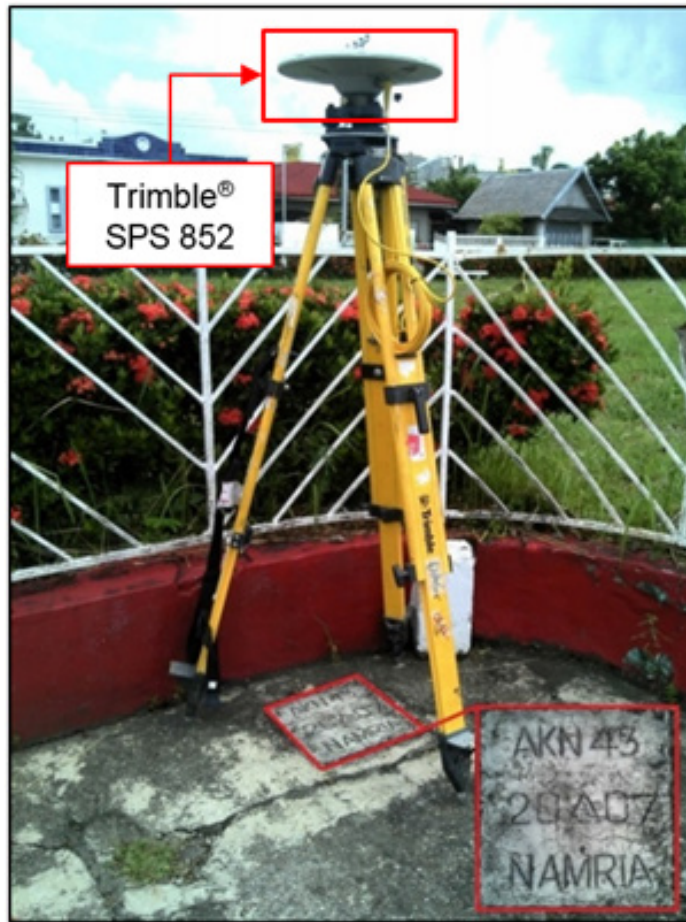
Figure 34. Trimble® SPS 852 GNSS receiver base station at AKN-43 in front of Banga Municipal Hall, Brgy. Poblacoin, Municipality of Banga

The GNSS receiver set up and established control points in Aklan survey are shown in Figure 34 to Figure 37.

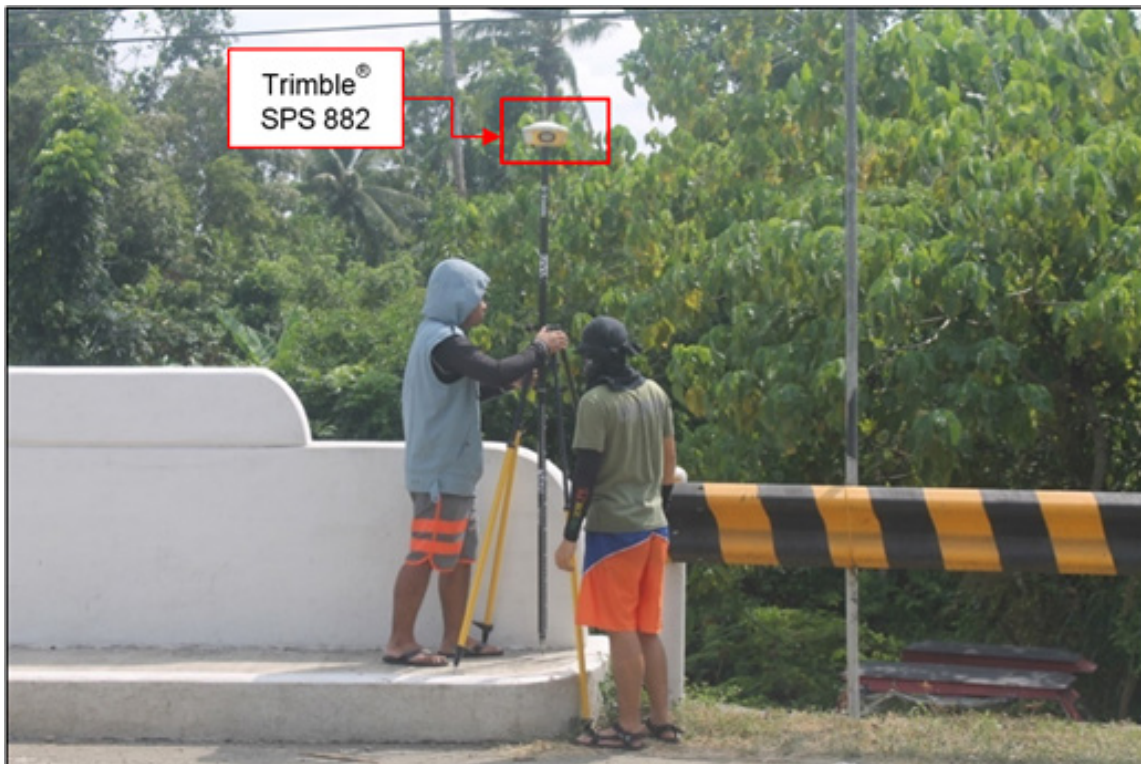
Figure 35. Trimble® SPS 882 GNSS receiver setup at AK-173, Dumga Bridge, Brgy. Dumga, Municipality of Makato

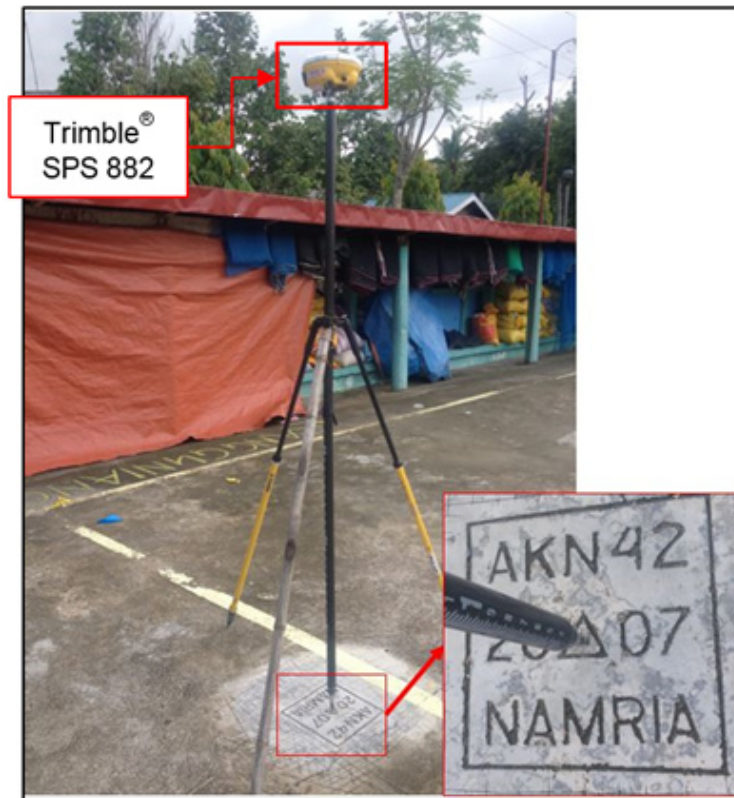
Figure 36. Trimble® SPS 882 GNSS receiver setup at AKN-42 inside a basketball court in Brgy. Libang, Municipality of Makato

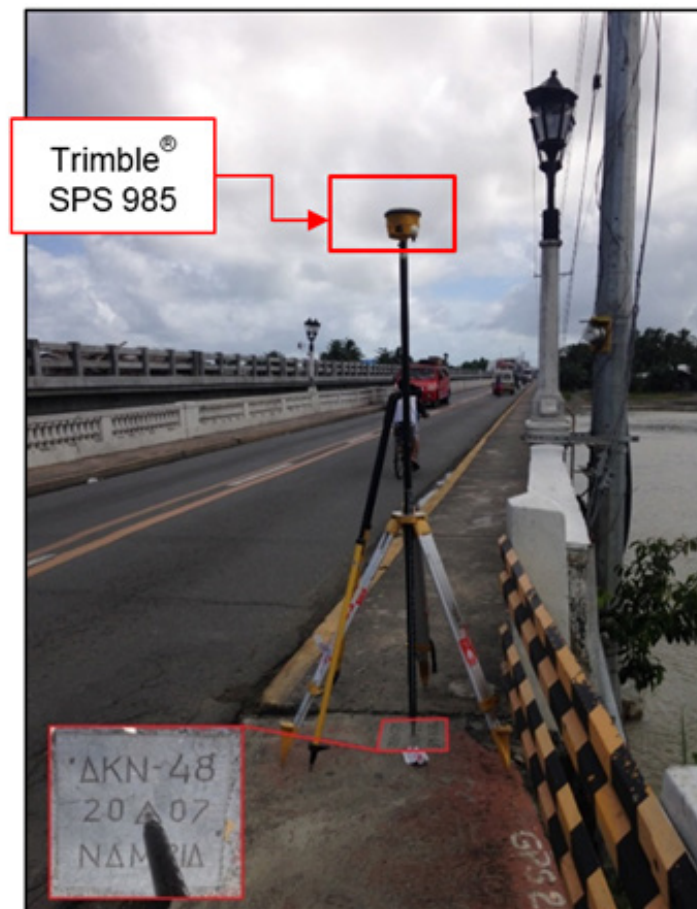
Figure 37. Trimble® SPS 985 GNSS receiver occupation at AKN-48 in Kalibo Bridge, Brgy. Poblacion, Municipality of Kalibo

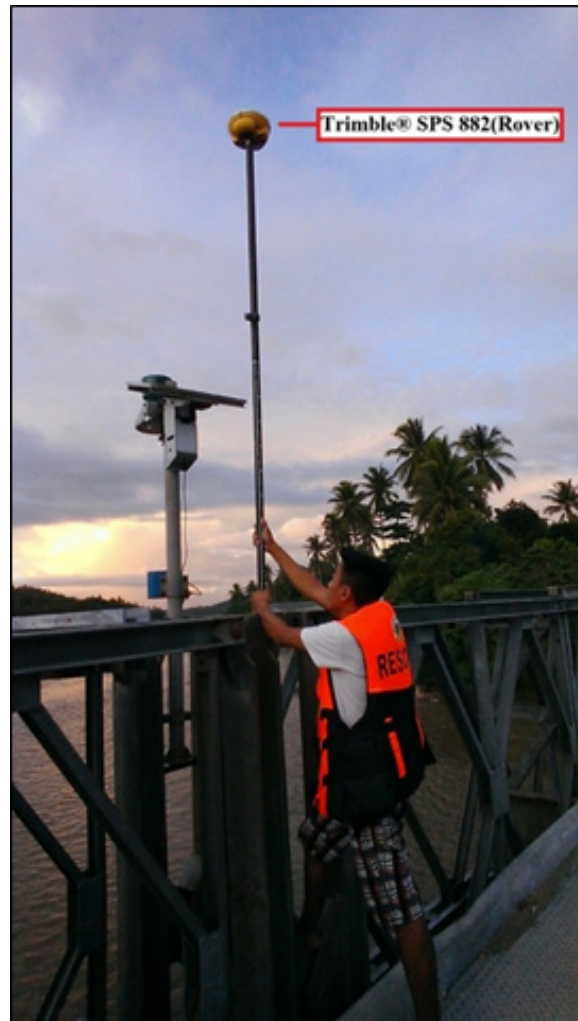
Cross section and as-built survey were conducted on November 2, 2015 at the downstream side of Guadalupe Bridge located in Brgy. Poblacion, Municipality of Madalag. using a Trimble® SPS 882 in GNSS PPK survey technique as shown in Figure 38.

Figure 38. AWLS elevation acquisition at Guadalupe Bridge, Brgy. Poblacion, Municipality of Madalag

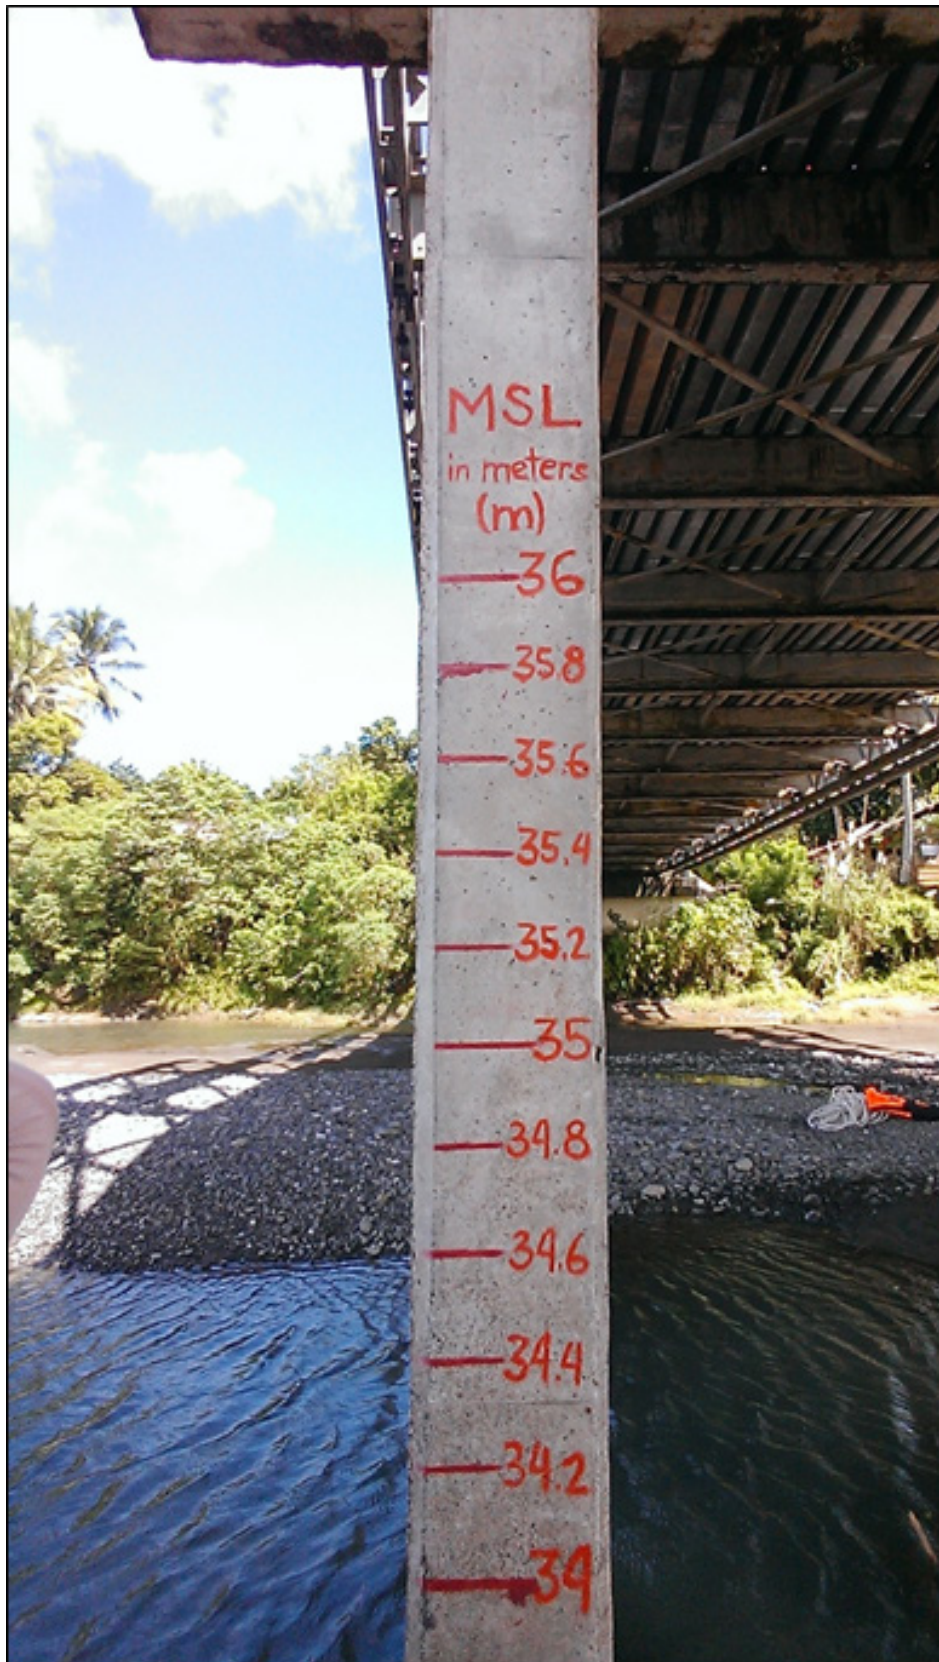
The water surface elevation of Aklan River in Guadalupe Bridge was acquired using PPK survey technique on November 2, 2015 at 11:46 a.m. The resulting water surface elevation data at Guadalupe Bridge is 37.435 m above MSL. This was translated into a marking on the bridge's pier to serve as a reference for flow data gathering and depth gauge deployment of UP Cebu PHIL-LIDAR 1. The marked water level marking for Guadalupe Bridge is shown in Figure 42.

Figure 42. Water level gauge at one of the pier of Guadalupe Bridge, Brgy. Poblacion, Municipality of Madalag

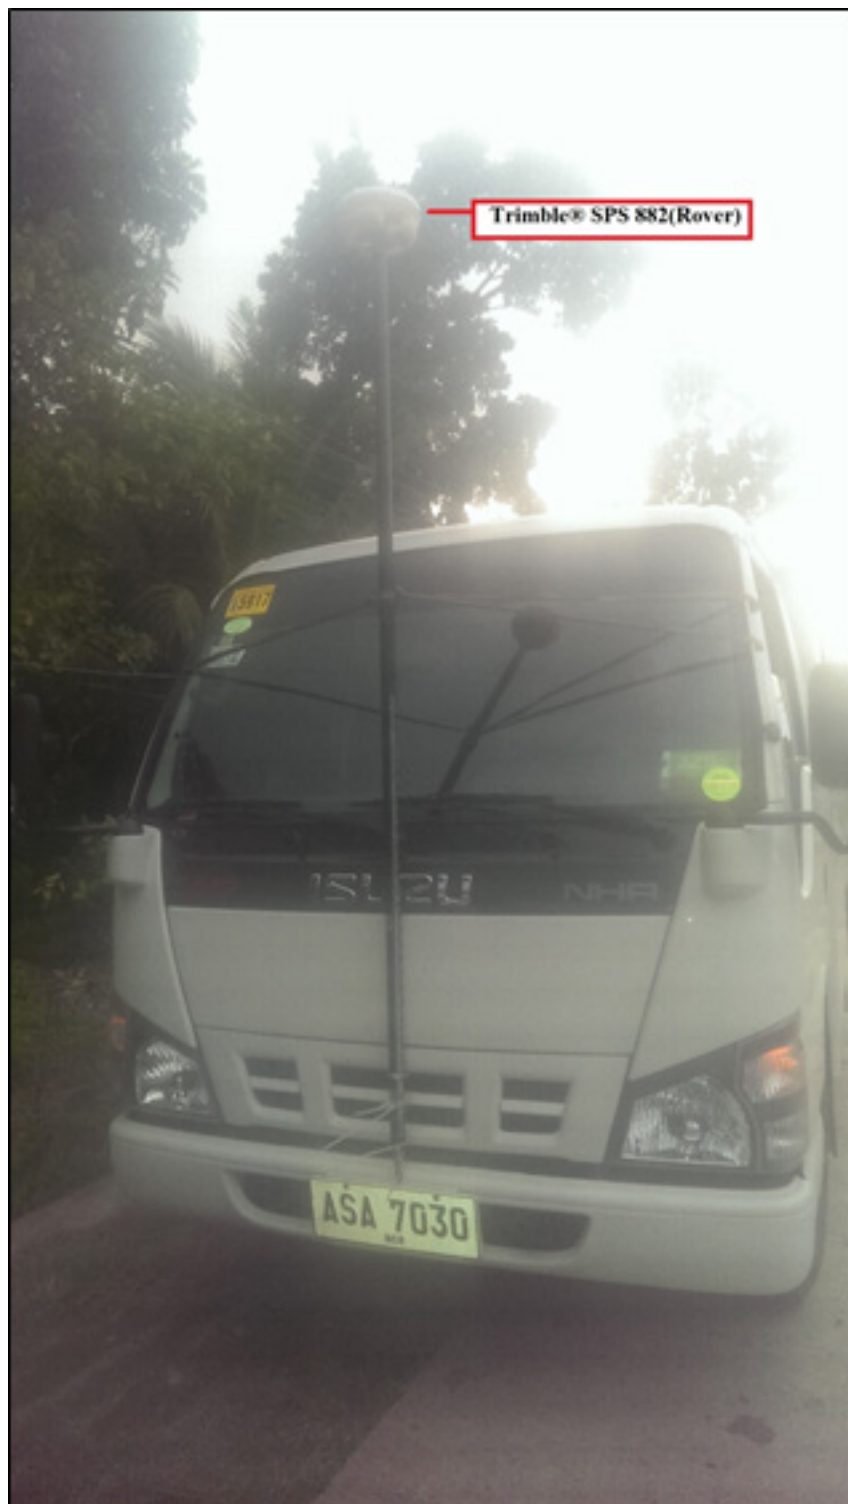
Validation Points Acquisition Survey was conducted on November 1, 2015 using a survey-grade GNSS Rover receiver mounted on a pole which was attached to the front of vehicle as shown in Figure 43. It was secured with a nylon rope to ensure that it was horizontally and vertically balanced. The antenna height is 2.532 m measured from the ground up to the bottom of notch of the GNSS Rover receiver. The survey was conducted using PPK technique on a continuous topo mode and by setting up a base station on AKN-43 in Brgy. Poblacion, Banga which is shown in Figure 42. The ground validation survey covered the major roads running along Aklan West Road and Iloilo-Antique Road from Brgy. Solido, Nagas City to Brgy. Aliputos, Numancia City, Aklan.

Figure 43. Validation points acquisition survey set-up

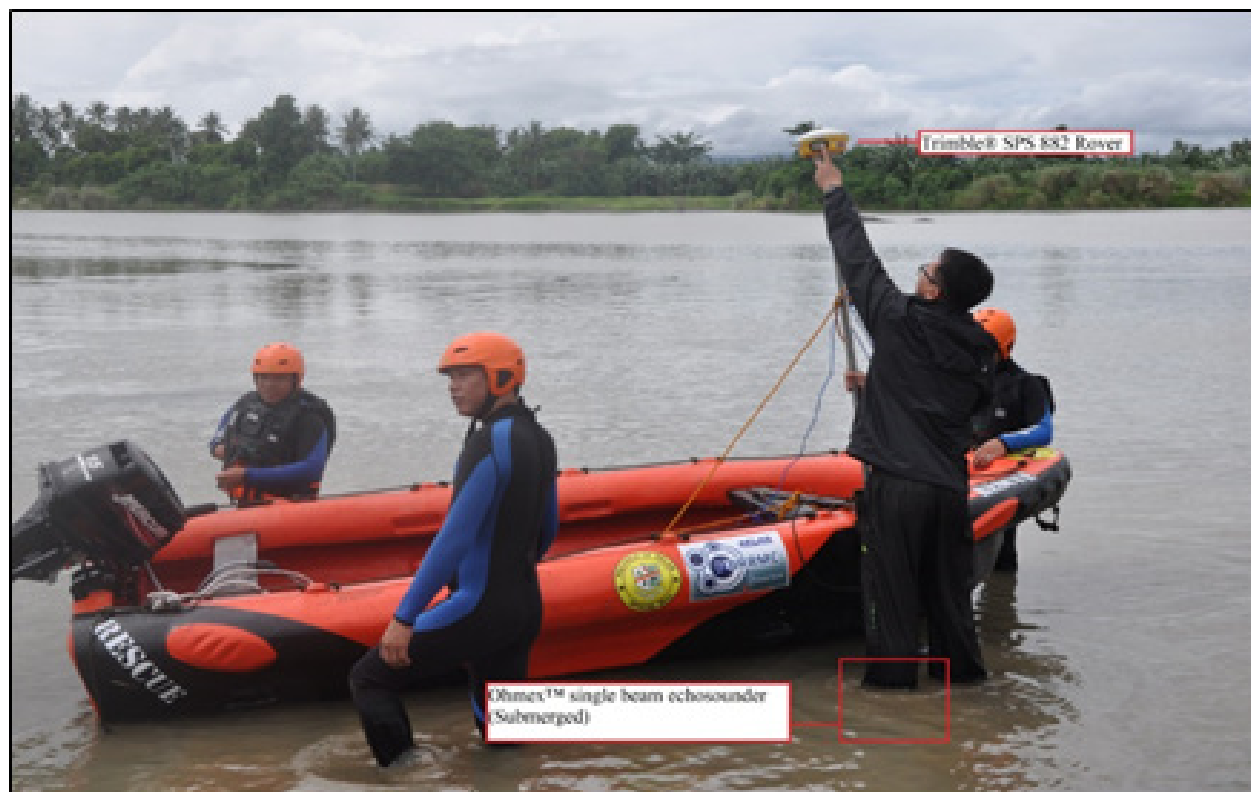
Bathymetric survey was conducted from November 3, 2015 using Trimble® SPS 882 in GNSS PPK survey technique and an Ohmex™ single beam echo sounder attached to a boat as shown in Figure 45. The survey started in the middle part of the river in Brgy. Cupang, Municipality of Malinao with coordinates 11°38'14.61781" 122°18'53.19268" and ended at the mouth of the river in Brgy. Pusiw, Municipality of Numancia with coordinates 11°44'10.95240" 122°22'00.21093".

Figure 45. OHMEX™ single beam echosounder set up on a boat for Aklan River bathymetric survey

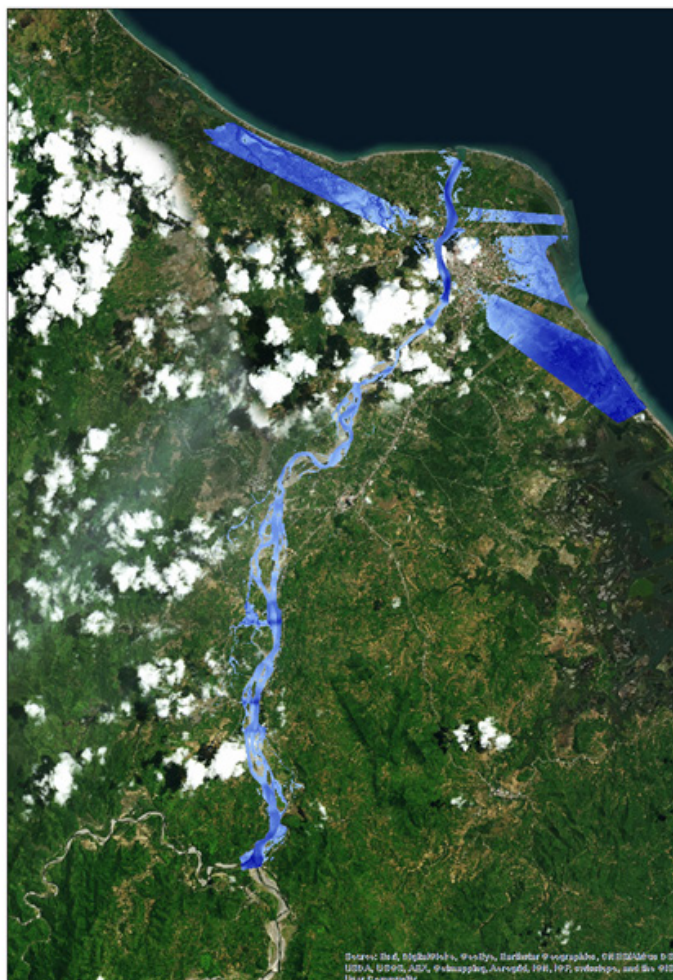
The HEC-RAS Flood Model produced a simulated water level at every cross-section for every time step for every flood simulation created. The resulting model will be used in determining the flooded areas within the model. The simulated model will be an integral part in determining real-time flood inundation extent of the river after it has been automated and uploaded on the DREAM website. The sample generated map of Aklan River using the calibrated HMS event flow is shown in Figure 68.

Figure 69. Sample output of Aklan RAS Model

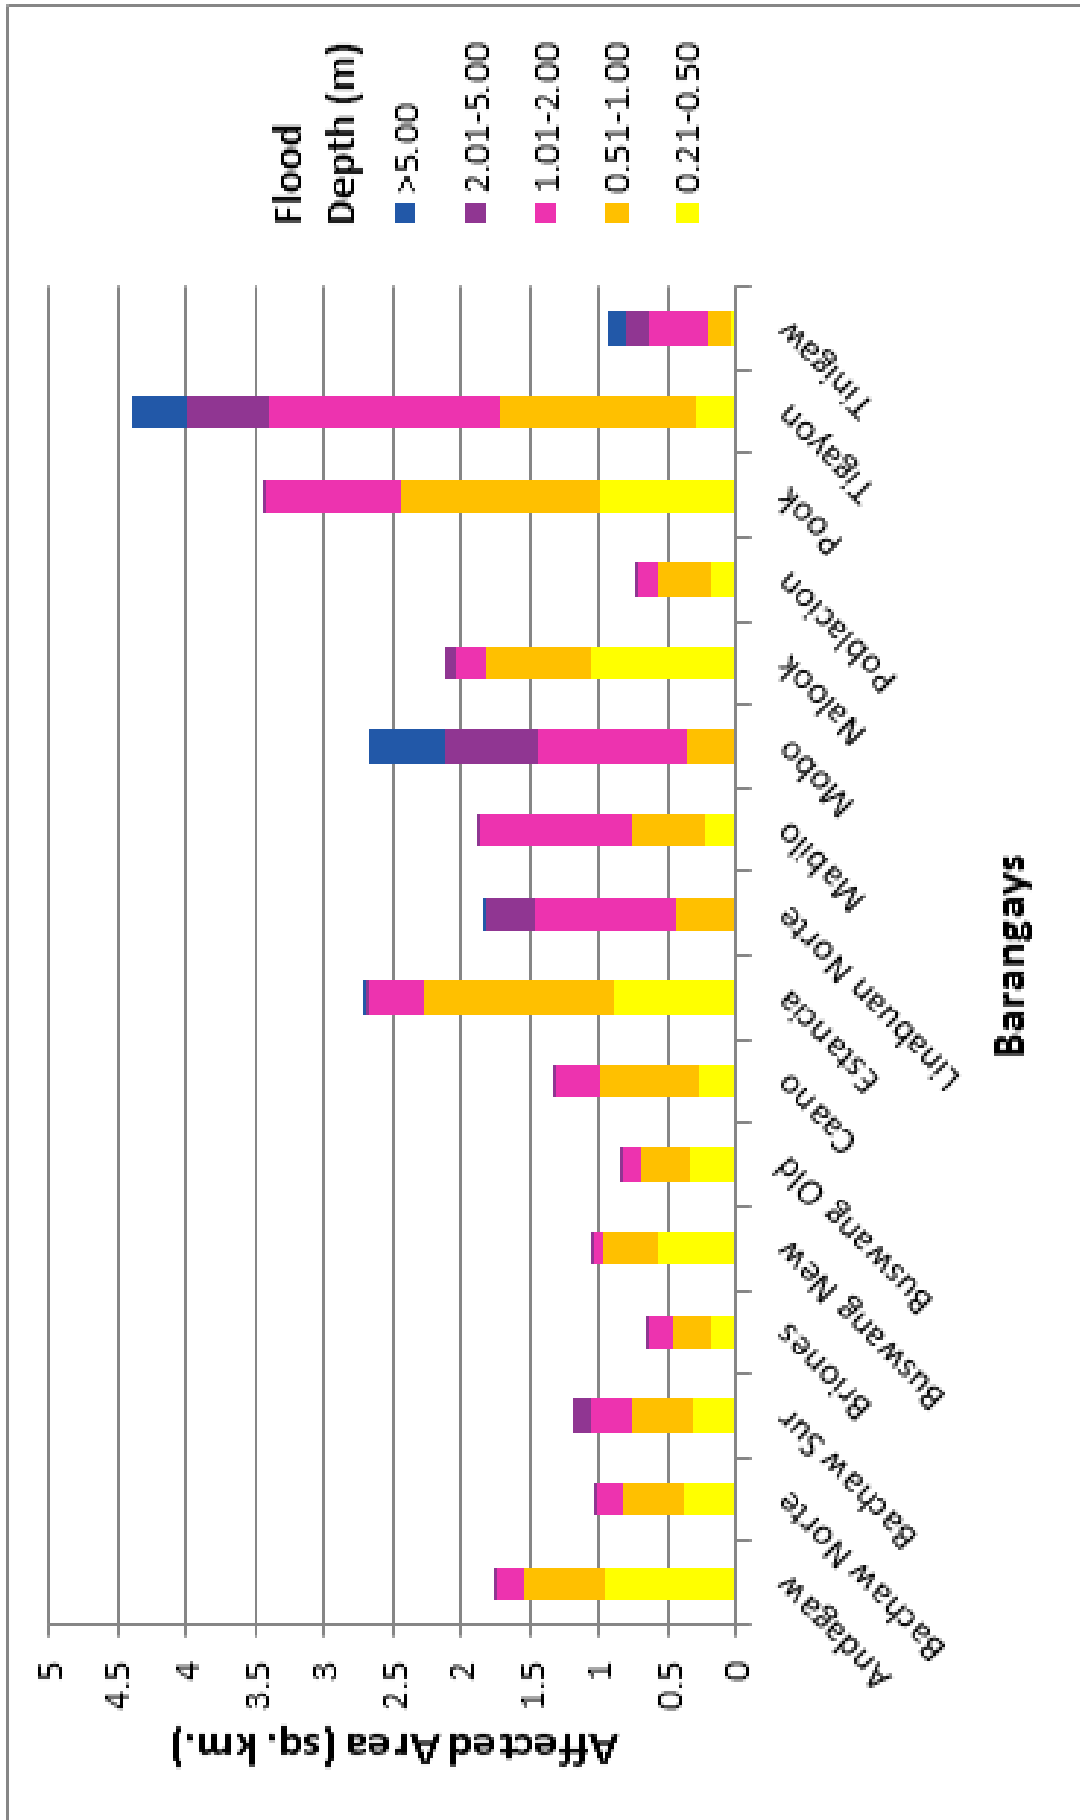
For the municipality of Kalibo, with an area of 40.15 sq. km., 12.84% will experience flood levels of less 0.20 meters. 17.02% of the area will experience flood levels of 0.21 to 0.50 meters while 25.14%, 21%, 5.2%, and 2.79% of the area will experience flood depths of 0.51 to 1 meter, 1.01 to 2 meters, 2.01 to 5 meters, and more than 5 meters, respectively. Listed in Table 37 are the affected areas in square kilometres by flood depth per barangay.

Figure 77. Affected Areas in Kalibo, Aklan during 5-Year Rainfall Return Period

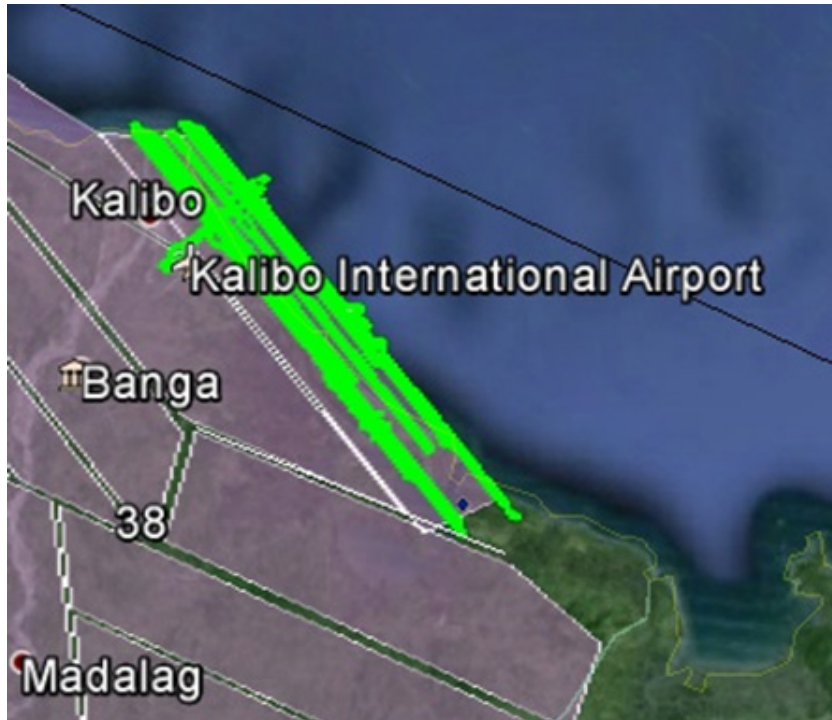
Flight No. : 1212A
Area: BLK 38F
Mission Name: 3BLK38FS073B
Parameters: Alt: 600m; Scan Fz: 40; Scan ange: 18; Overlap: 30%

Figure A-7.7. Swath for Flight No. 1212A

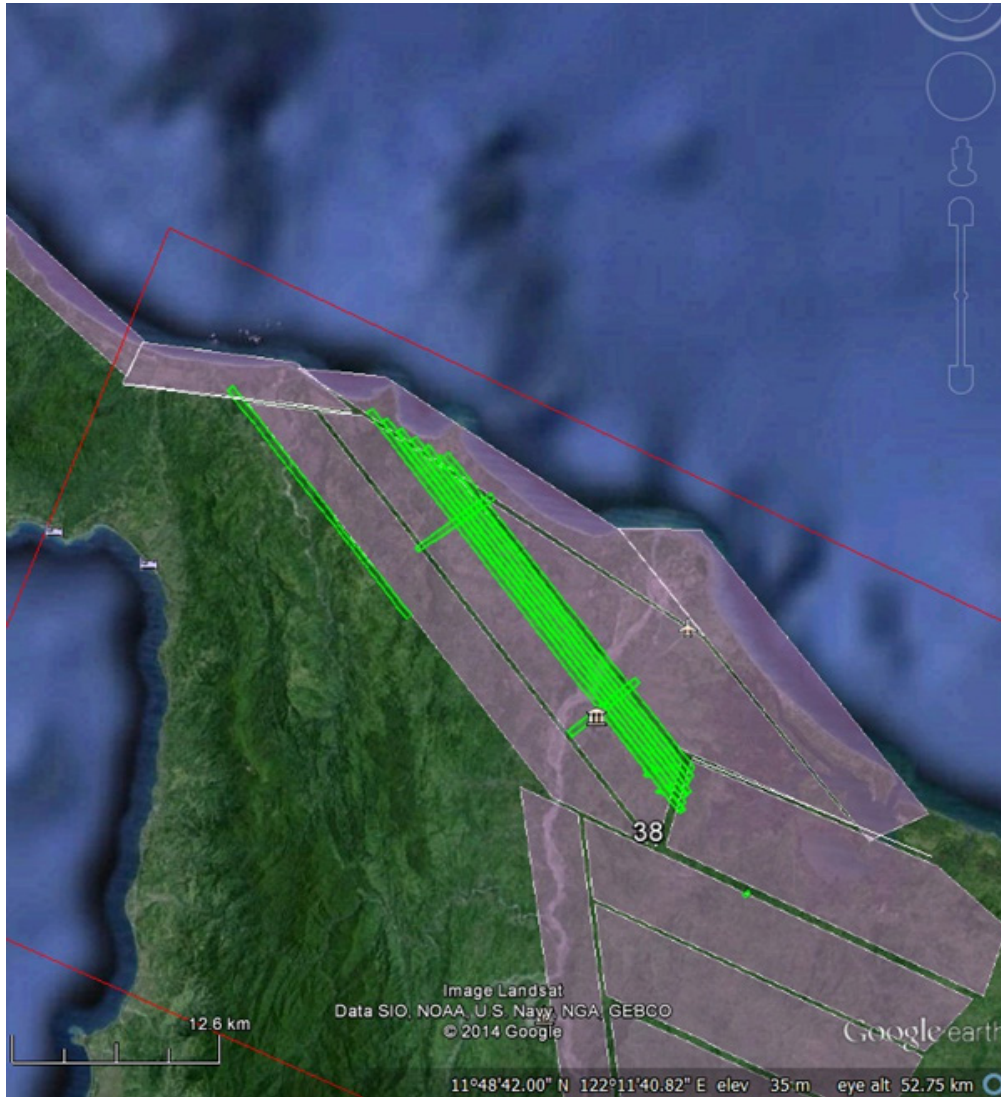
Flight No. : 1240A
Area: BLK 38F
Mission Name: 3BLK38HS080B
Parameters: Alt: 600m; Scan Fz: 40; Scan ange: 18; Overlap: 30%

Figure A-7.14. Swath for Flight No. 1240A

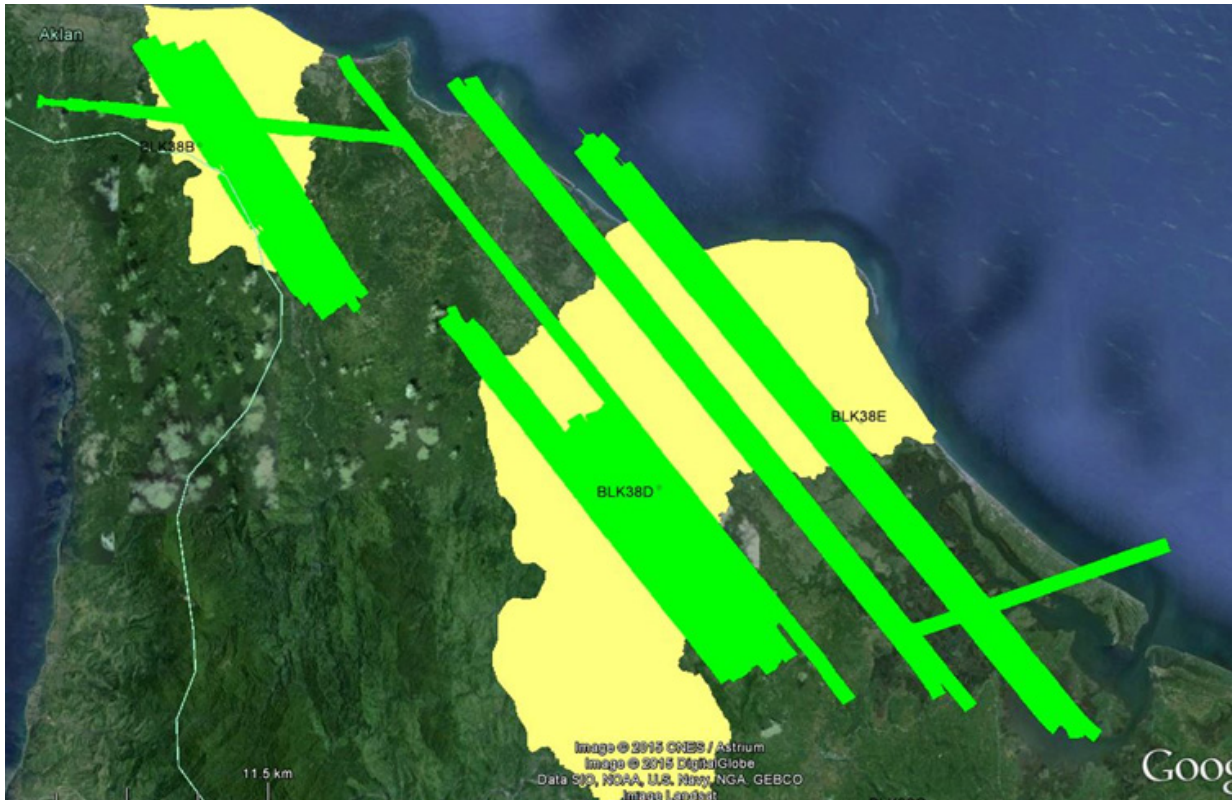
Flight No. : 2770G
Area: BLKs38 B, D & E
Mission Name: 2BLK38BDVES268A
Parameters: Alt: 800m; Scan Fz: 50; Scan angle: 20; PRF: 125
Area surveyed: 188.62 sq km.

Figure A-7.19. Swath for Flight No. 2770G

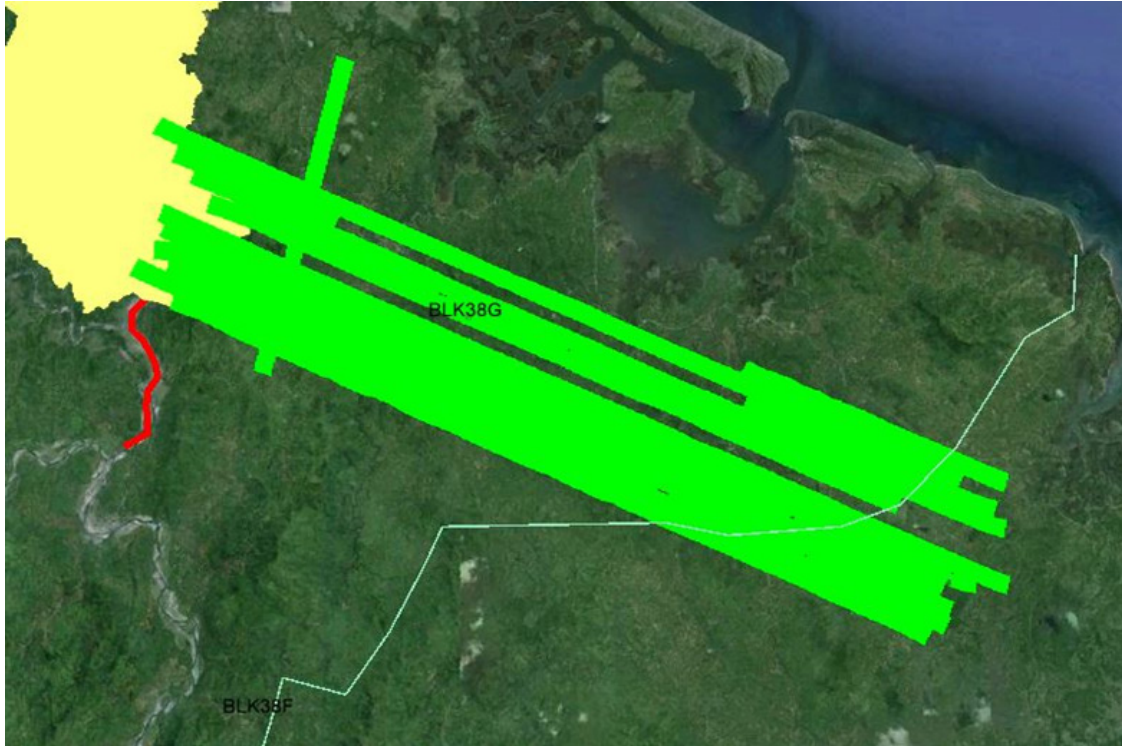
Flight No. : 2772G
Area: BLK38G
Mission Name: 2BLK38GS268B
Parameters: Alt: 800m; Scan Fz: 50; Scan angle: 20; PRF: 125
Area surveyed: 131.52 sq km.

Figure A-7.20. Swath for Flight No. 2772G
