HAZARD MAPPING OF THE PHILIPPINES USING LIDAR (PHIL-LIDAR 1)

LiDAR Surveys and Flood Mapping of Calbiga River

University of the Philippines Training Center
for Applied Geodesy and Photogrammetry
Visayas State University

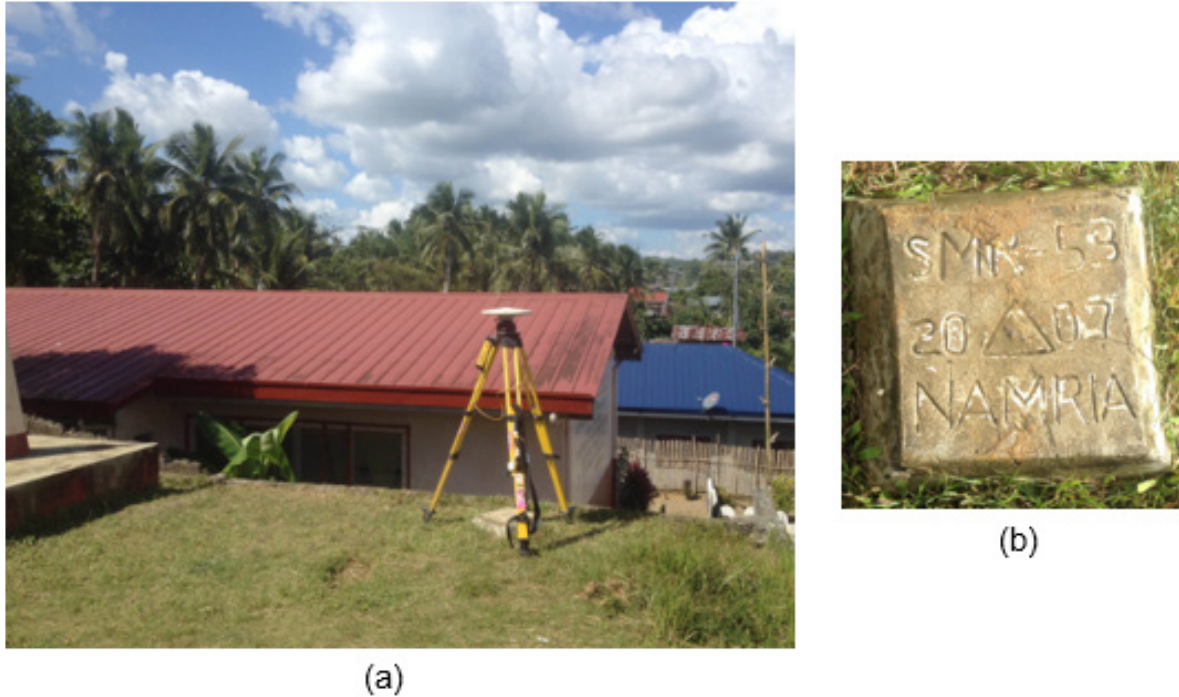
Figure 3. GPS set-up over SMR-53 located near the school building flag pole of San Isidro Elementary, Brgy. San Isidro, Santa Rita (a) and NAMRIA reference point SMR-53 (b) as recovered by the field team.

Figure 3 to Figure 5 show the recovered NAMRIA reference points within the area, while Table 2 to Table 4 show the corresponding details about the following NAMRIA control stations and established points. In addition, Table 5 shows the list of all ground control points occupied in line with their respective mission names and flight numbers, together with the dates of acquisition.

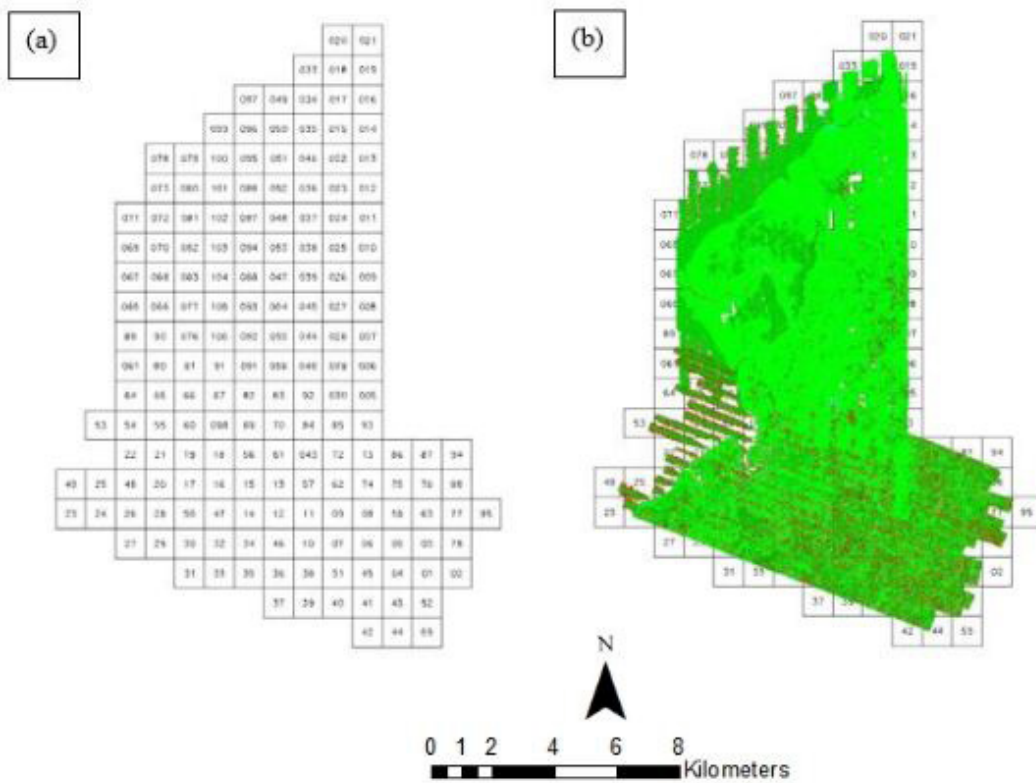
Figure 16. Tiles for Calbiga floodplain (a) and classification results (b) in TerraScan.

The tile system that TerraScan employed for the LiDAR data and the final classification image for a block in Calbiga floodplain is shown in Figure 16. A total of 203 1km by 1km tiles were produced. The number of points classified to the pertinent categories is illustrated in Table 11. The point cloud has a maximum and minimum height of 298.19 meters and 40.33 meters respectively.

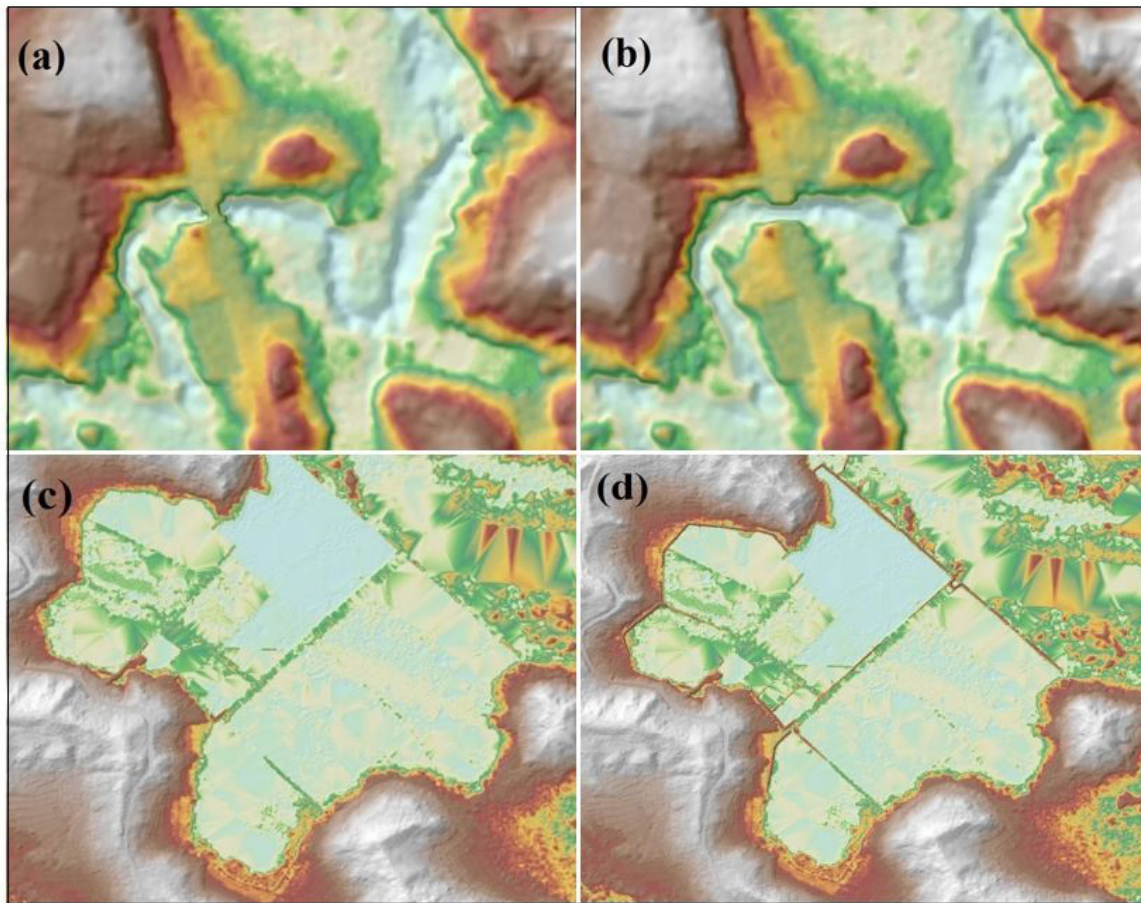
Figure 19. Portions in the DTM of Calbiga flood plain – a bridge before (a) and after (b) manual editing; a paddy field before (c) and after (d) data retrieval.

Portions of DTM before and after manual editing are shown in Figure 19. The bridge (Figure 19a) is considered to be an impedance to the flow of water along the river and has to be removed (Figure 19b) in order to hydrologically correct the river. The paddy field (Figure 19c) has been misclassified and removed during classification process and has to be retrieved to complete the surface (Figure 19d) to allow the correct flow of water.

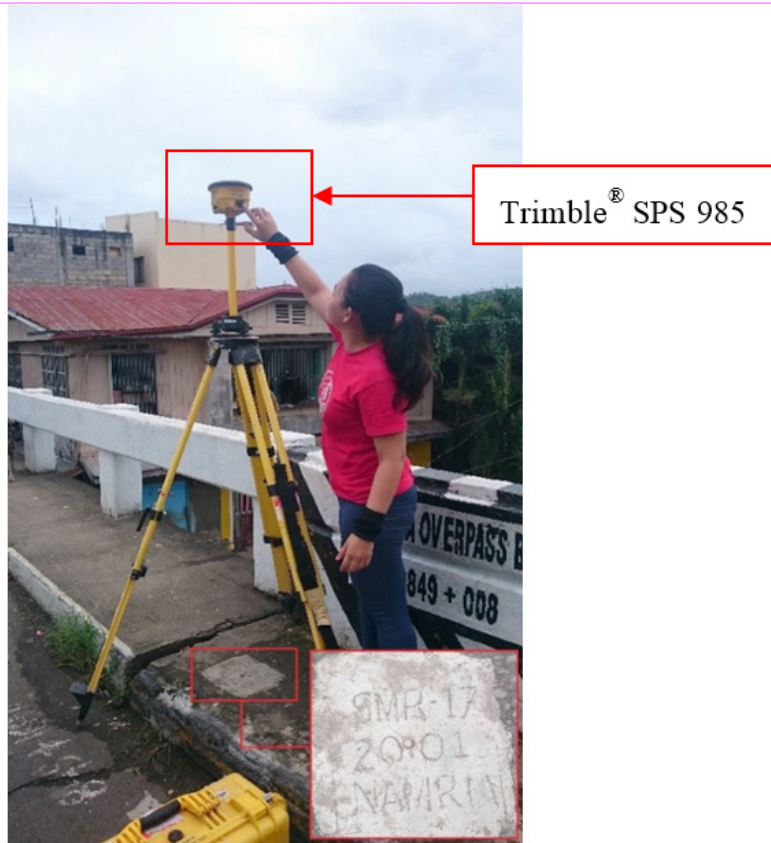
Figure 29. GNSS base set up, Trimble® SPS 985, at SMR-17, located in Brgy. Macaalan, Municipality of Calbiga, Samar

The GNSS set up made in the location of the reference and control points are exhibited are shown in Figure 29 to Figure 32.

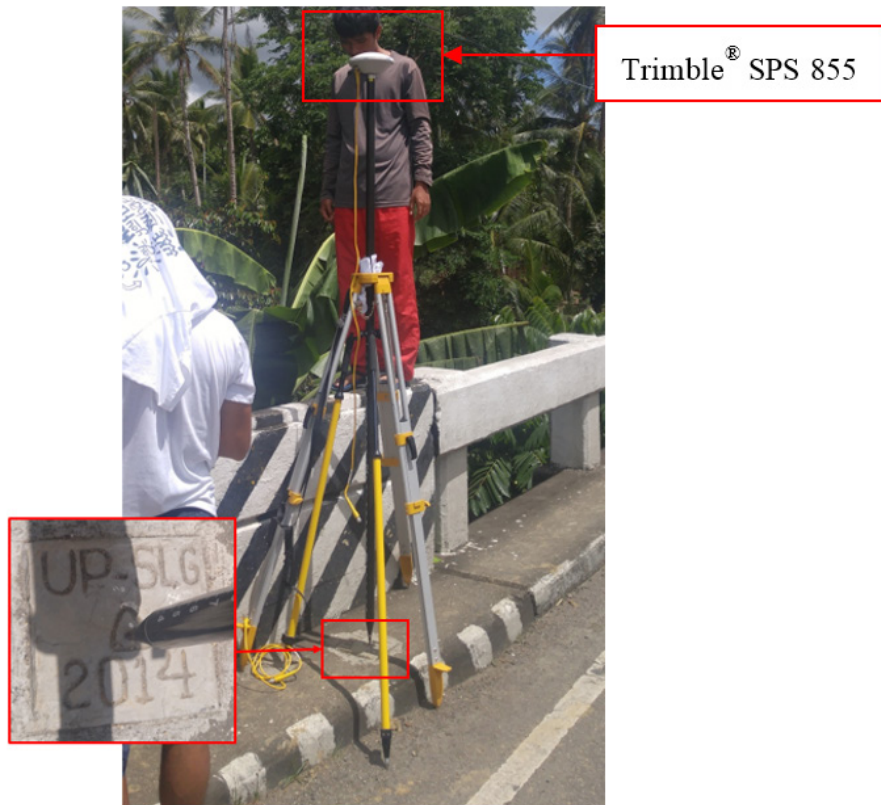
Figure 30. GNSS base set up, Trimble® SPS 855, at UP-SLG, located at the approach of the left side of Silaga Bridge in Brgy. Tominamos, Municipality of Santa Rita, Samar

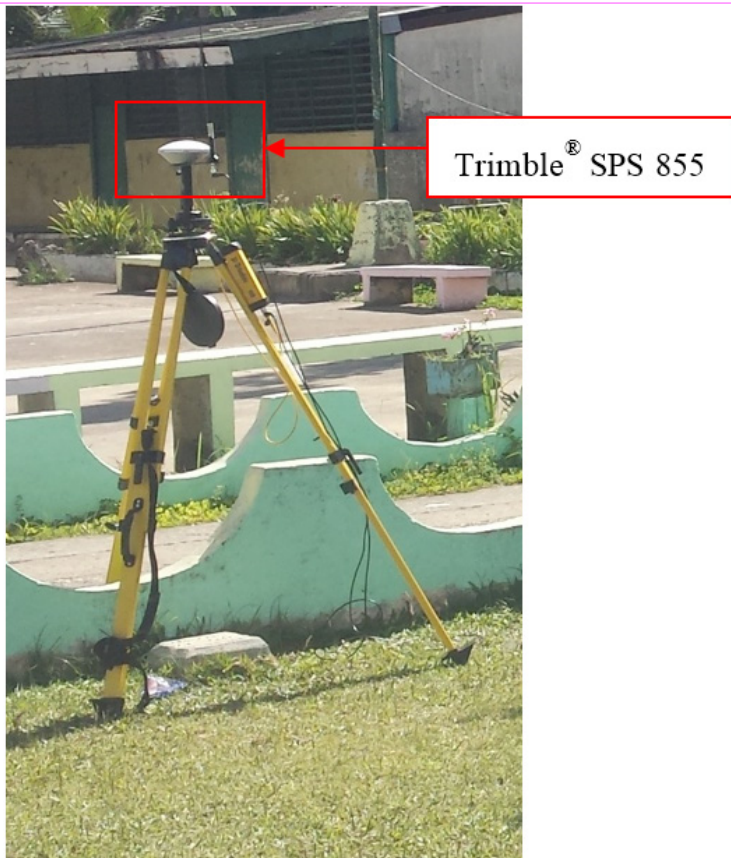
Figure 31. GNSS base set up, Trimble® SPS 855, at SMR-3024A, located at the approach of the entrance gate of Canticum Elementary School in Brgy. Canticum, Municipality of Calbiga, Samar

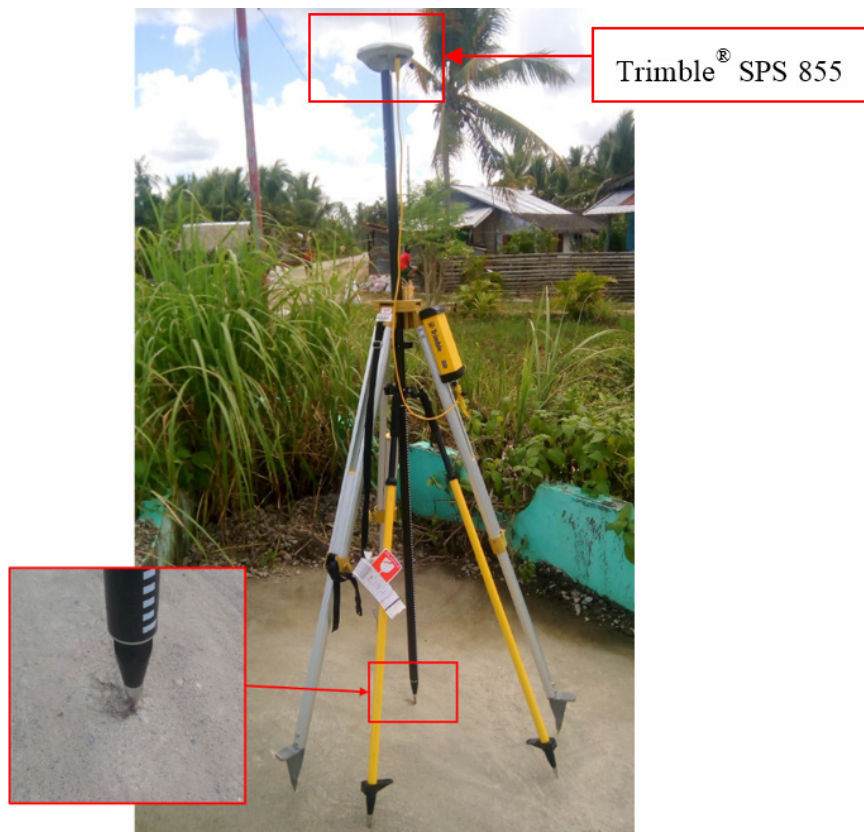
Figure 32. GNSS base set up, Trimble® SPS 855, at BARVSU, located at one of the corners of the Barangay Basketball Court in Brgy. Barobaybay, Municipality of Calbiga, Samar

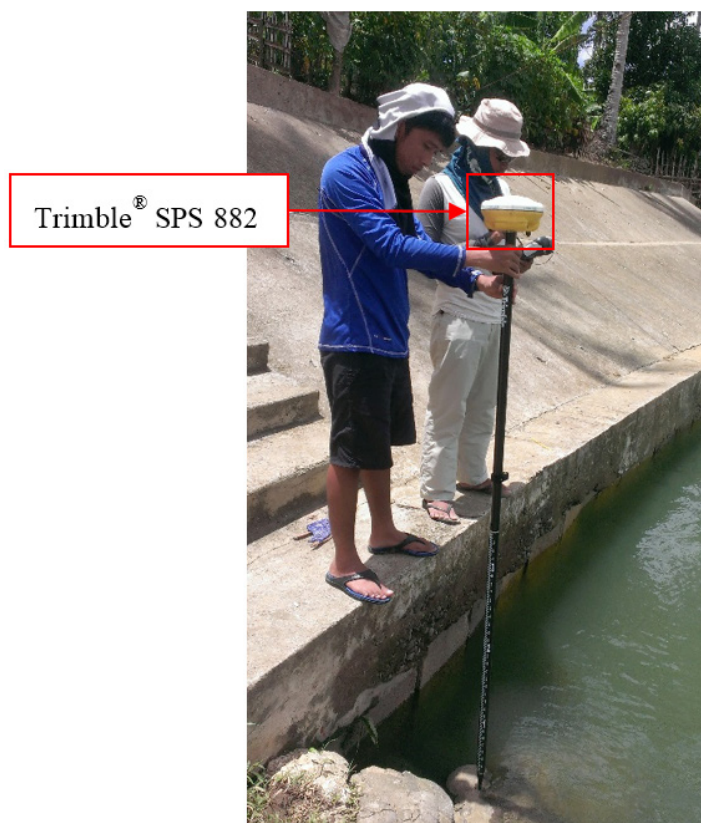
Figure 33. Cross-Section Survey for Calbiga River

Cross-section survey was conducted at the deployment site in Brgy. Macaalan, Municipality of Calbiga, on April 12, 2016 using a GNSS receiver, Trimble® SPS 882, in PPK survey technique. The area identified by Visayas State University for their flow data gathering is a non-bridge location as shown in Figure 33.

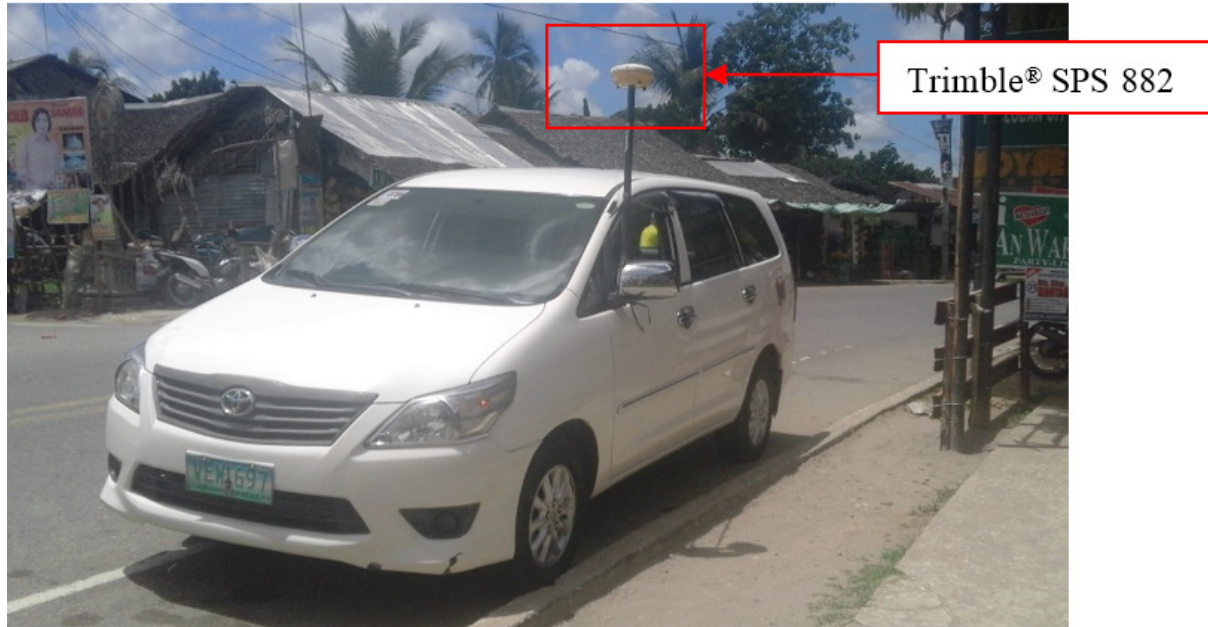
Figure 36. Validation points acquisition survey set up

Validation points acquisition survey was conducted on April 11, 2016 using a survey-grade GNSS Rover receiver, Trimble® SPS 882, mounted on a pole which was attached to the side of vehicle as shown in Figure C-10. It was secured with a nylon rope to ensure that it was horizontally and vertically balanced. The antenna height was 2.089 m and measured from the ground up to the bottom of notch of the GNSS Rover receiver. The PPK technique utilized for the conduct of the survey was set to continuous topo mode with SMR-17 occupied as the GNSS base stations in the conduct of the survey.

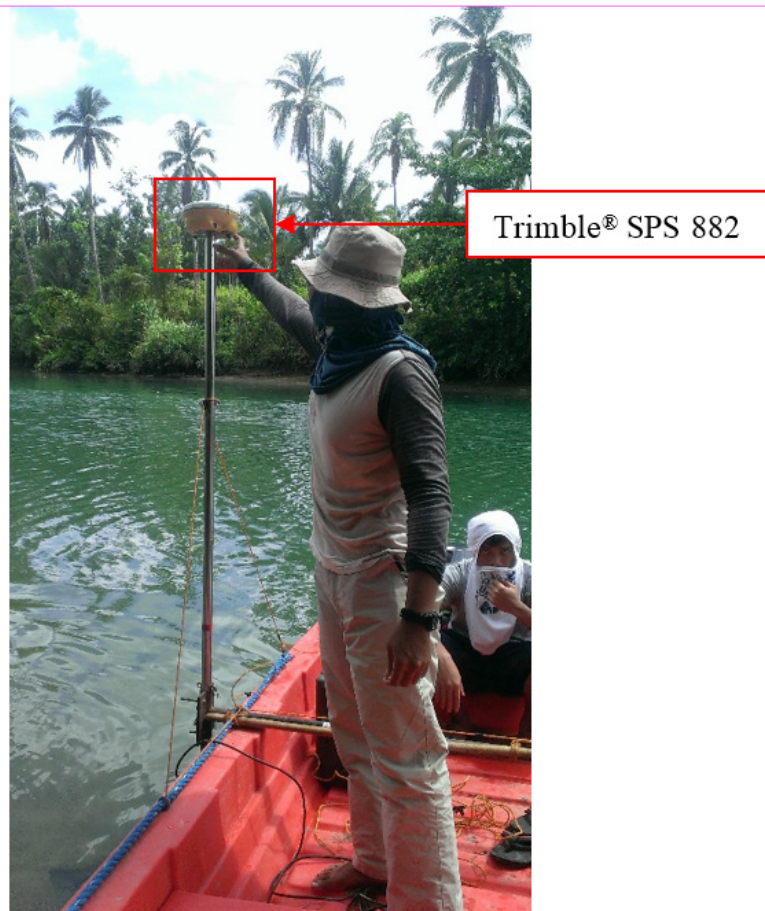
Figure 38. Bathymetry by boat set up for Calbiga River survey

Bathymetric survey was executed on September 8-10, 2015 using a Trimble® SPS 882 in GNSS PPK survey technique and Ohmex™ single beam echo sounder, as illustrated in Figure C-12. The extent of the survey is from the upstream in Brgy Otoc, Municipality of Calbiga with coordinates 11°36'11.89402"N, 125°01'40.33722"E, down to the mouth of the river in Brgy. Barabaybau, also in Calbiga with coordinates 11°39'46.73581"N, 124°58'17.13663"E, as shown in the map in Figure 39.

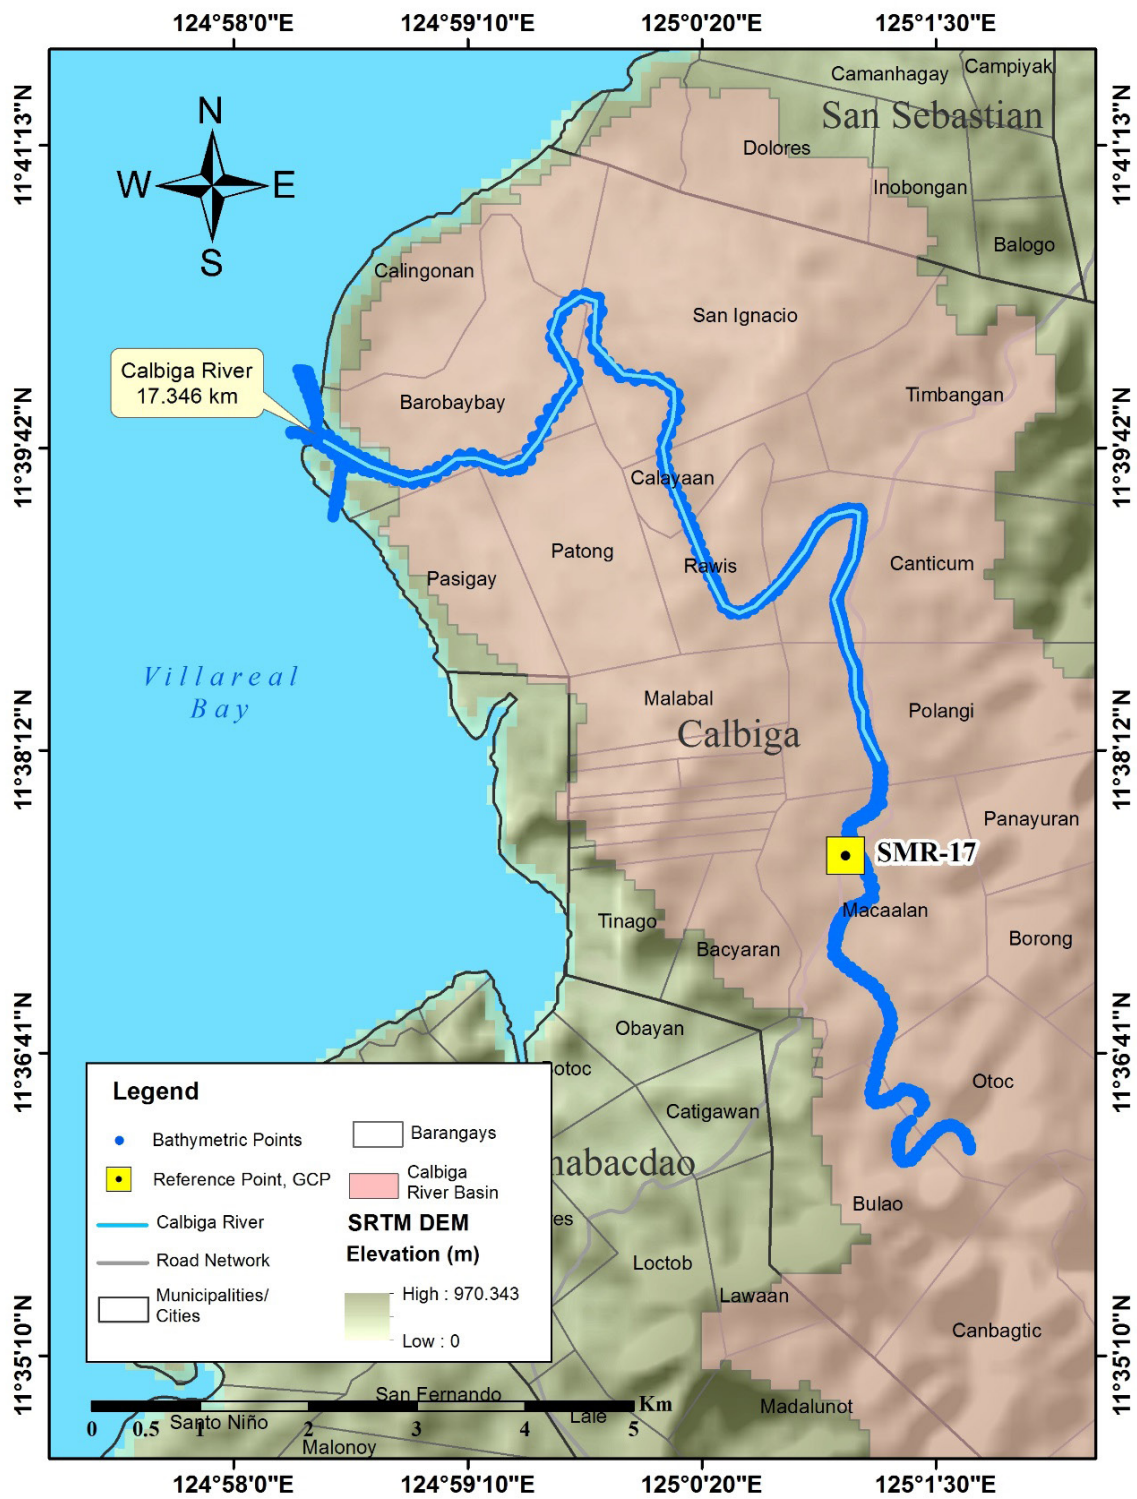
Figure 39. Bathymetric survey of Calbiga River

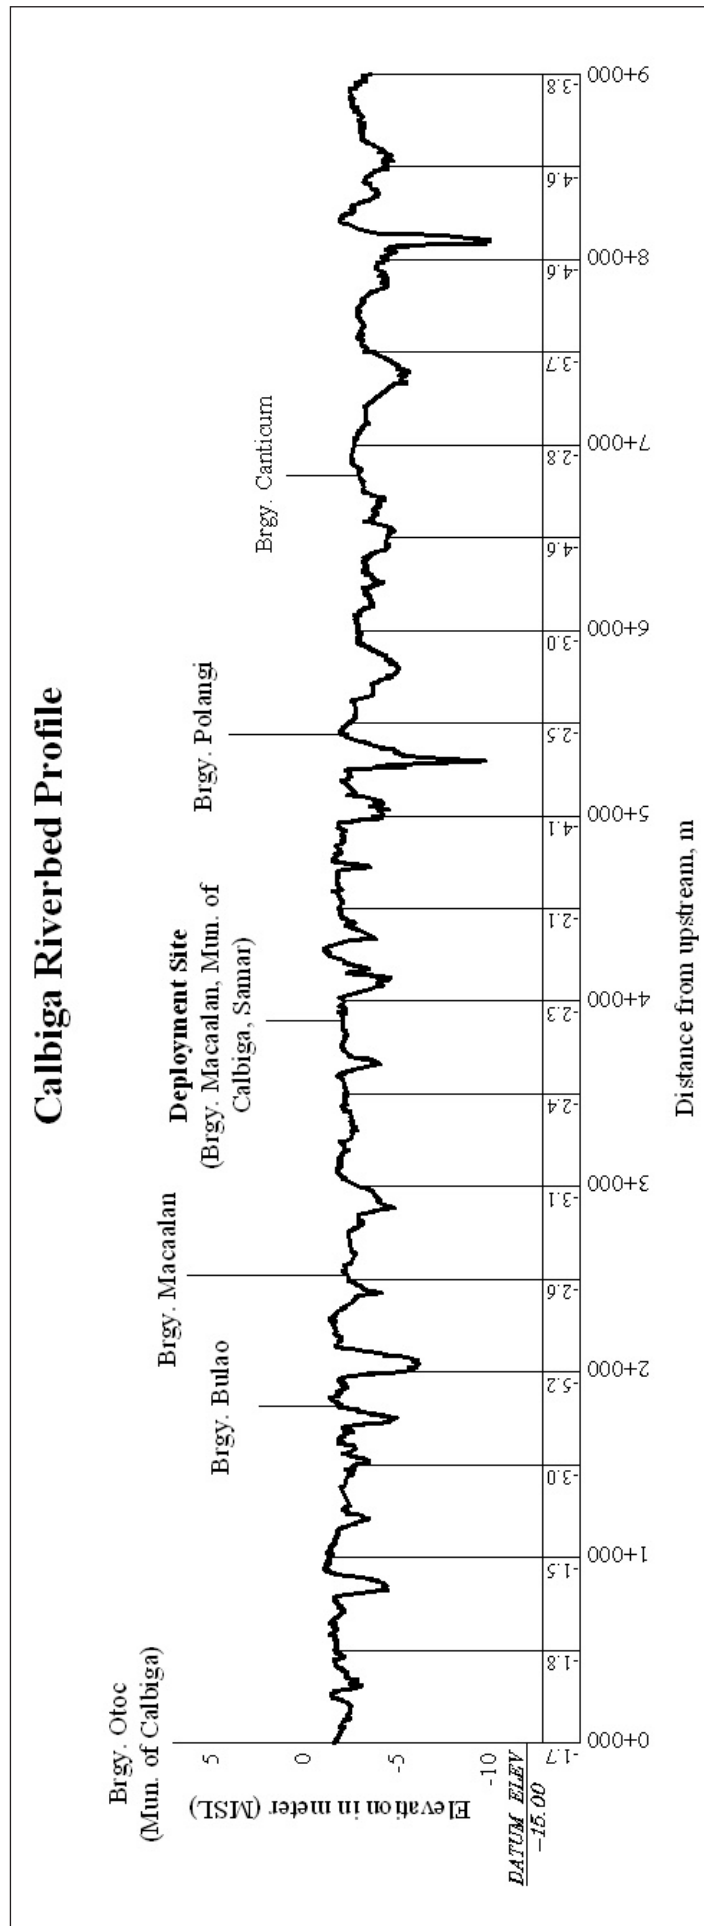
Figure 40. Riverbed profile of Calbiga River (1 of 2)

A CAD drawing was also produced to illustrate the riverbed profile of Calbiga River. As shown in Figure 40 and Figure 41, the highest and lowest elevation has a 26-meter difference. The highest elevation observed was -0.528 m above MSL located at the upstream portion of the river in Brgy. Otoc while the lowest was -11.592 m below MSL located at the mid portion of the river in Brgy. Macaalan, both in Municipality of Calbiga. The bathymetric survey gathered a total of 23,457 points covering 17.346 km of the river traversing ten barangays in Municipality of Calbiga. The survey extended the planned bathymetric lines up to Brgy. Otoc as requested by VSU to include the flood prone areas.

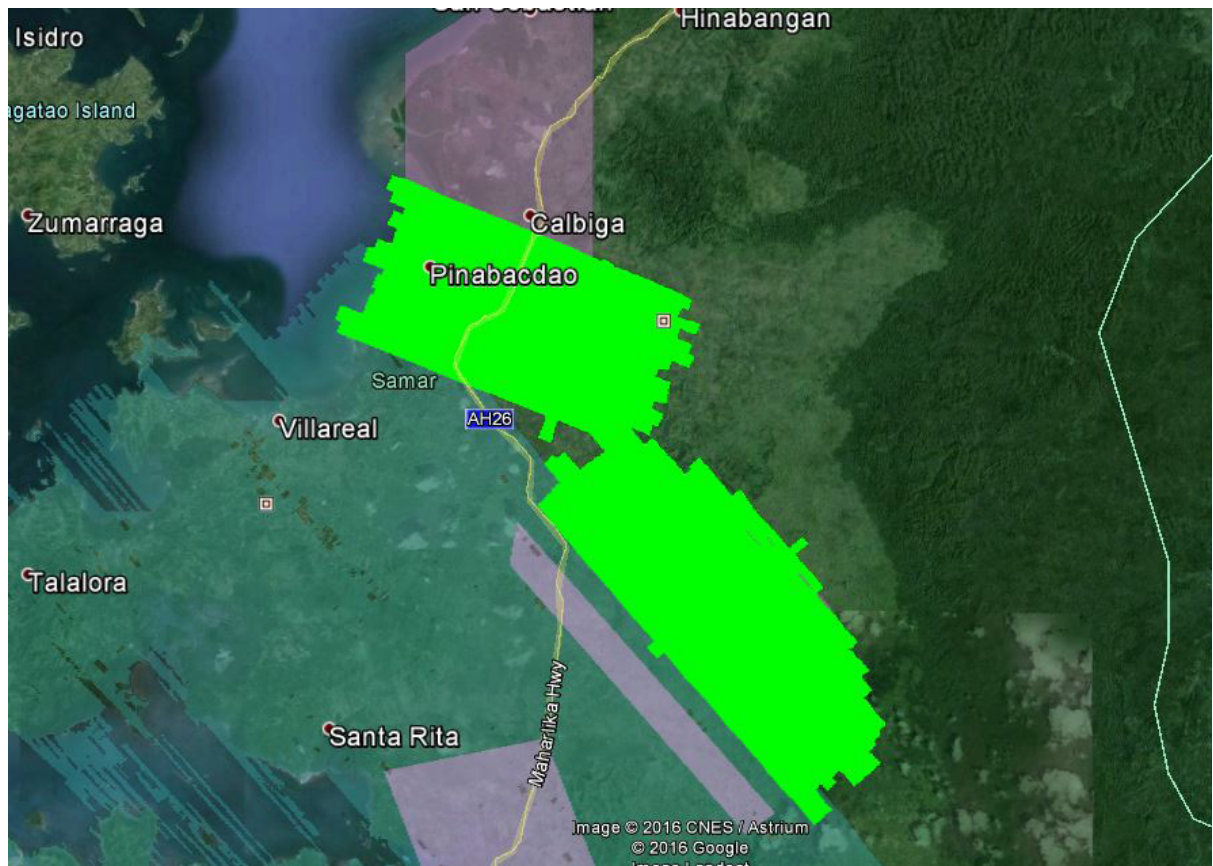
FLIGHT NO.: 3727G
 AREA: Samar
 MISSION NAME: 2BLK34IJ029B
 ALT: 800m SCAN_FREQ: 40Hz
 SCAN_ANGLE: 25 deg SURVEYED AREA: 144.55 sq.km.
