Hazard Mapping of the Philippines Using LIDAR (Phil-LIDAR 1)

LiDAR Surveys and Flood Mapping of Musi-Musi River

University of the Philippines Training Center
for Applied Geodesy and Photogrammetry
Central Mindanao University (CMU)

APRIL 2017

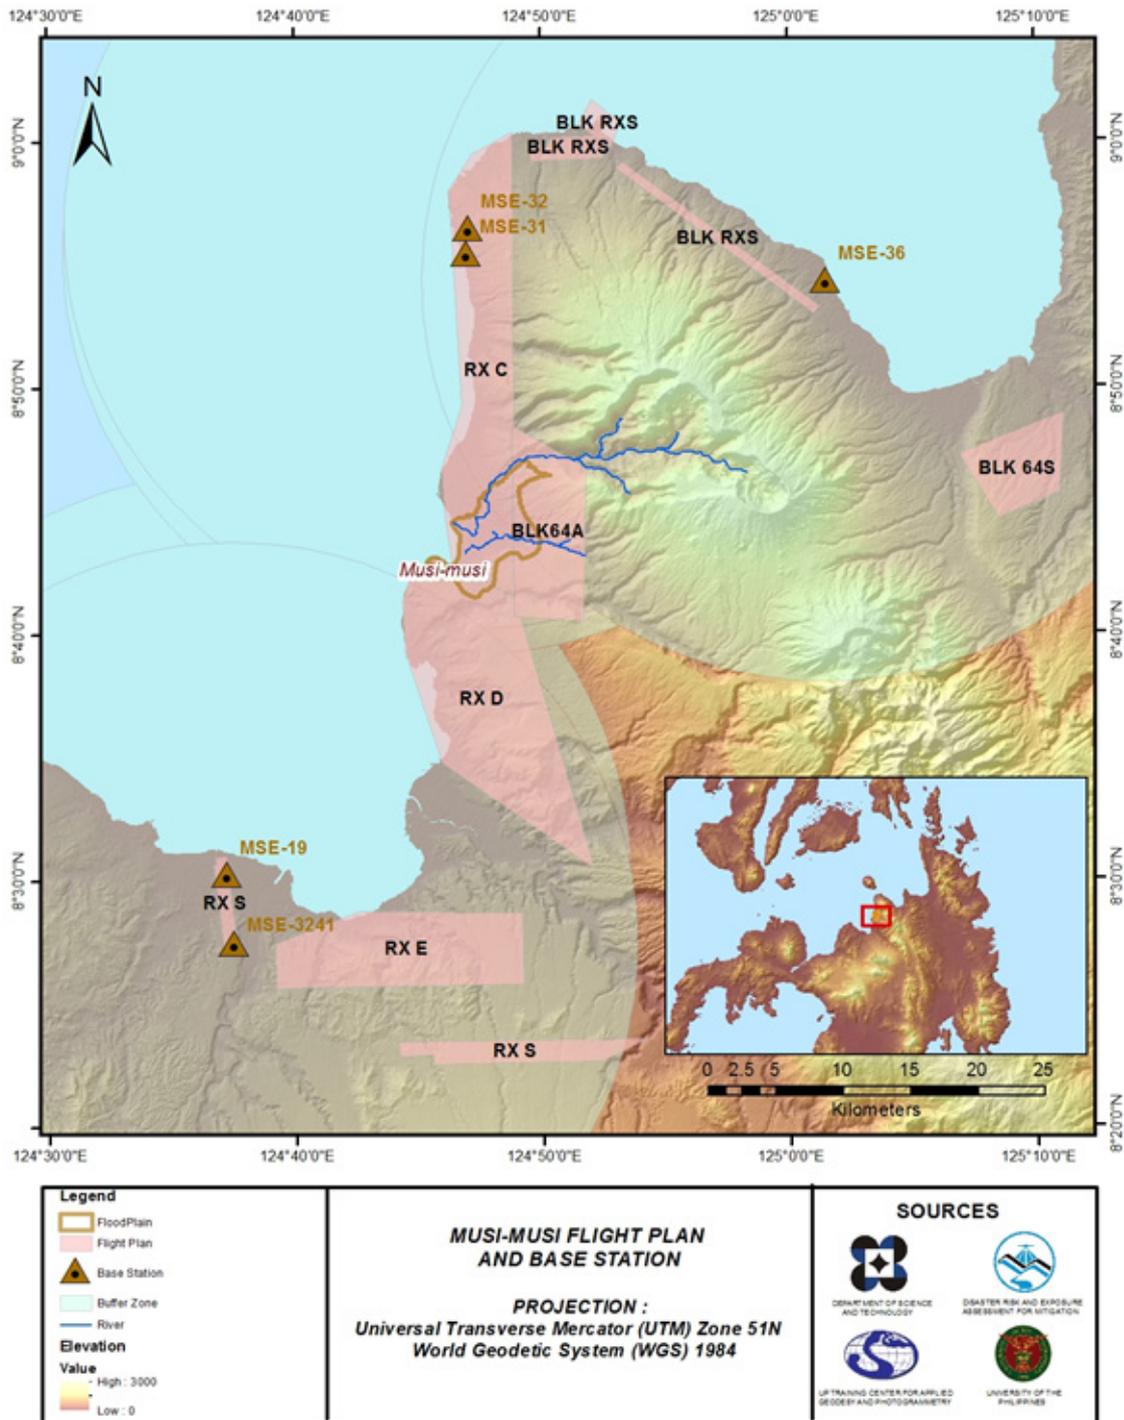
Figure 2. Flight plans and base stations used for Musi-Musi Floodplain.

Plans were made to acquire LiDAR data within the delineated priority area for Musi-musi floodplain in Misamis Oriental. These missions were planned for 12 lines that ran for at most four and a half (4.5) hours including take-off, landing and turning time. The flight planning parameters for the LiDAR system is found in Table 1. Figure 2 shows the flight plan for Musi-musi floodplain.

The project team was able to recover five (5) NAMRIA ground control points: MSE-19, MSE-31, MSE-32, MSE-36 which are of second (2nd) order accuracy and MSE-3241, which is of 3rd order accuracy. The certifications for the NAMRIA reference points are found in Annex 2. These were used as base stations during flight operations for the entire duration of the survey (May 25 – June 19, 2014) and November 15, 2016. Base stations were observed using dual frequency GPS receivers, TRIMBLE SPS 882 and SPS 852. Flight plans and location of base stations used during the aerial LiDAR acquisition in Musi-musi floodplain are shown in Figure 2.

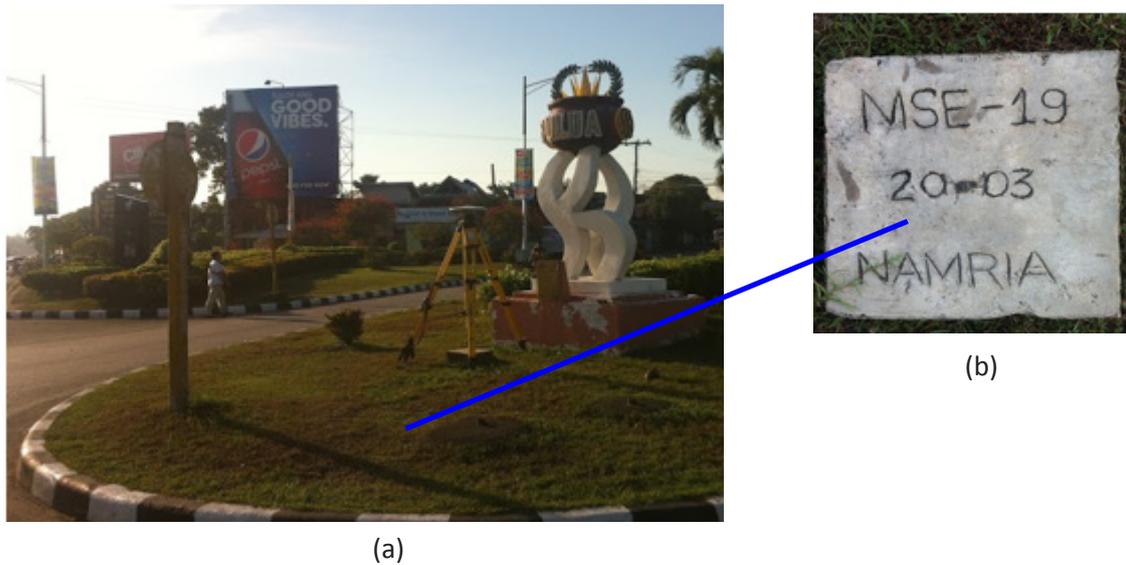
Figure 3. GPS set-up over MSE-19 at the center island located at the road intersections going to Cagayan de Oro, Butuan City and Iligan City (a) and NAMRIA reference point MSE-16 (b) as recovered by the field team.

Figure 3 to Figure 7 show the recovered NAMRIA reference points within the area. In addition, Table 2 to Table 6 show the details about the following NAMRIA control stations, while Table 7 shows the list of all ground control points occupied during the acquisition together with the corresponding dates of utilization.

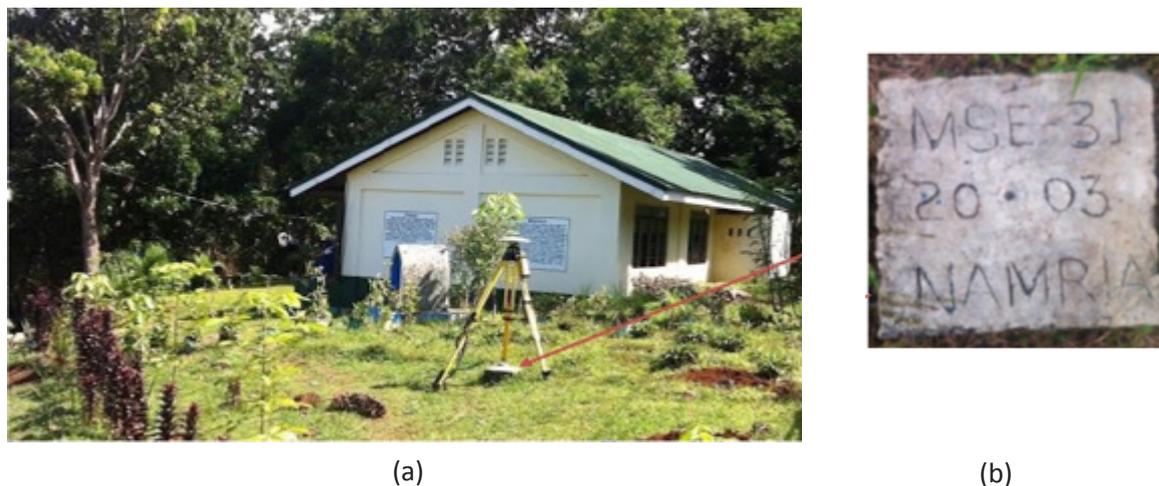
Figure 4. GPS set-up over MSE-31 inside the school grounds of Binuangan National High School of Sitio Naratulan, Binuangan, Misamis Oriental (a) and NAMRIA reference point MSE-31 (b) as recovered by the field team.

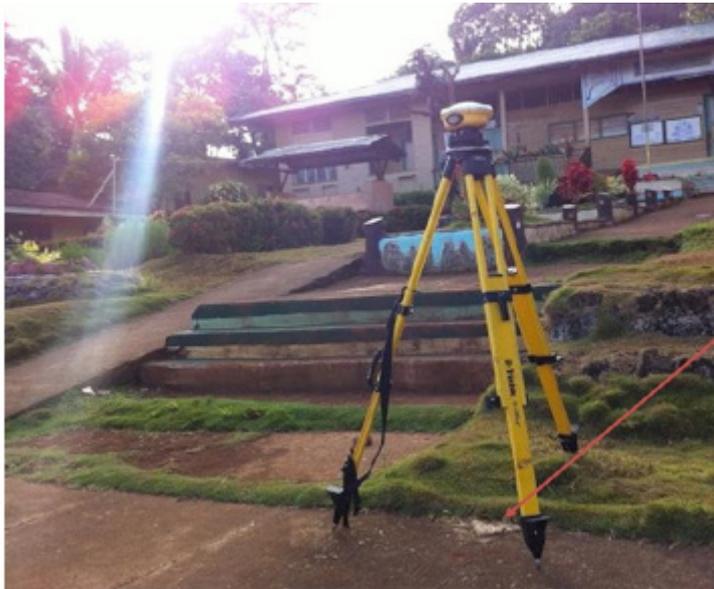
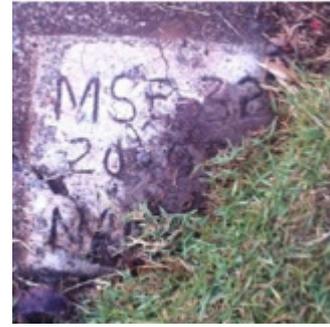
Figure 5. GPS set-up over MSE-32 inside Alicomohan Elementary school, just in front of the school's flag pole, situated at Barangay Alicomohan, Sugbongcogon, Misamis Oriental. (a) and NAMRIA reference point MSE-32 (b) as recovered by the field team.

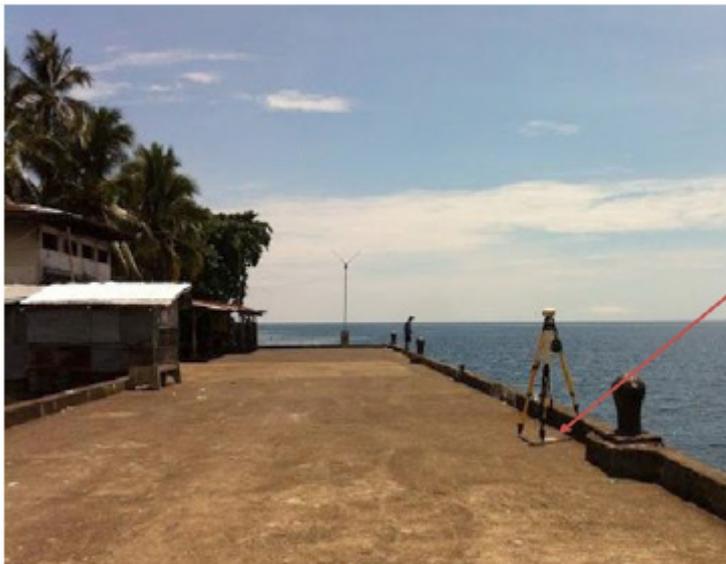
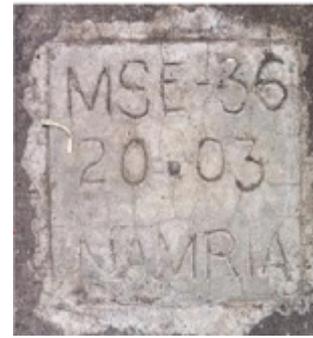
Figure 6. GPS set-up over MSE-36 within Medina municipal port (a) and NAMRIA reference point MSE-32 (b) as recovered by the field team.

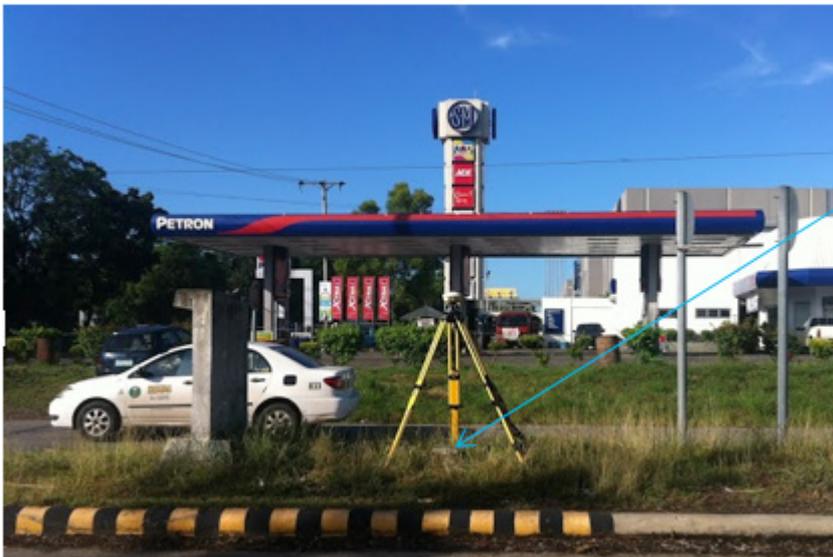
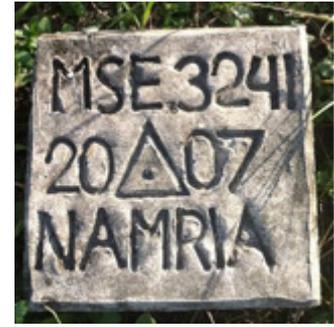
Figure 7. GPS set-up over MSE-3241 on a center island near a gasoline station beside SM Cagayan de Oro (a) and NAMRIA reference point MSE-3241 (b) as recovered by the field team.

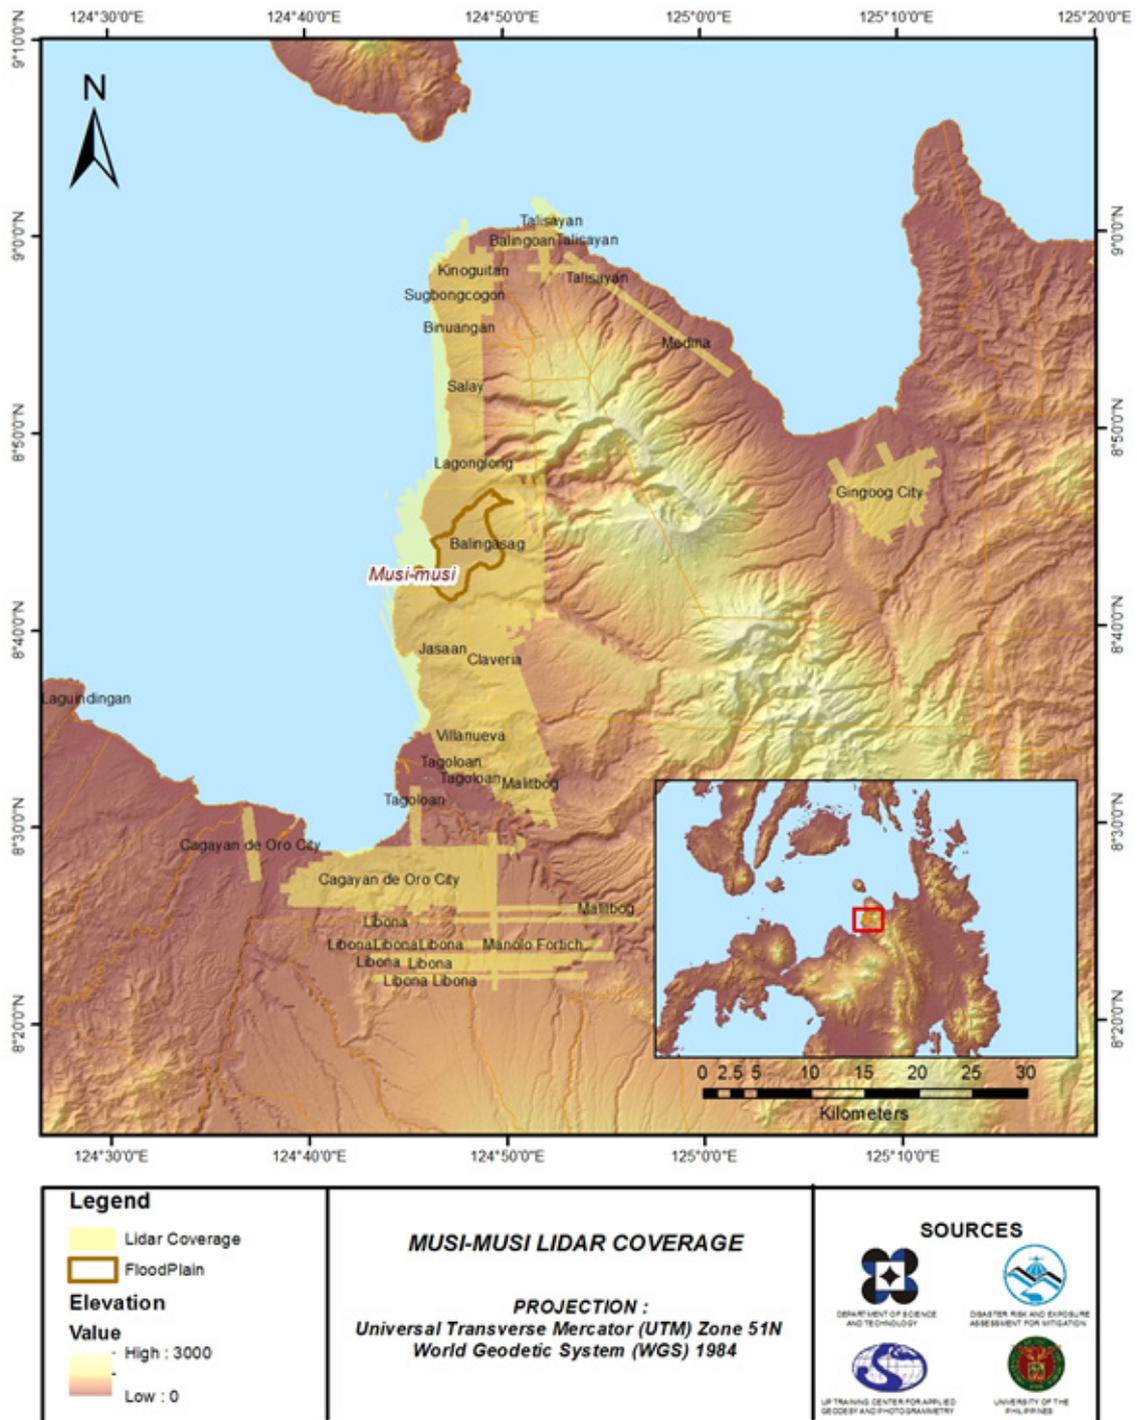
Figure 8. Actual LiDAR survey coverage for Musi-musi floodplain.

Musi-musi floodplain is located in the provinces of Misamis Oriental with majority of the floodplain situated within the municipality of Balingasag. The municipality of Jasaan is fully covered by the survey. The list of municipalities and cities surveyed, with at least one (1) square kilometer coverage, is shown in Table 10. The actual coverage of the LiDAR acquisition for Musi-musi floodplain is presented in Figure 8.

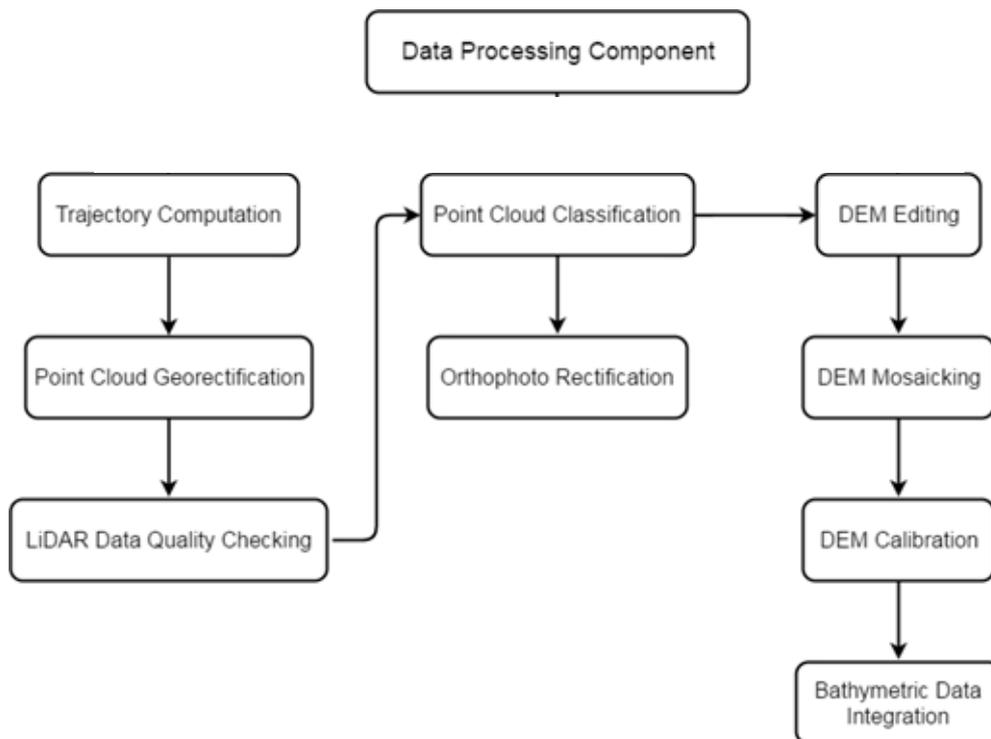
Figure 9. Schematic Diagram for Data Pre-Processing Component

The data transmitted by the Data Acquisition Component are checked for completeness based on the list of raw files required to proceed with the pre-processing of the LiDAR data. Upon acceptance of the LiDAR field data, georeferencing of the flight trajectory is done in order to obtain the exact location of the LiDAR sensor when the laser was shot. Point cloud georectification is performed to incorporate correct position and orientation for each point acquired. The georectified LiDAR point clouds are subject for quality checking to ensure that the required accuracies of the program, which are the minimum point density, vertical and horizontal accuracies, are met. The point clouds are then classified into various classes before generating Digital Elevation Models such as Digital Terrain Model and Digital Surface Model.

Using the elevation of points gathered in the field, the LiDAR-derived digital models are calibrated. Portions of the river that are barely penetrated by the LiDAR system are replaced by the actual river geometry measured from the field by the Data Validation and Bathymetry Component. LiDAR acquired temporally are then mosaicked to completely cover the target river systems in the Philippines. Orthorectification of images acquired simultaneously with the LiDAR data is done through the help of the georectified point clouds and the metadata containing the time the image was captured.

These processes are summarized in the flowchart shown in Figure 9.

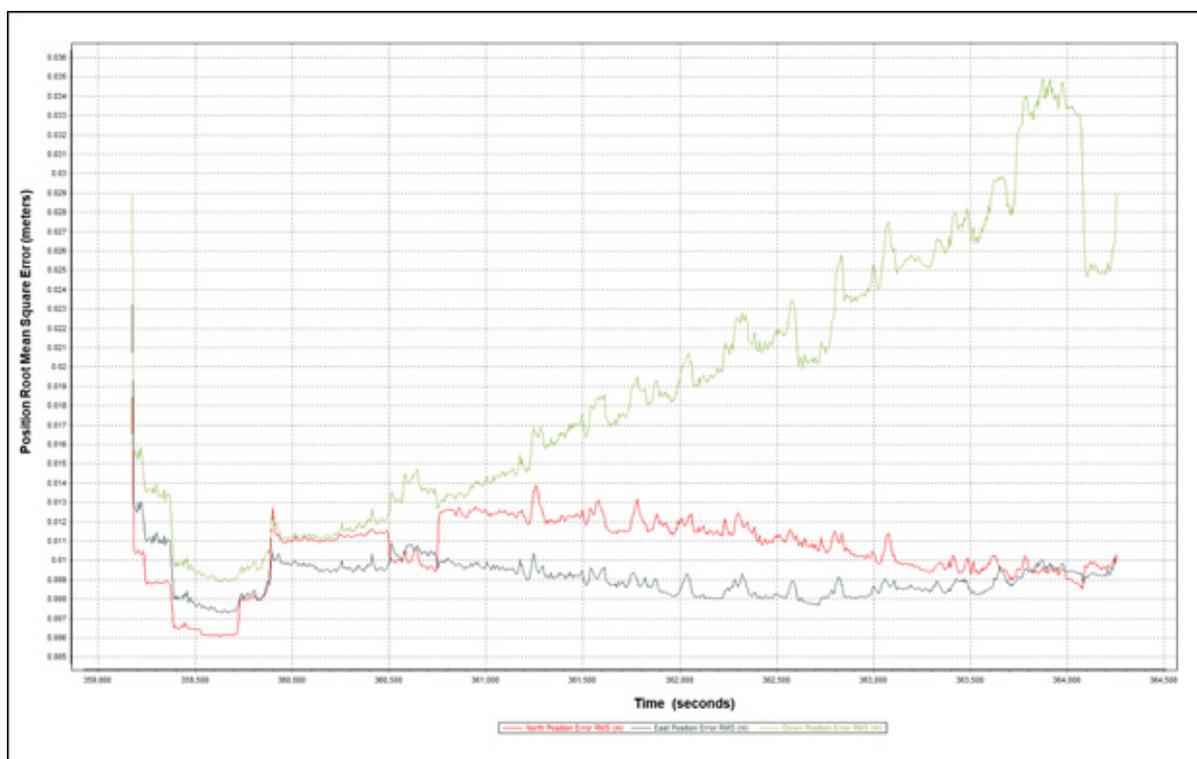
Figure 10. Smoothed Performance Metric Parameters of a Musi-musi Flight 1609P.

The time of flight was from 359200 seconds to 364200 seconds, which corresponds to morning of June 19, 2014. The initial spike that is seen on the data corresponds to the time that the aircraft was getting into position to start the acquisition, and the POS system starts computing for the position and orientation of the aircraft. Redundant measurements from the POS system quickly minimize the RMSE value of the positions. The periodic increase in RMSE values from an otherwise smoothly curving RMSE values correspond to the turn-around period of the aircraft, when the aircraft makes a turn to start a new flight line. Figure 10 shows that the North position RMSE peaks at 1.40 centimeters, the East position RMSE peaks at 1.30 centimeters, and the Down position RMSE peaks at 3.50 centimeters, which are within the prescribed accuracies described in the methodology.

The Smoothed Performance Metric parameters of the computed trajectory for flight 1609P, one of the Musi-musi flights, which is the North, East, and Down position RMSE values are shown in Figure 10. The x-axis corresponds to the time of flight, which is measured by the number of seconds from the midnight of the start of the GPS week, which on that week fell on June 19, 2014 00:00AM. The y-axis is the RMSE value for that particular position.

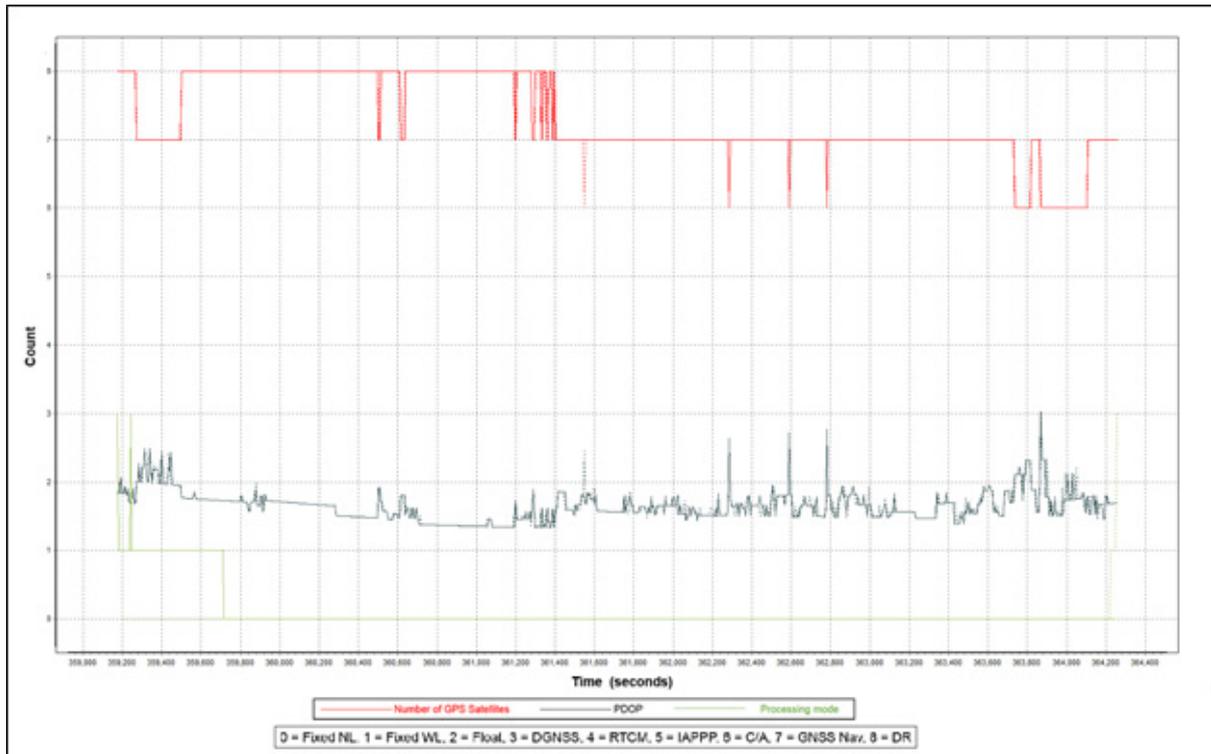
Figure 11. Solution Status Parameters of Musi-musi Flight 1609P.

The Solution Status parameters of flight 1609P, one of the Musi-musi flights, which are the number of GPS satellites, Positional Dilution of Precision, and the GPS processing mode used are shown in Figure 11. The graphs indicate that the number of satellites during the acquisition did not go down to 6. Majority of the time, the number of satellites tracked was between 6 and 10. The PDOP value also did not go above the value of 3, which indicates optimal GPS geometry. The processing mode stayed at the value of 0 for majority of the survey with some peaks up to 1 attributed to the turns performed by the aircraft. The value of 0 corresponds to a Fixed, Narrow-Lane mode, which is the optimum carrier-cycle integer ambiguity resolution technique available for POSPAC MMS. All of the parameters adhered to the accuracy requirements for optimal trajectory solutions, as indicated in the methodology. The computed best estimated trajectory for all Musi-musi flights is shown in Figure 12.

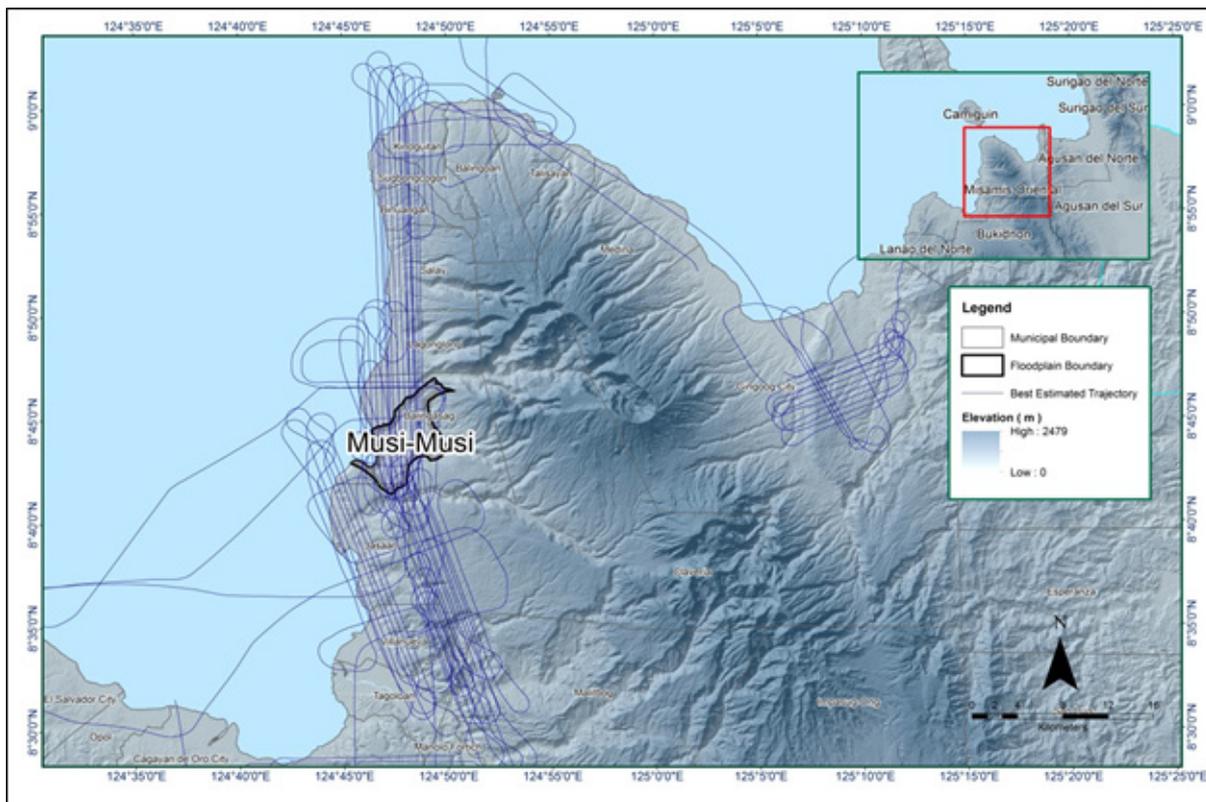
Figure 12. Best Estimated Trajectory of the lidar missions conducted over the Musi-Musi floodplain.

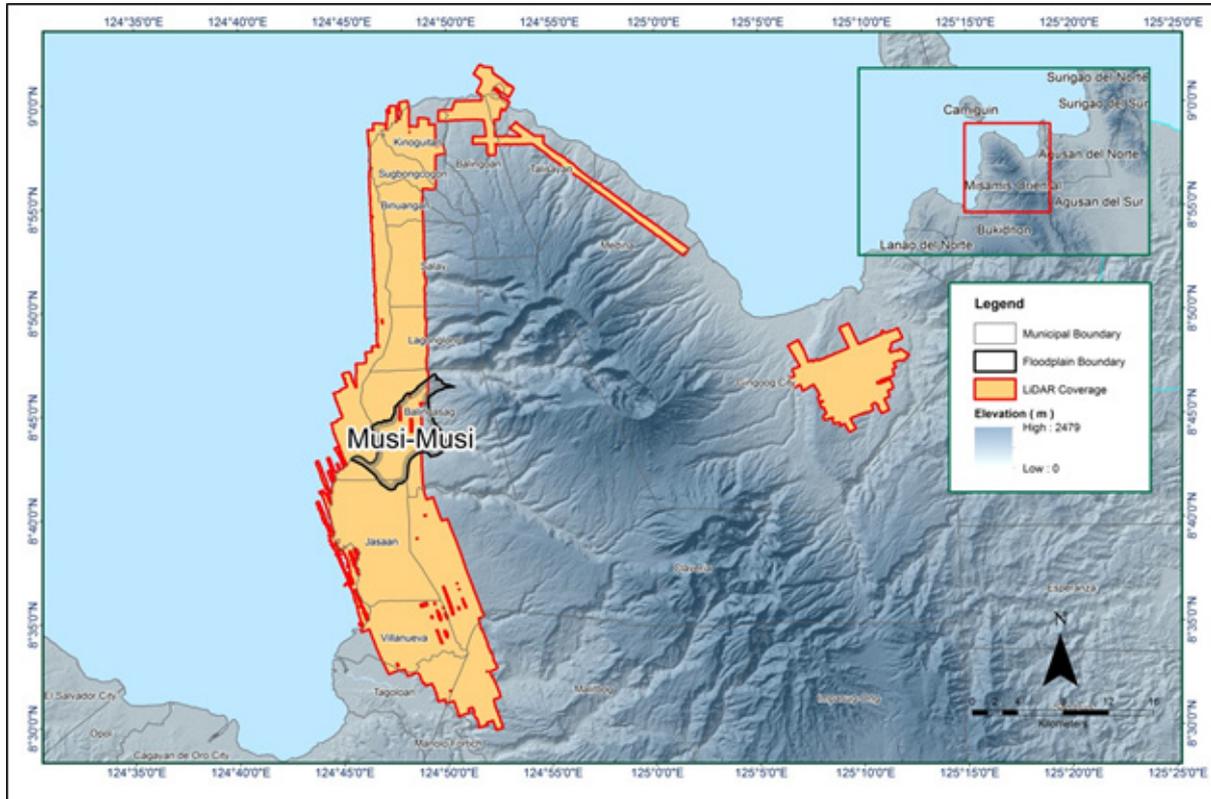
Figure 13. Boundary of the processed LiDAR data over Musi-musi Floodplain

The boundary of the processed LiDAR data on top of a SAR Elevation Data over Musi-musi Floodplain is shown in Figure B-5. The map shows gaps in the LiDAR coverage that are attributed to cloud coverage.

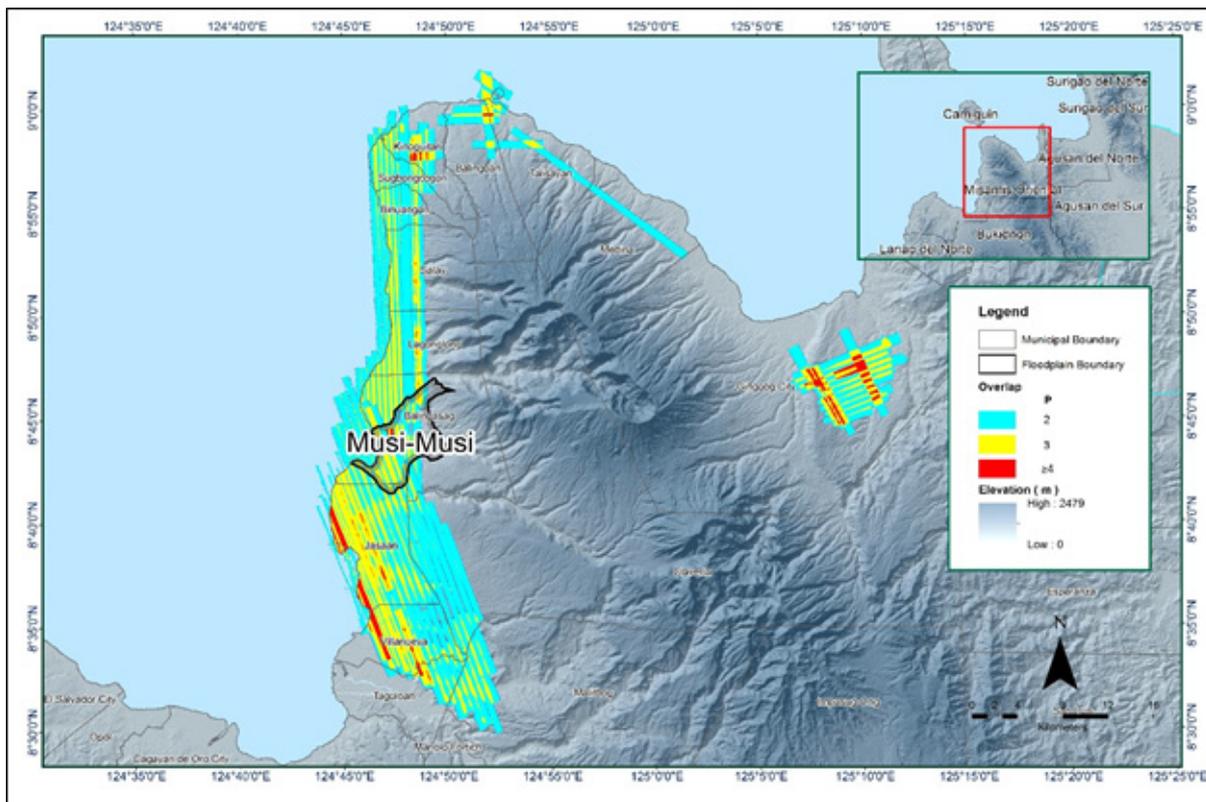
Figure 14. Image of data overlap for Muisi-musi floodplain.

The overlap statistics per block for the Muisi-musi floodplain can be found in Annex 8. Mission Summary Reports. It should be noted that one pixel corresponds to 25.0 square meters on the ground. For this area, the minimum and maximum percent overlaps are 30.50% and 38.61% respectively, which passed the 25% requirement.

The overlap data for the merged LiDAR blocks, showing the number of channels that pass through a particular location is shown in Figure 14. Since the Pegasus system employs two channels, we would expect an average value of 2 (blue) for areas where there is limited overlap, and a value of 3 (yellow) or more (red) for areas with three or more overlapping flight lines.

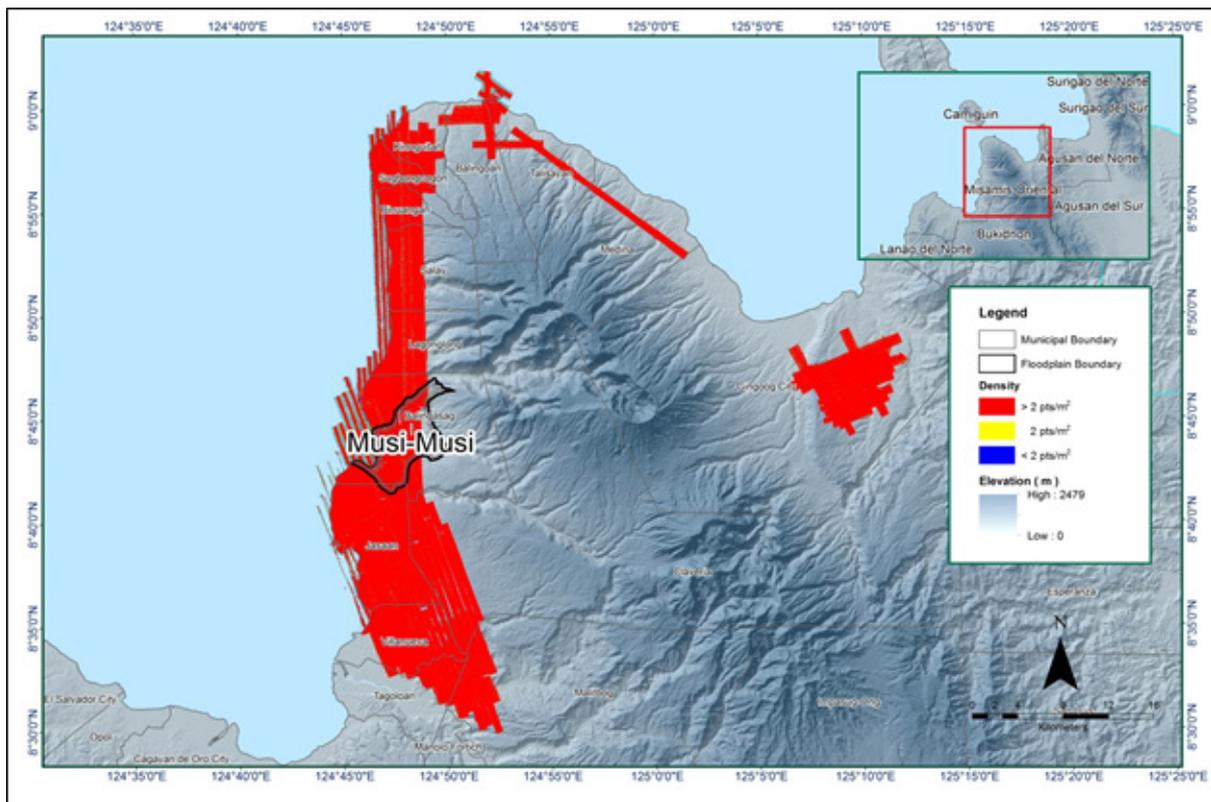
Figure 15. Density map of merged LiDAR data for Musi-musi floodplain.

The density map for the merged LiDAR data, with the red parts showing the portions of the data that satisfy the 2 points per square meter criterion is shown in Figure 15. It was determined that all LiDAR data for Muisi-musi floodplain satisfy the point density requirement, and the average density for the entire survey area is 4.63 points per square meter.

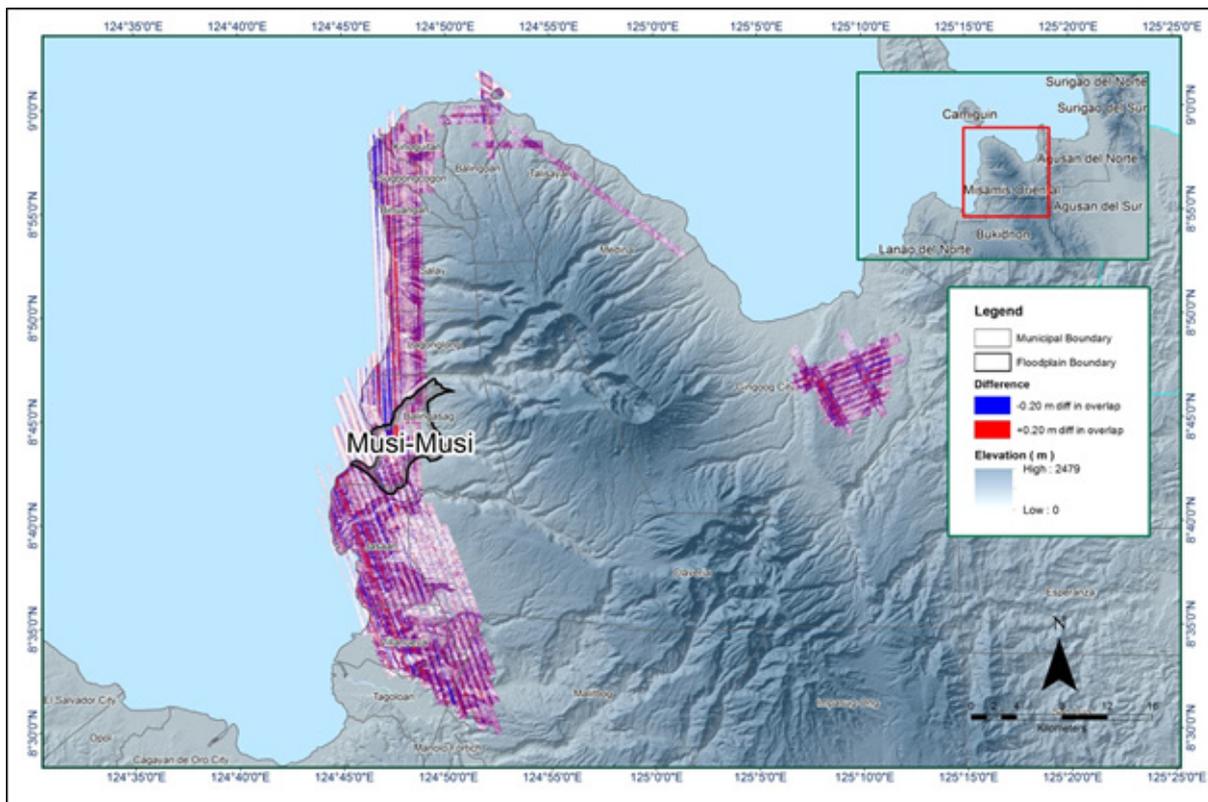
Figure 16. Elevation difference map between flight lines for Musi-musi floodplain.

The elevation difference between overlaps of adjacent flight lines is shown in Figure 16. The default color range is from blue to red, where bright blue areas correspond to portions where elevations of a previous flight line, identified by its acquisition time, are higher by more than 0.20m relative to elevations of its adjacent flight line. Bright red areas indicate portions where elevations of a previous flight line are lower by more than 0.20m relative to elevations of its adjacent flight line. Areas with bright red or bright blue need to be investigated further using Quick Terrain Modeler software.

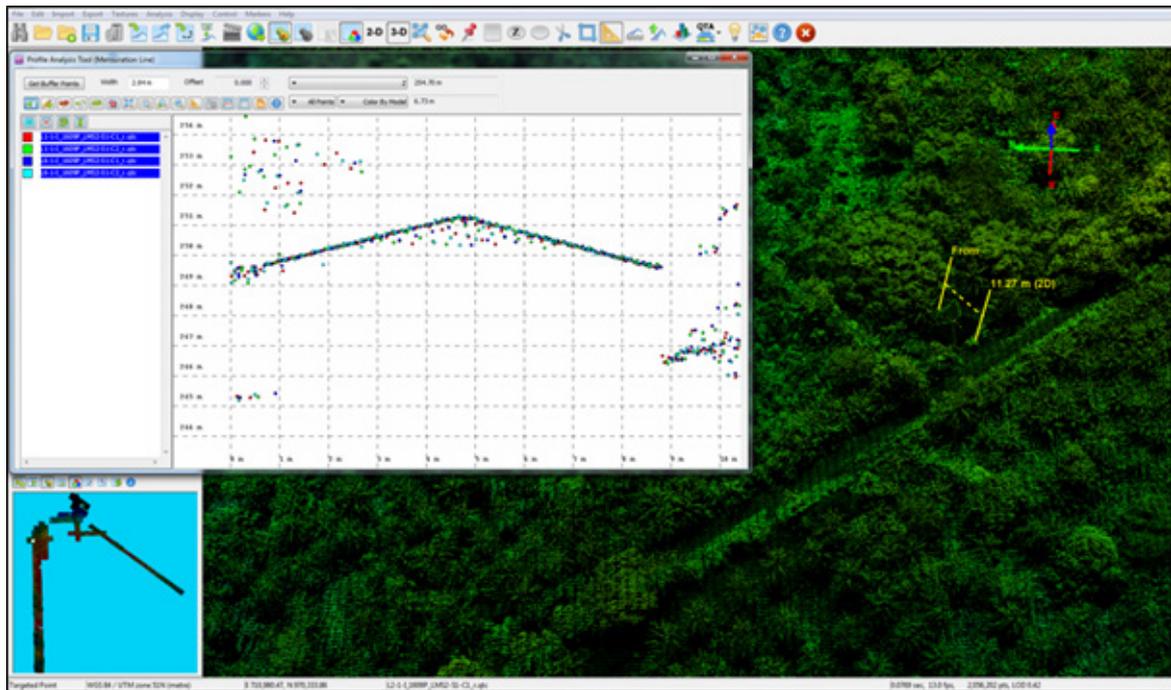
Figure 17. Quality checking for a Musi-musi flight 1609P using the Profile Tool of QT Modeler.

A screen capture of the processed LAS data from a Musi-musi flight 1609P loaded in QT Modeler is shown in Figure 17. The upper left image shows the elevations of the points from two overlapping flight strips traversed by the profile, illustrated by a dashed yellow line. The x-axis corresponds to the length of the profile. It is evident that there are differences in elevation, but the differences do not exceed the 20-centimeter mark. This profiling was repeated until the quality of the LiDAR data becomes satisfactory. No reprocessing was done for this LiDAR dataset.

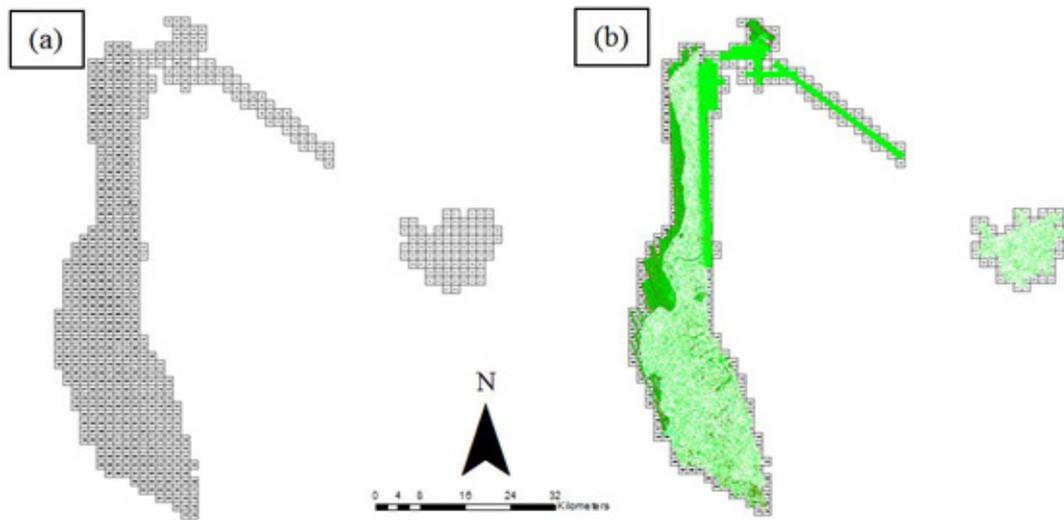
Figure 18. Tiles for Musi-musi floodplain (a) and classification results (b) in TerraScan.

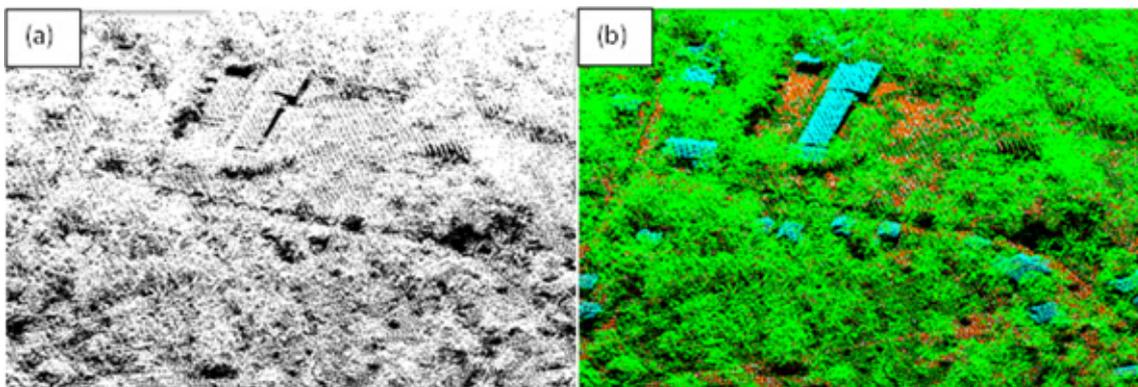
Figure 19. Point cloud before (a) and after (b) classification.

An isometric view of an area before and after running the classification routines is shown in Figure 19. The ground points are in orange, the vegetation is in different shades of green, and the buildings are in cyan. It can be seen that residential structures adjacent or even below canopy are classified correctly, due to the density of the LiDAR data.

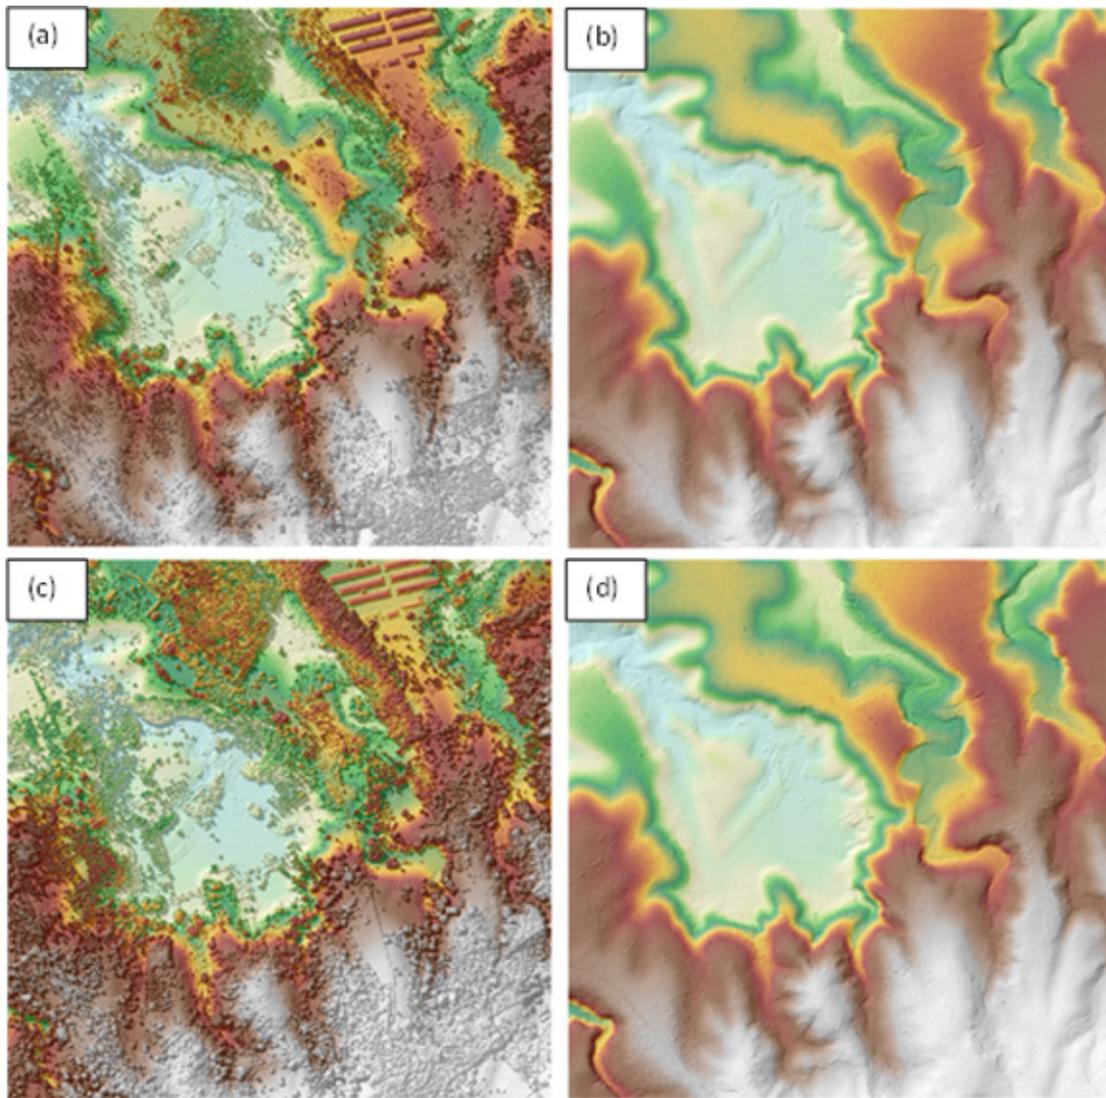
Figure 20. The Production of last return DSM (a) and DTM (b), first return DSM (c) and secondary DTM (d) in some portion of Musi-musi floodplain.

The production of last return (V_ASCII) and the secondary (T_ASCII) DTM, first (S_ASCII) and last (D_ASCII) return DSM of the area in top view display are shown in Figure 20. It shows that DTMs are the representation of the bare earth while on the DSMs, all features are present such as buildings and vegetation.

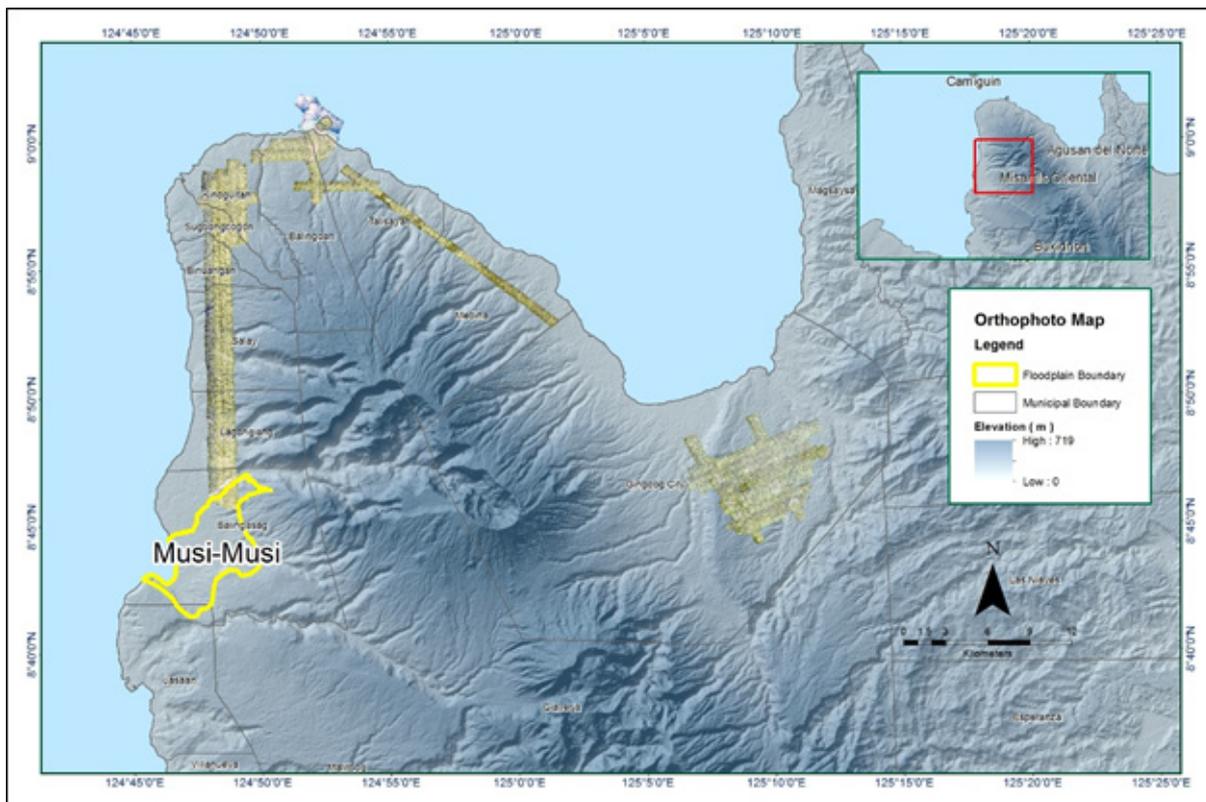
Figure 21. Musi-musi floodplain with available orthophotographs.

The 267 1km by 1km tiles area covered by Musi-musi floodplain is shown in Figure 21. After tie point selection to fix photo misalignments, color points were added to smoothen out visual inconsistencies along the seamlines where photos overlap. The Musi-musi floodplain has a total of 140.62 sq.km orthophotograph coverage comprised of 614 images. A zoomed in version of sample orthophotographs named in reference to its tile number is shown in Figure 22.

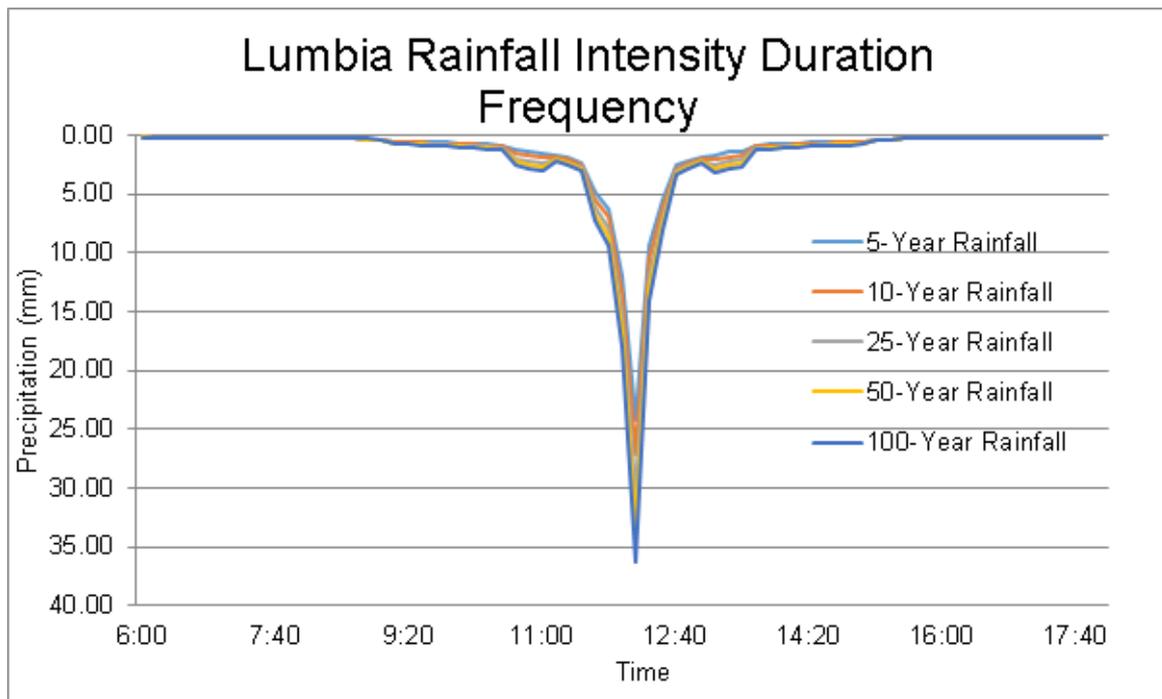
Figure 52. Synthetic storm generated for a 24-hr period rainfall for various return periods

Discharge simulations based on historical data were performed in the calibrated hydrologic model. Among the readily available datasets is the Rainfall Intensity Duration Frequency (RIDF) which is a probability that a particular average rainfall intensity will occur in a specific time frame. Data is usually being utilized to create representation on the estimates of the return period of an observed rainfall event. The RIDF used was based on a 26-year record of Lumbia Rain Gauge of the Philippines Atmospheric Geophysical and Astronomical Services Administration (PAGASA). The Lumbia station was chosen for the simulation due to its proximity to the Musi-musi river basin. Five return periods data namely, 5, 10, 25, 50 and 100-year RIDFs were used for the simulation.

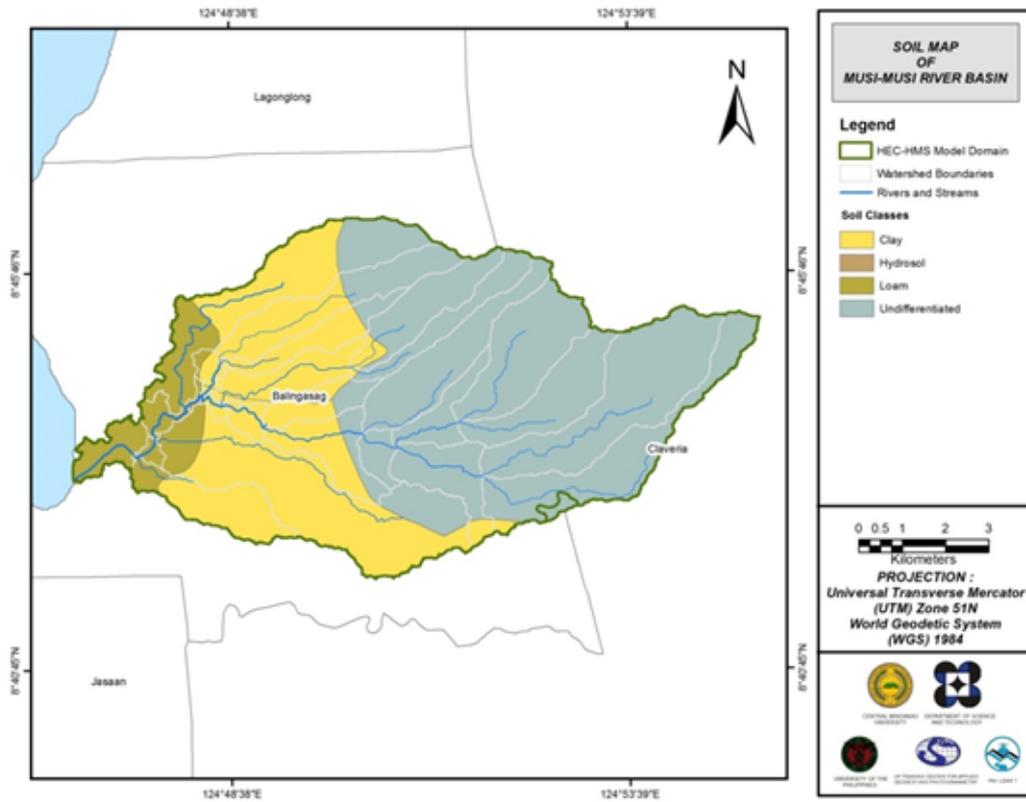
Figure 53. The soil map of the Musi-musi River Basin

The soil dataset was taken before 2004 by the Bureau of Soils and Water Management (BSWM), under the Department of Agriculture (DA). The land cover dataset file is from the National Mapping and Resource information Authority (NAMRIA). The soil and land cover of the Musi-Musi River Basin are shown in Figures 53 and 54, respectively.

For Musi-Musi, four soil classes were identified. These are loam, clay, hydrosol, and undifferentiated soil. Moreover, six land cover classes were identified. These are brushland, built-up, cultivated areas, grassland, mangrove, and tree plantation and perennial.
