Hazard Mapping of the Philippines Using LIDAR (Phil-LIDAR 1)

LiDAR Surveys and Flood Mapping of Musi-Musi River

University of the Philippines Training Center
for Applied Geodesy and Photogrammetry
Central Mindanao University (CMU)

APRIL 2017

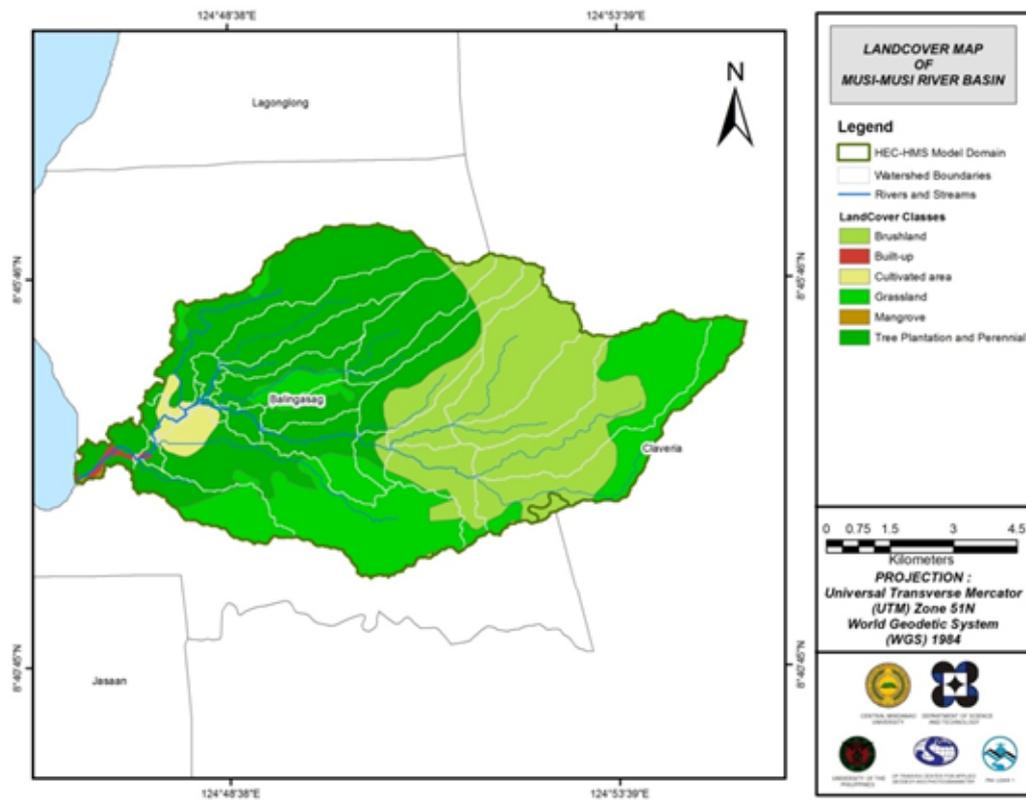
Figure 54. The land cover map of the Musi-musi River Basin (Source: NAMRIA)

The soil dataset was taken before 2004 by the Bureau of Soils and Water Management (BSWM), under the Department of Agriculture (DA). The land cover dataset file is from the National Mapping and Resource information Authority (NAMRIA). The soil and land cover of the Musi-Musi River Basin are shown in Figures 53 and 54, respectively.

For Musi-Musi, four soil classes were identified. These are loam, clay, hydrosol, and undifferentiated soil. Moreover, six land cover classes were identified. These are brushland, built-up, cultivated areas, grassland, mangrove, and tree plantation and perennial.

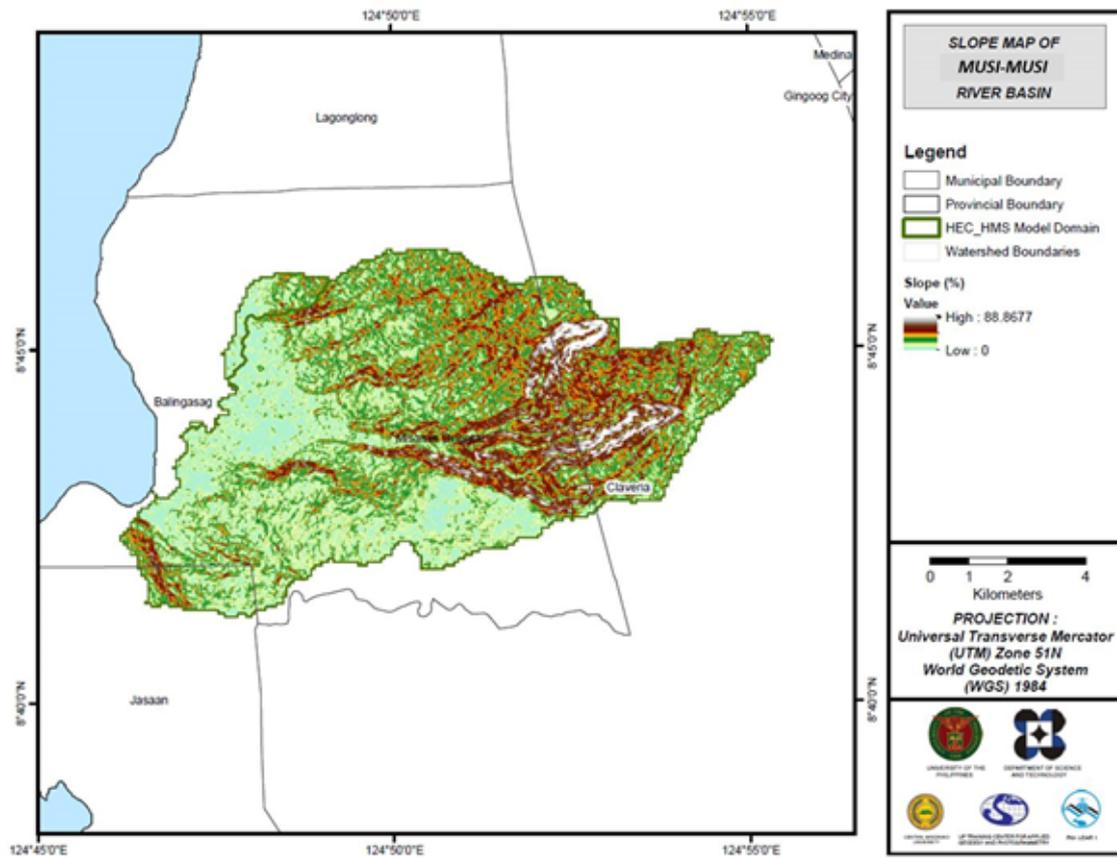
Figure 55. Slope map of Musi-Musi River Basin

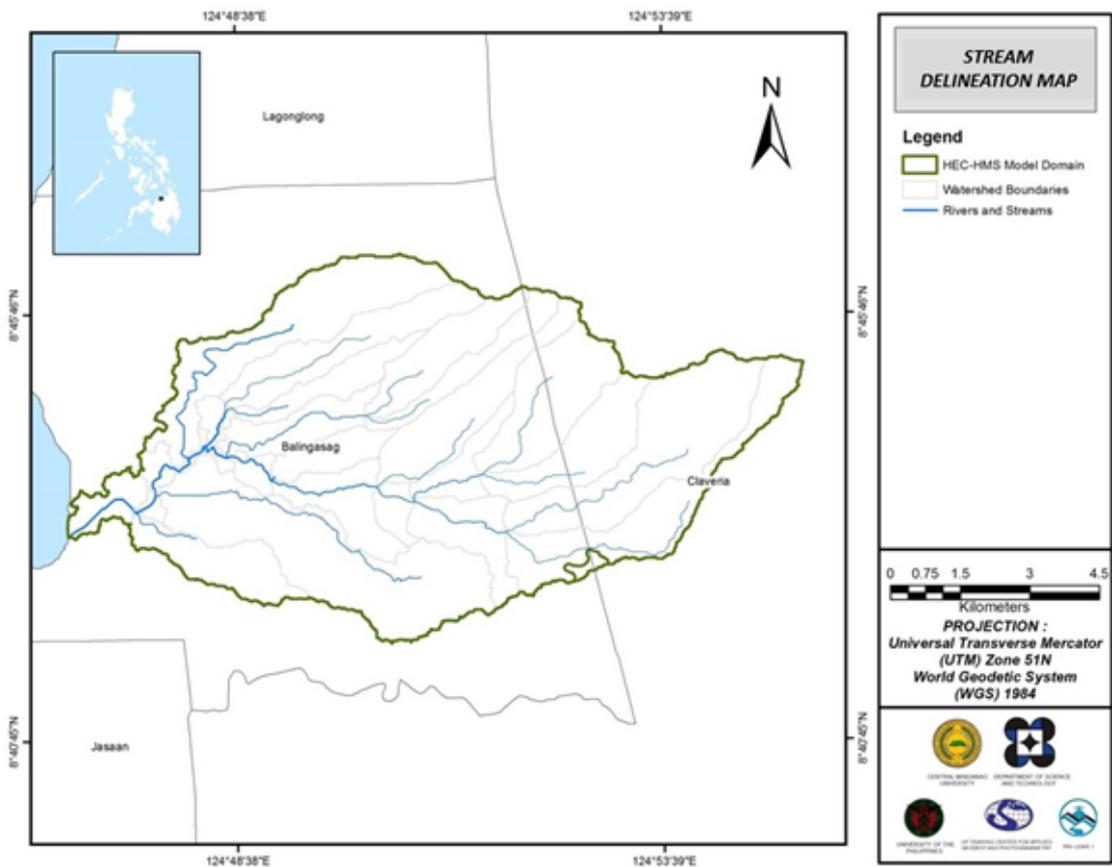
Figure 56. Stream delineation map of Musi-Musi river basin

The basin model of Musi-musi with delineated basin and subbasins was generated using Synthetic Aperture Radar (SAR) 10m Digital Elevation Model (DEM) and digitized river centerline extracted from Google Earth through ArcGIS10.1 extension tool GeoHMS10.1. The basin model consists of 27 sub basins, 14 reaches, and 12 junctions. The main outlet is assigned at the estuary. The basins were identified based on soil and land cover characteristics of the area. Precipitation from the 29-30 December 2014 (Typhoon Seniang) was taken from DOST rain gauge. Finally, it was calibrated using discharge data gathered at the Musi-musi Bridge using mechanical flow meter and deployed digital depth gauge.

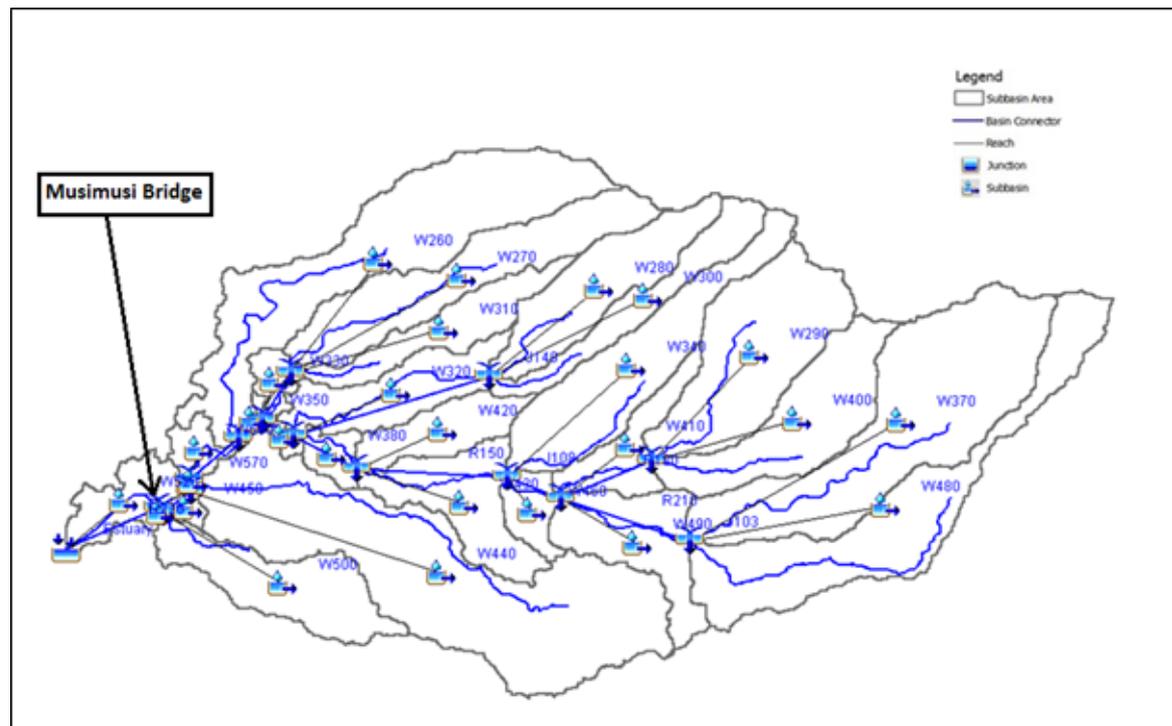
Figure 57. The Musi-Musi river basin model generated using HEC-HMS

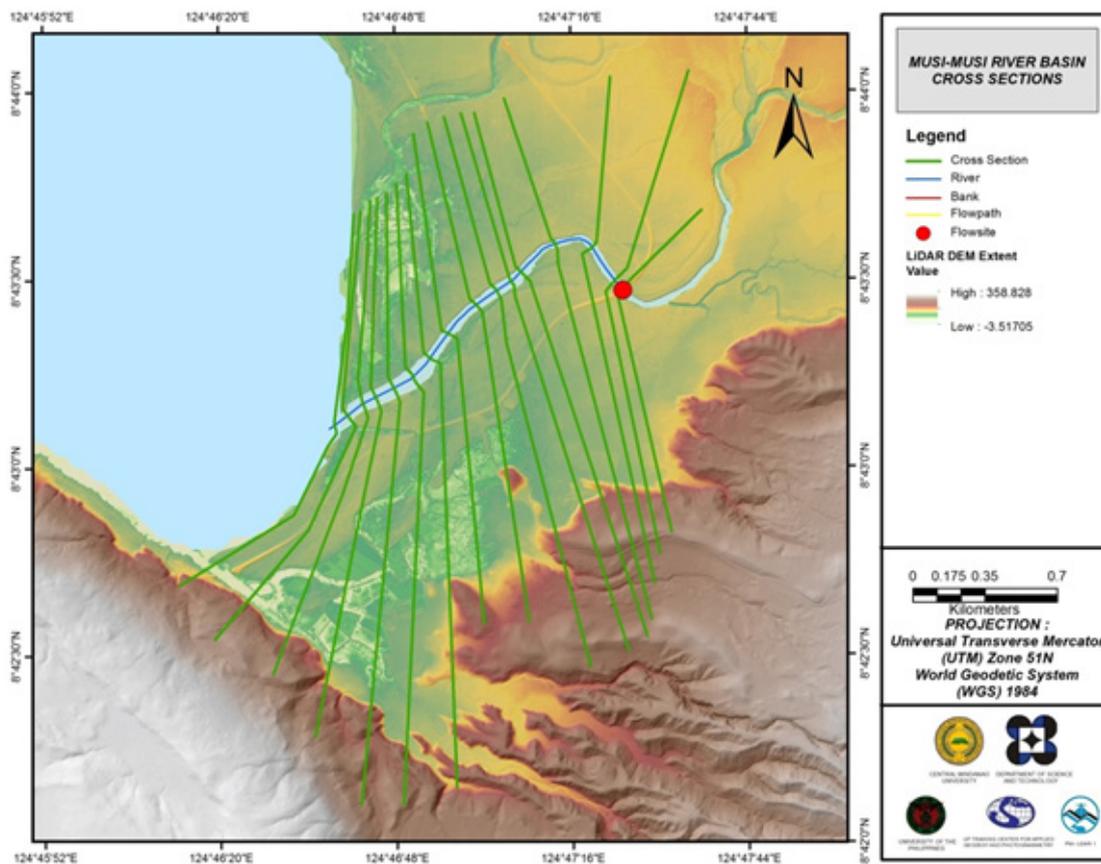
Riverbed cross-sections of the watershed are necessary in the HEC-RAS model setup and in an important composition of the river geometry. The cross-section data for the HEC-RAS model was derived from the LiDAR DEM data. It was defined using the Arc GeoRAS tool and was post-processed in ArcGIS. The river geometry of Musi-musi consists of one (1) river centerline, two (2) banks, three (3) flowpaths, and 16 cross section polylines RAS layers.

Figure 58. Musi-musi River Cross-section generated using HEC GeoRAS tool

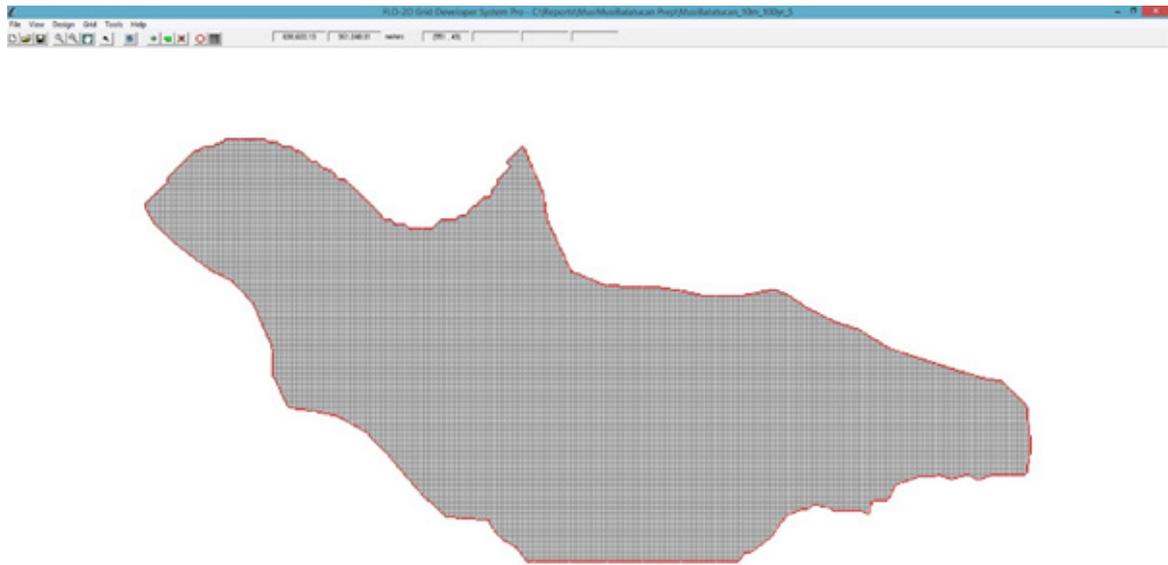
The automated modelling process allows for the creation of a model with boundaries that are almost exactly coincidental with that of the catchment area. As such, they have approximately the same land area and location. The entire area is divided into square grid elements, 10 meter by 10 meter in size. Each element is assigned a unique grid element number which serves as its identifier, then attributed with the parameters required for modelling such as x-and y-coordinate of centroid, names of adjacent grid elements, Manning coefficient of roughness, infiltration, and elevation value. The elements are arranged spatially to form the model, allowing the software to simulate the flow of water across the grid elements and in eight directions (north, south, east, west, northeast, northwest, southeast, southwest). Based on the elevation and flow direction, it is seen that the water will generally flow from the south of the model to the northeast, following the main channel. As such, boundary elements in those particular regions of the model are assigned as inflow and outflow elements respectively.

Figure 59. Screenshot of subcatchment with the computational area to be modeled in FLO-2D GDS Pro

The simulation is then run through FLO-2D GDS Pro. This particular model had a computer run time of 39.55225 hours. After the simulation, FLO-2D Mapper Pro is used to transform the simulation results into spatial data that shows flood hazard levels, as well as the extent and inundation of the flood. Assigning the appropriate flood depth and velocity values for Low, Medium, and High creates the following food hazard map. Most of the default values given by FLO-2D Mapper Pro are used, except for those in the Low hazard level. For this particular level, the minimum h (Maximum depth) is set at 0.2 m while the minimum vh (Product of maximum velocity (v) times maximum depth (h)) is set at 0 m²/s. The creation of a flood hazard map from the model also automatically creates a flow depth map depicting the maximum amount of inundation for every grid element. The legend used by default in Flo-2D Mapper is not a good representation of the range of flood inundation values, so a different legend is used for the layout. In this particular model, the inundated parts cover a maximum land area of 39 385 900.00 m².

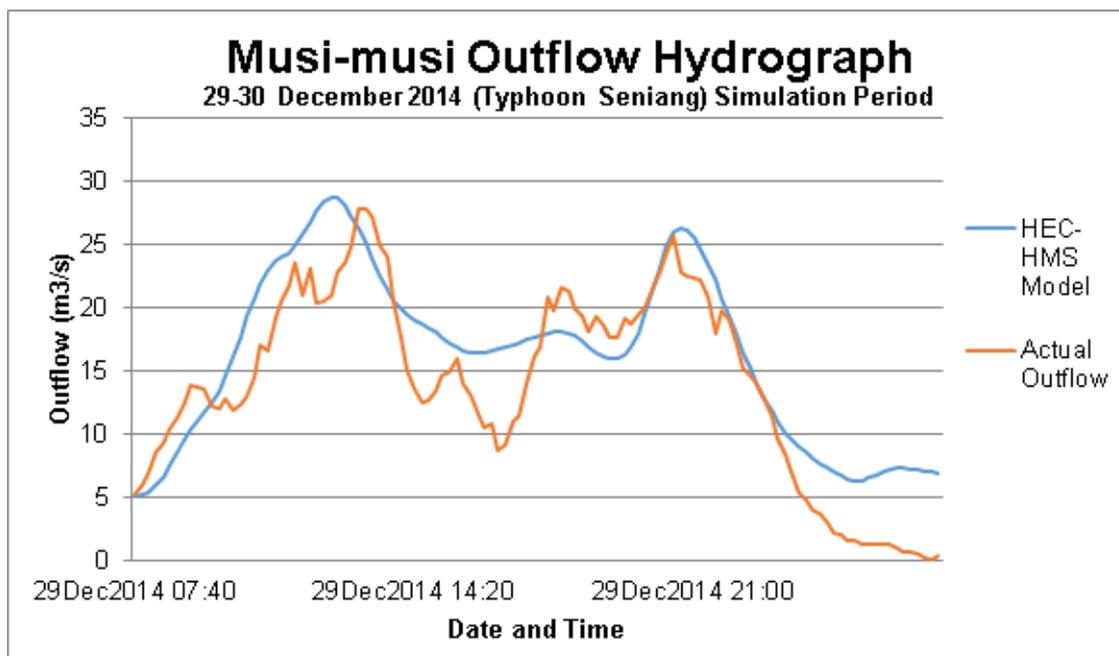
After calibrating the Musi-Musi HEC-HMS river basin model, its accuracy was measured against the observed values (See Annex 9). Figure 60 shows the comparison between the two discharge data.

Figure 60. Outflow Hydrograph of Musi-Musi produced by the HEC-HMS model compared with observed outflow.

Initial abstraction defines the amount of precipitation that must fall before surface runoff. The magnitude of the outflow hydrograph increases as initial abstraction decreases. The range of values from 100mm to 275mm means that there is a high amount of infiltration or rainfall interception by vegetation.

Curve number is the estimate of the precipitation excess of soil cover, land use, and antecedent moisture. The magnitude of the outflow hydrograph increases as curve number increases. The range of 38 to 73.837 for curve number is lower than the advisable range for Philippine watersheds depending on the soil and land cover of the area. For Musi-Musi, the basin mostly consists of brushlands, grasslands, tree plantation and perennial, and the soil consists of clay, loam, and undifferentiated soil.

The Pearson correlation coefficient (r^2) assesses the strength of the linear relationship between the observations and the model. This value being close to 1 corresponds to an almost perfect match of the observed discharge and the resulting discharge from the HEC HMS model. Here, it measured 0.90.

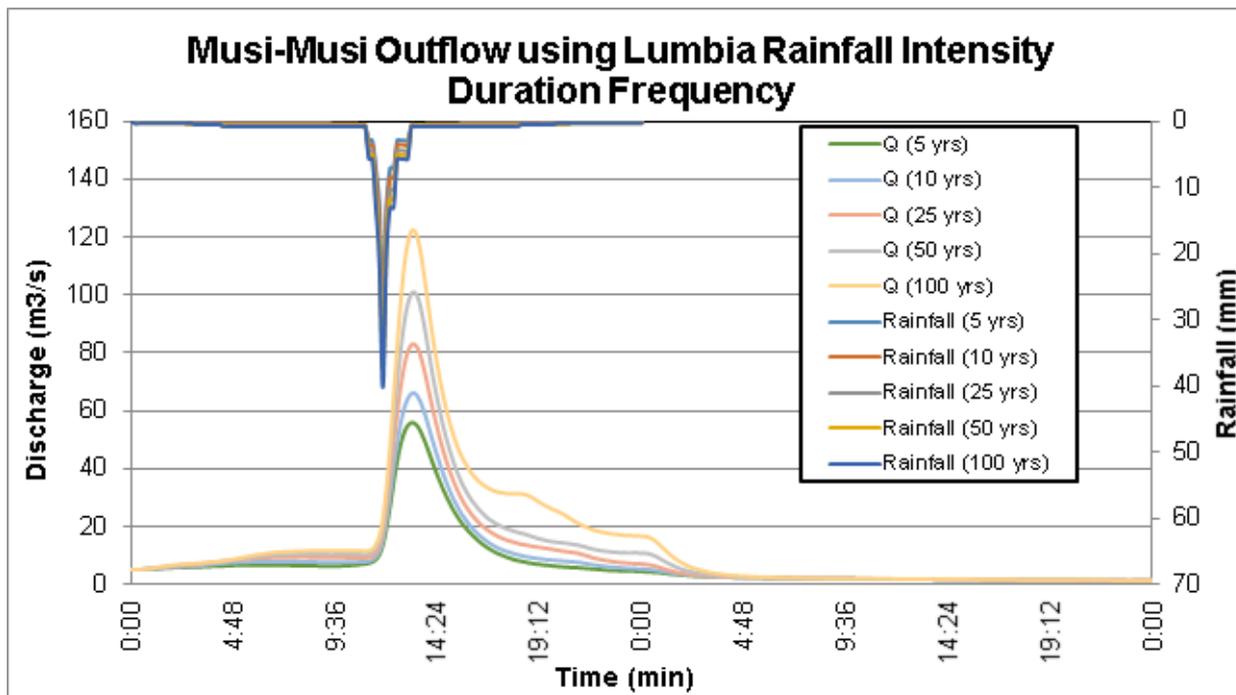
The summary graph (Figure 61) shows the Musi-Musi outflow using the Lumbia Rainfall Intensity-Duration-Frequency curves (RIDF) in 5 different return periods (5-year, 10-year, 25-year, 50-year, and 100-year rainfall time series) based on the Philippine Atmospheric Geophysical and Astronomical Services Administration (PAG-ASA) data. The simulation results reveal significant increase in outflow magnitude as the rainfall intensity increases for a range of durations and return periods.

Figure 61. Outflow hydrograph at Musi-Musi Station generated using Lumbia RIDF simulated in HEC-HMS

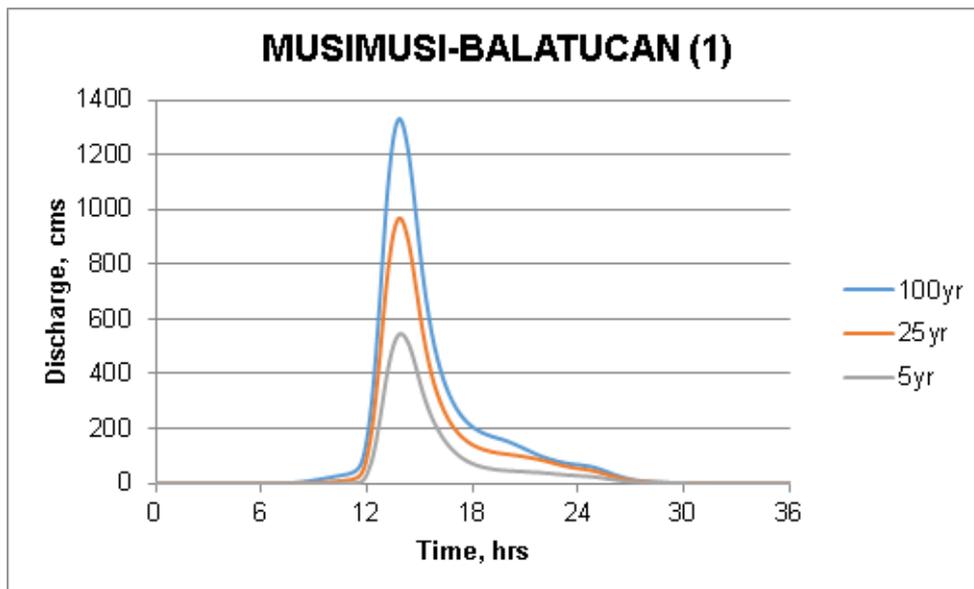
The river discharges for the three rivers entering the floodplain are shown in Figure 62 to Figure 63 and the peak values are summarized in Table 32 to Table 33.

Figure 62. Musi-Musi and Balatucan river (1) generated discharge using 5-, 25-, and 100-year Lumbia rainfall intensity-duration-frequency (RIDF) in HEC-HMS

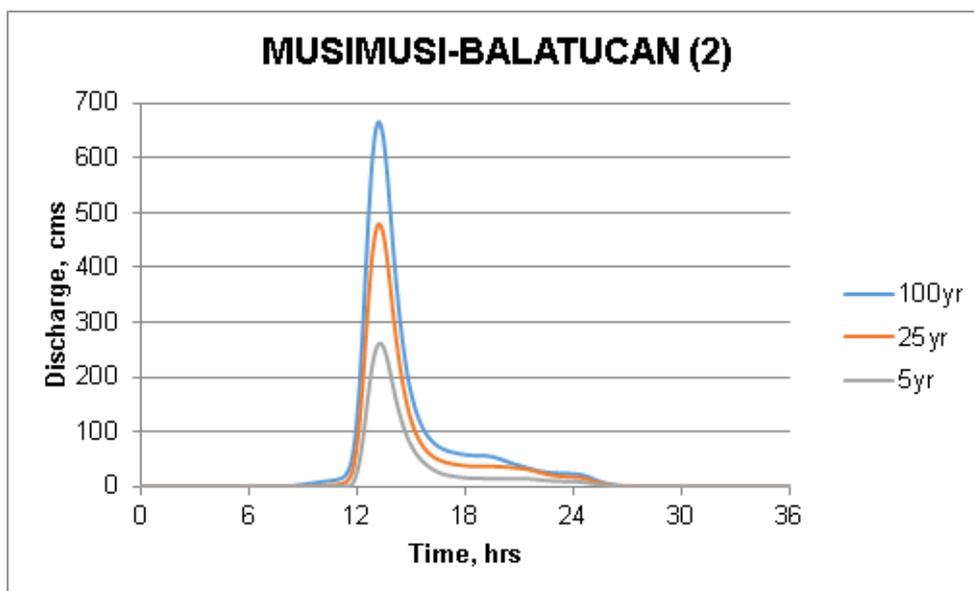
Figure 63. Musi-Musi and Balatucan river (2) generated discharge using 5-, 25-, and 100-year Lumbia rainfall intensity-duration-frequency (RIDF) in HEC-HMS

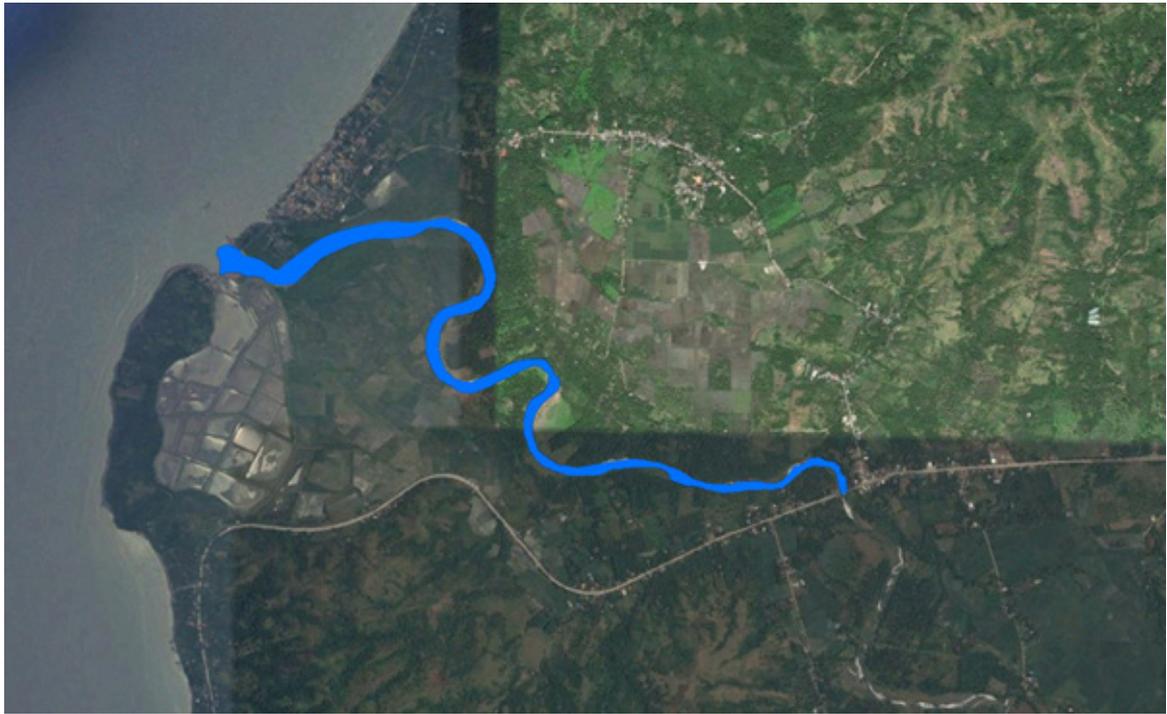
The HEC-RAS Flood Model produced a simulated water level at every cross-section for every time step for every flood simulation created. The resulting model will be used in determining the flooded areas within the model. The simulated model will be an integral part in determining real-time flood inundation extent of the river after it has been automated and uploaded on the DREAM website. For this publication, only a sample output map river was to be shown. The sample generated map of Musi-Musi River using the calibrated HMS base flow is shown in Figure 64.

Figure 64. Sample output of Balatucan - Musi-Musi RAS Model

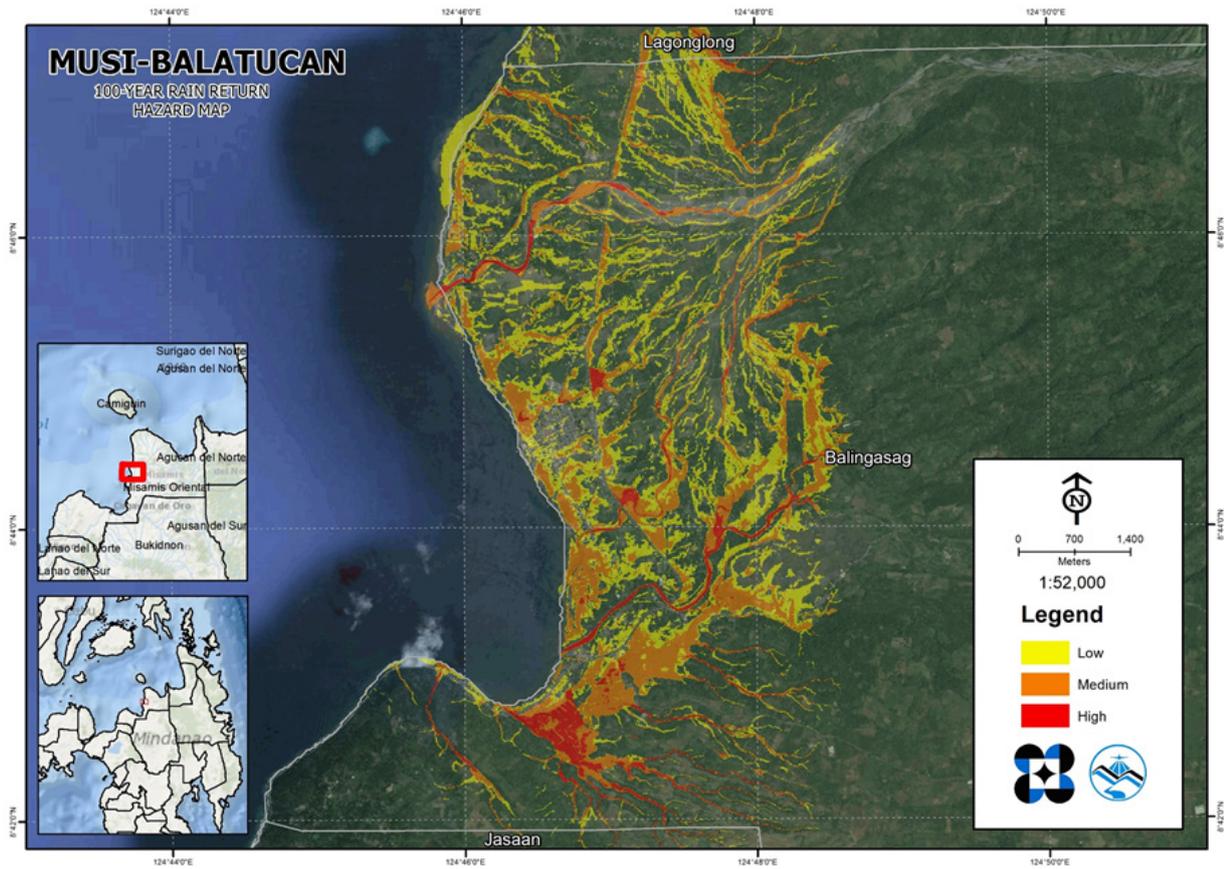
The resulting hazard and flow depth maps have a 10m resolution. Figure 65 to Figure 70 shows the 5-, 25-, and 100-year rain return scenarios of the Musi-Balatucan floodplain. The floodplain, with an area OF 46.31 sq. km., covers four municipalites namely Balingasa, Claveria, Jasaan and Lagonglong. Table shows the percentage of area affected by flooding per municipality.

Figure 65. 100-year Flood Hazard Map for Musi-Musi-Balatuacan Floodplain

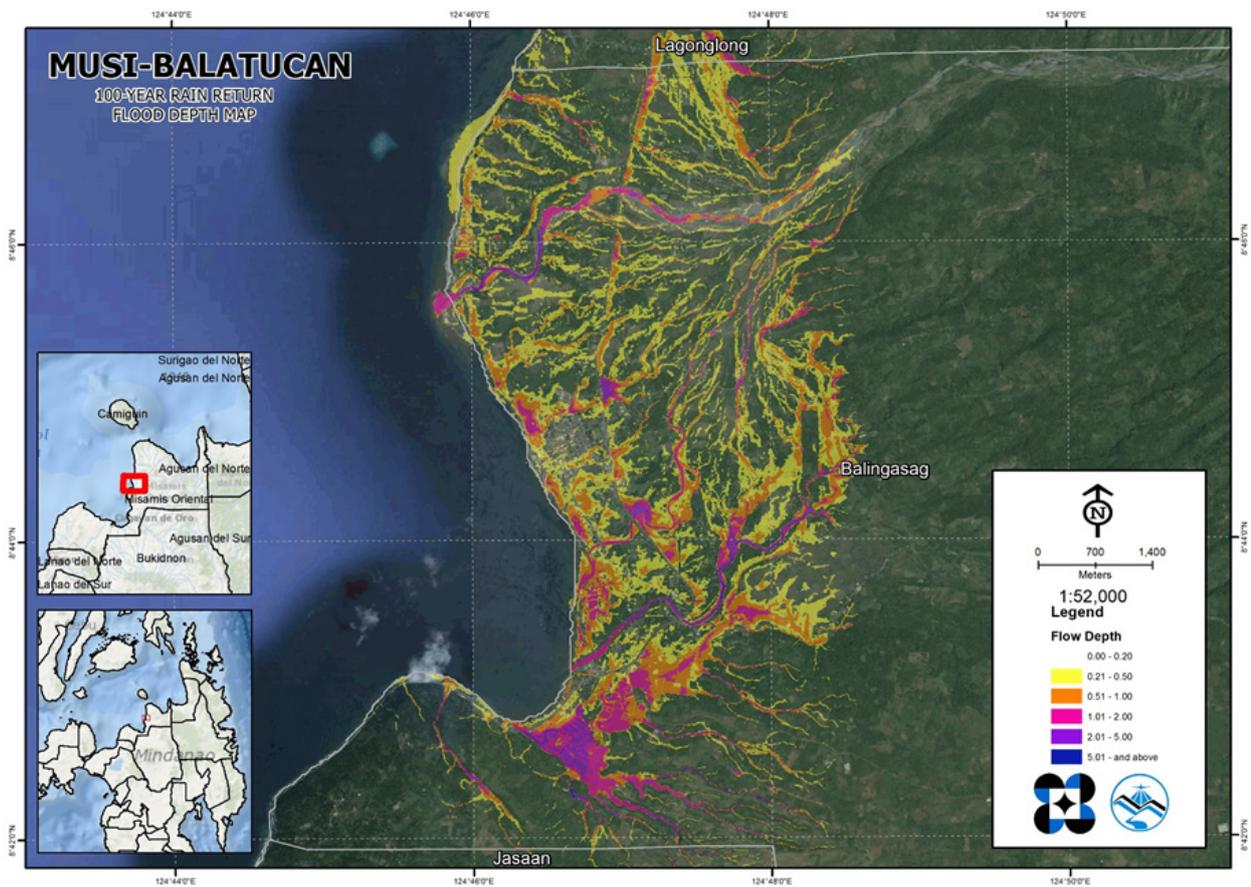
Figure 66. 100-year Flow Depth Map for Musi-Musi-Balatuacan Floodplain

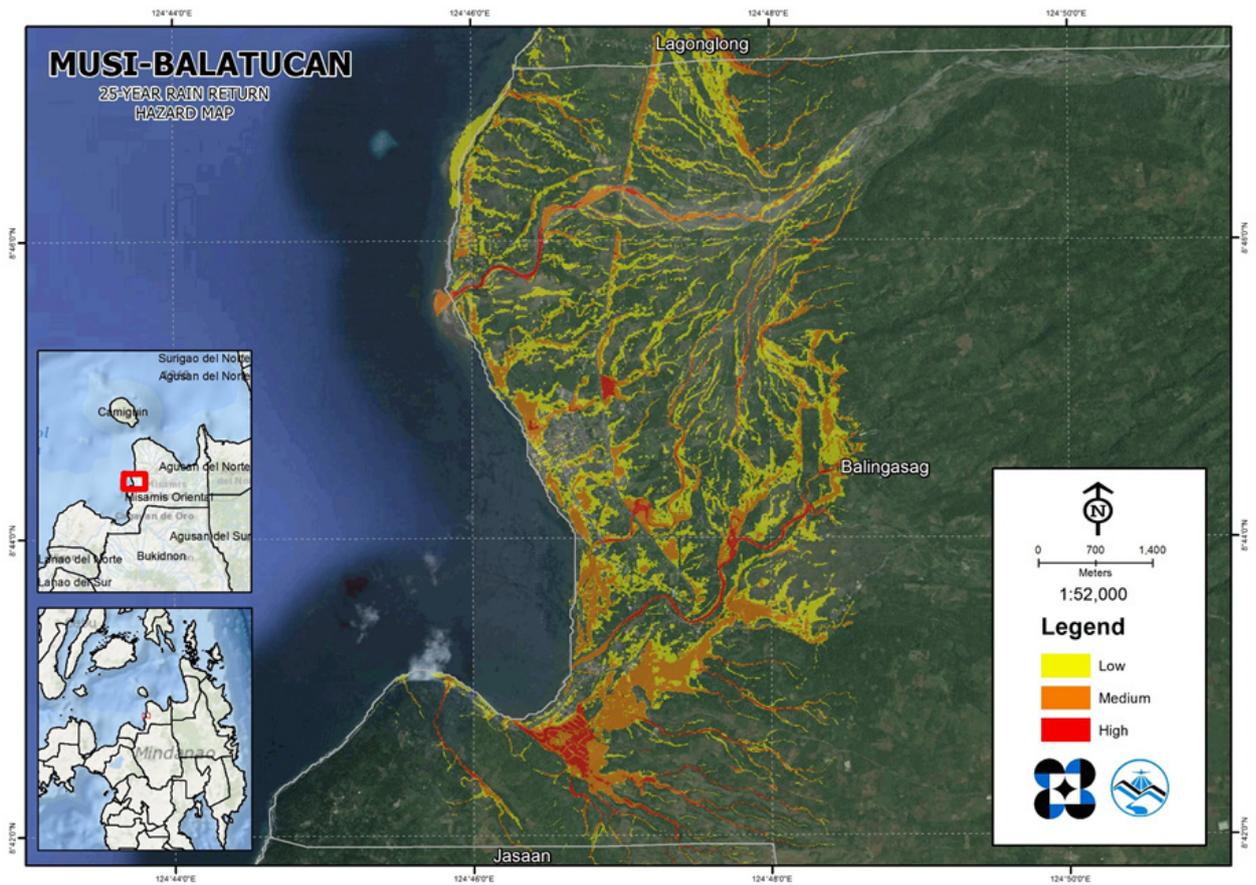
Figure 67. 25-year Flood Hazard Map for Musi-Musi-Balatuacan Floodplain

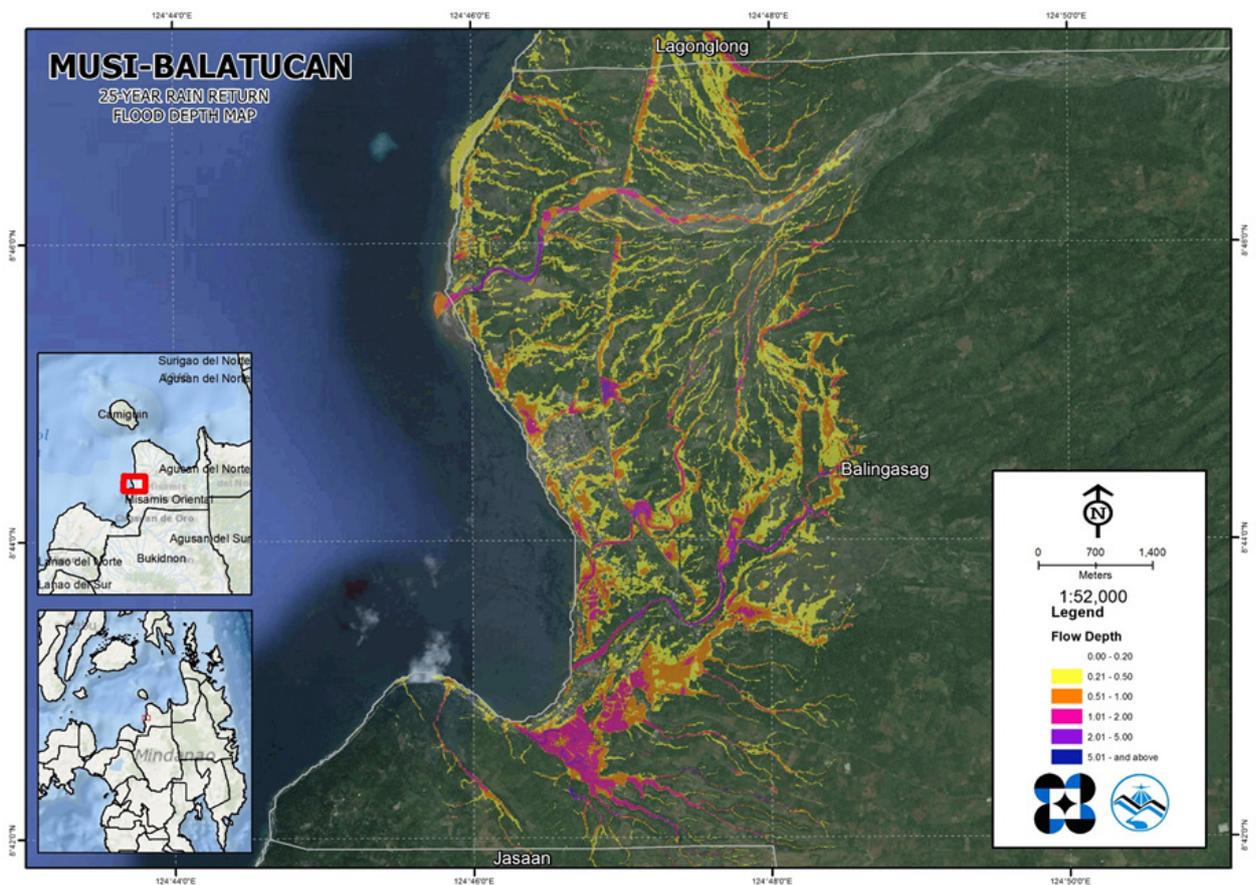
Figure 68. 25-year Flow Depth Map for Musi-Musi-Balatuacan Floodplain

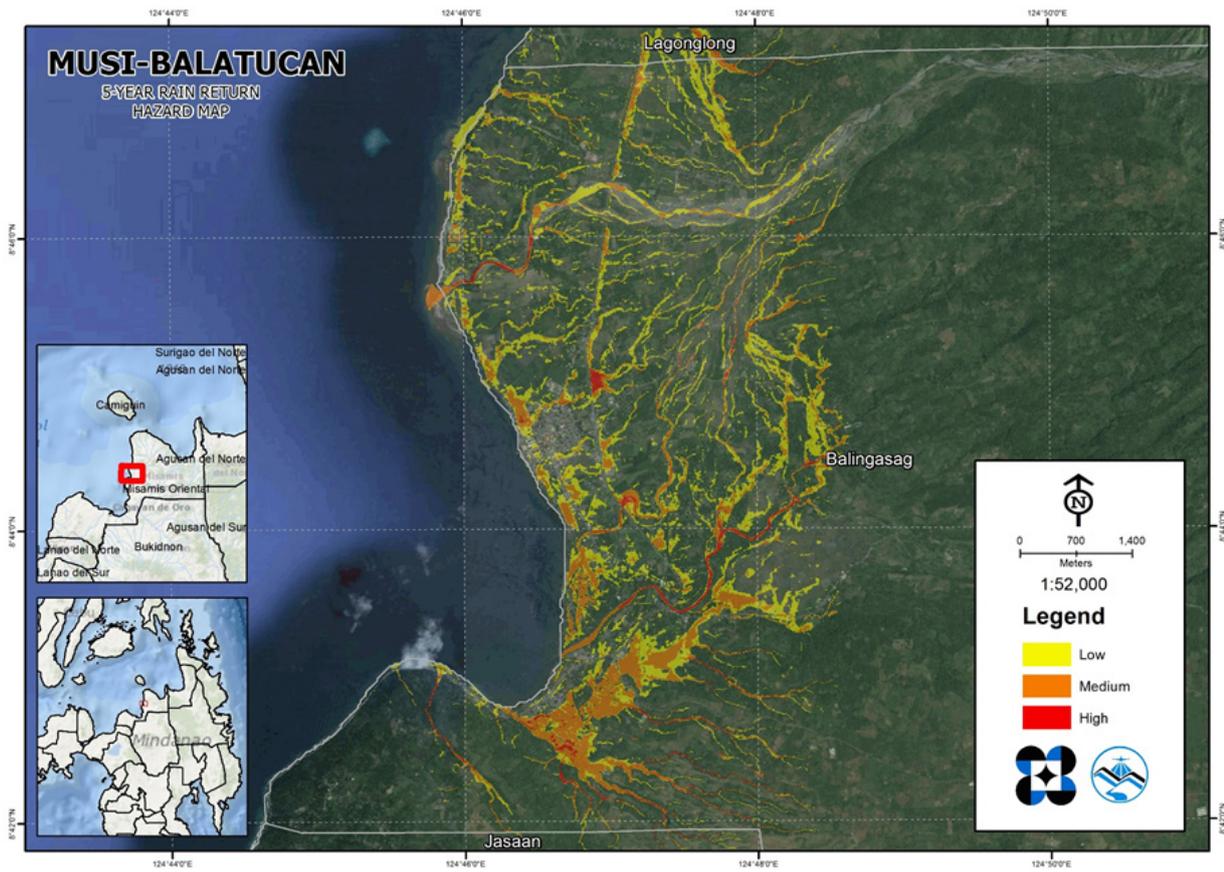
Figure 69. 5-year Flood Hazard Map for Musi-Musi-Balatuacan Floodplain

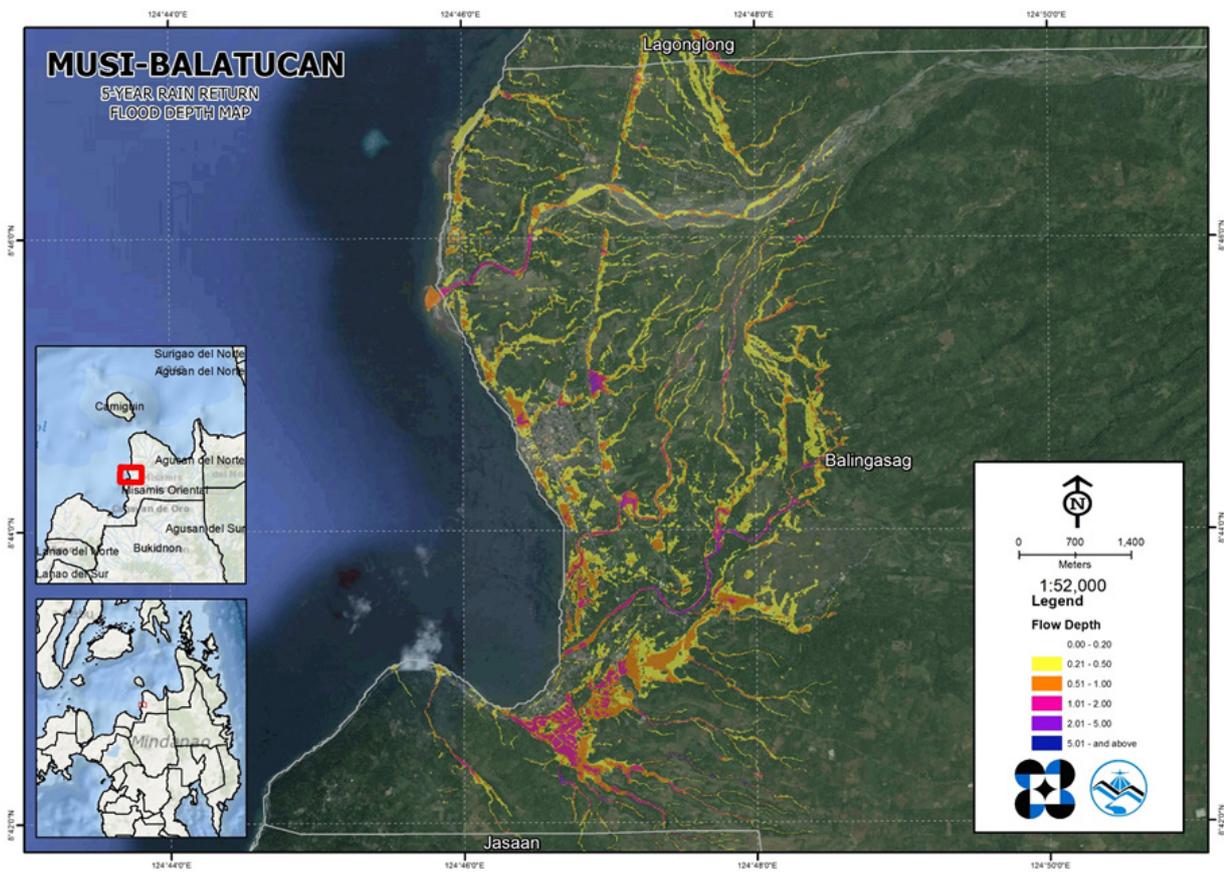
Figure 70. 5-year Flood Depth Map for MusiMusi-Balatuacan Floodplain

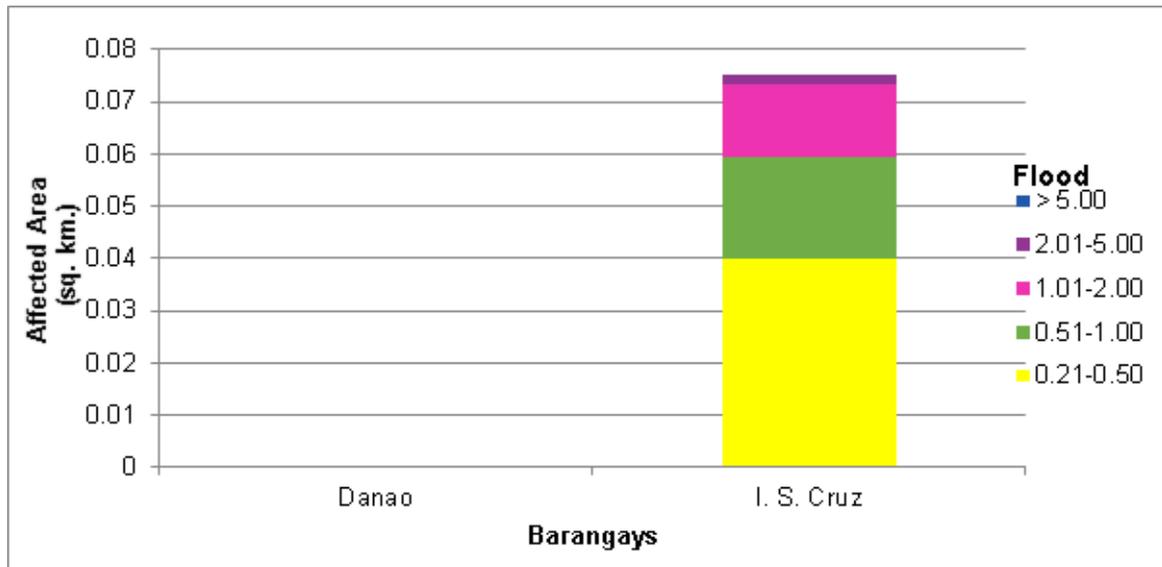
For the 5-year return period, 2.17% of the municipality of Jasaan with an area of 68.327103 sq. km. will experience flood levels of less than 0.20 meters. 0.06% of the area will experience flood levels of 0.21 to 0.50 meters while 0.03%, and 0.02% of the area will experience flood depths of 0.51 to 1 meter, and 1.01 to 2 meters, respectively. Listed in the table are the affected areas in square kilometers by flood depth per barangay.

Figure 74. Affected Areas in Jasaan, Misamis Oriental during 5-Year Rainfall Return Period

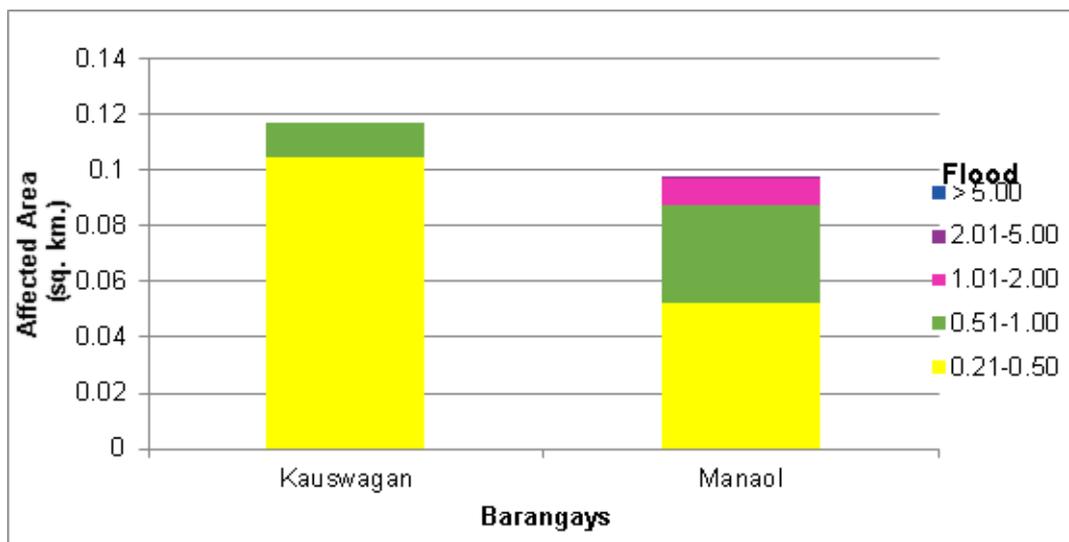
For the 5-year return period, 2.48% of the municipality of Lagonglong with an area of 46.624699 sq. km. will experience flood levels of less than 0.20 meters. 0.34% of the area will experience flood levels of 0.21 to 0.50 meters while 0.10%, and 0.02% of the area will experience flood depths of 0.51 to 1 meter, and 1.01 to 2 meters respectively. Listed in the table are the affected areas in square kilometers by flood depth per barangay.

Figure 75. Affected Areas in Lagonglong, Misamis Oriental during 5-Year Rainfall Return Period

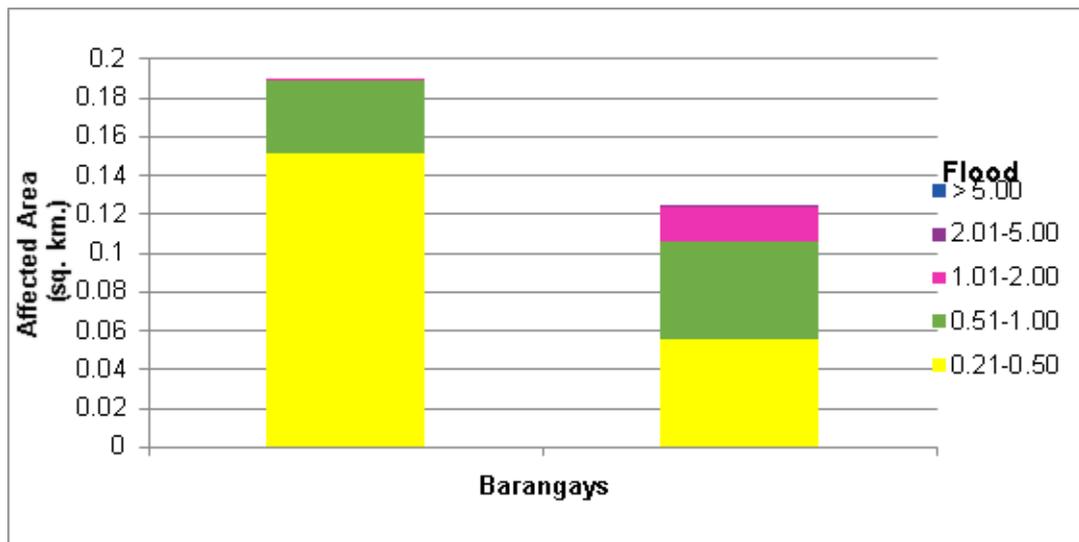
For the 25-year return period, 2.26% of the municipality of Lagonglong with an area of 46.624699 sq. km. will experience flood levels of less than 0.20 meters. 0.44% of the area will experience flood levels of 0.21 to 0.50 meters while 0.19%, 0.04%, 0.00%, and 0.00% of the area will experience flood depths of 0.51 to 1 meter, 1.01 to 2 meters, 2.01 to 5 meters, and more than 5 meters, respectively. Listed in the table are the affected areas in square kilometers by flood depth per barangay.

Figure 80. Affected Areas in Lagonglong, Misamis Oriental during 25-Year Rainfall Return Period

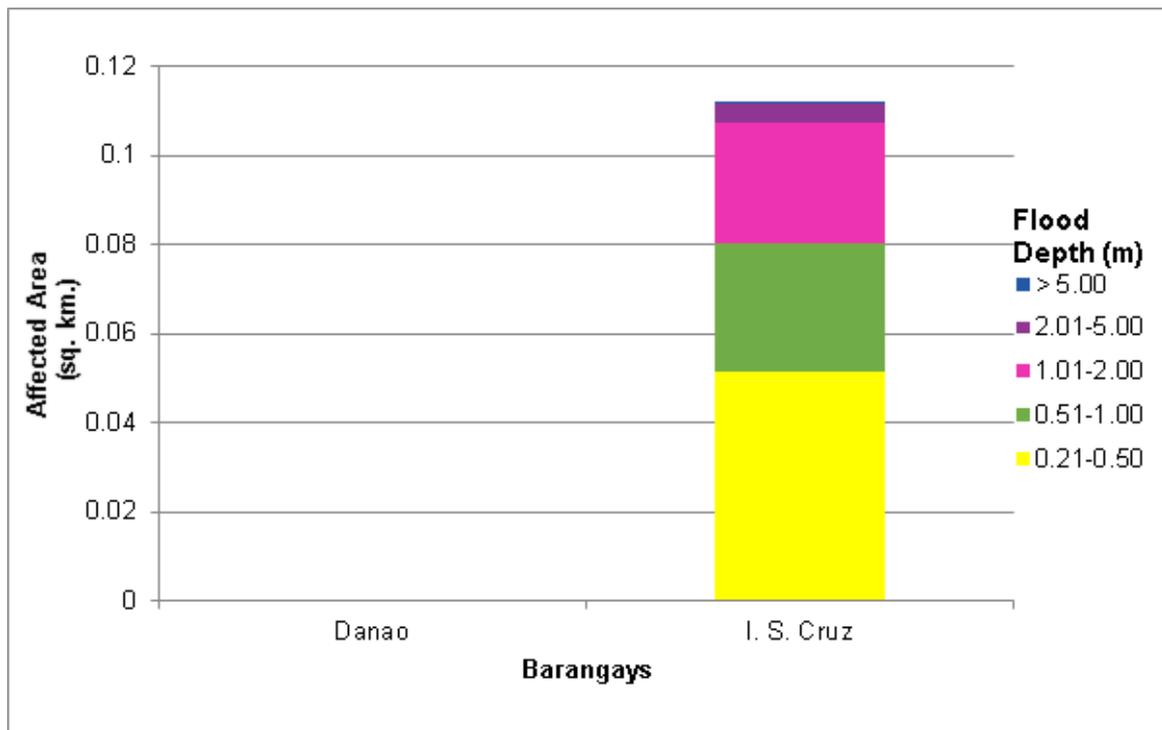
BALATUCAN – MUSI-MUSI BASIN		Affected Barangays in Jasaan	
		Danao	I. S. Cruz
Affected Area (sq. km.)	0.03-0.20	0.044129	1.402379
	0.21-0.50	0.000163	0.051441
	0.51-1.00	0	0.028861
	1.01-2.00	0	0.026922
	2.01-5.00	0	0.004593
	> 5.00	0	0.000099

Figure 84. Affected Areas in Jasaan, Misamis Oriental during 100-Year Rainfall Return Period

Figure 84. Affected Areas in Jasaan, Misamis Oriental during 100-Year Rainfall Return Period..... 85

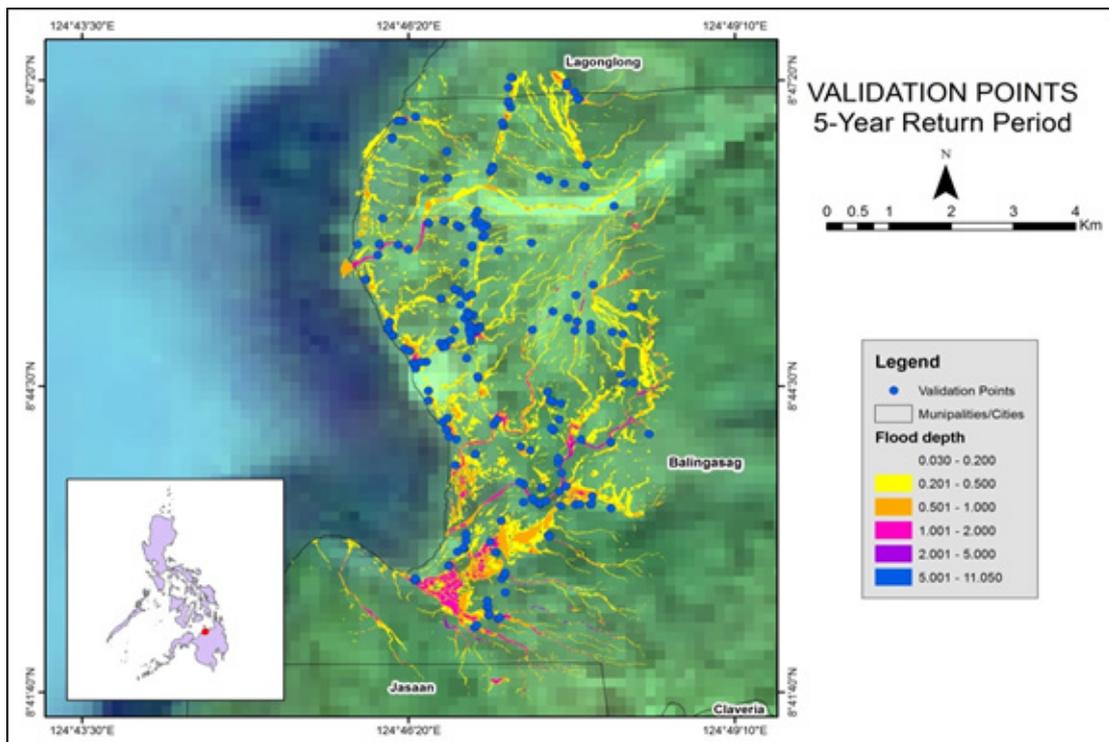
The flood validation consists of 221 points randomly selected all over the Balatucan - Musi-Musi flood plain. It has an RMSE value of 0.66. The validation points are found in ANNEX 11.

Figure 85. MusiMusi-Balatuacan Flood Validation Points

Figure 85. MusiMusi-Balatucan Flood Validation Points..... 87

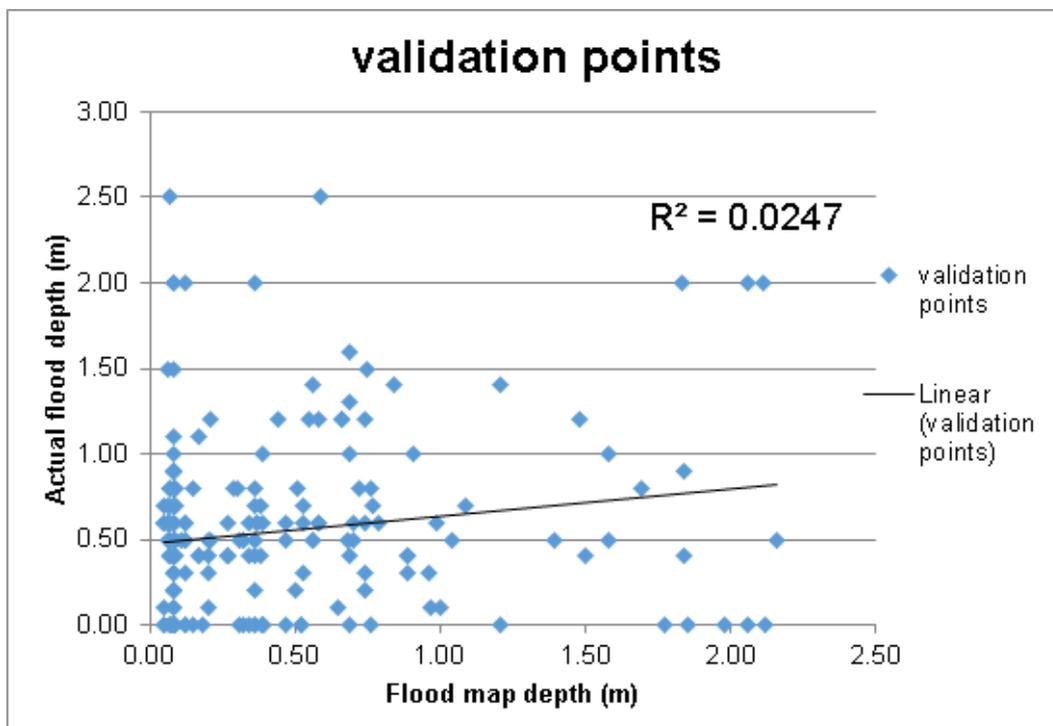
Figure 86. Flood map depth vs actual flood depth

Figure 86. Flood map depth vs actual flood depth..... 87
