Hazard Mapping of the Philippines Using LIDAR (Phil-LIDAR 1)

LiDAR Surveys and Flood Mapping of Musi-Musi River

University of the Philippines Training Center
for Applied Geodesy and Photogrammetry
Central Mindanao University (CMU)

APRIL 2017

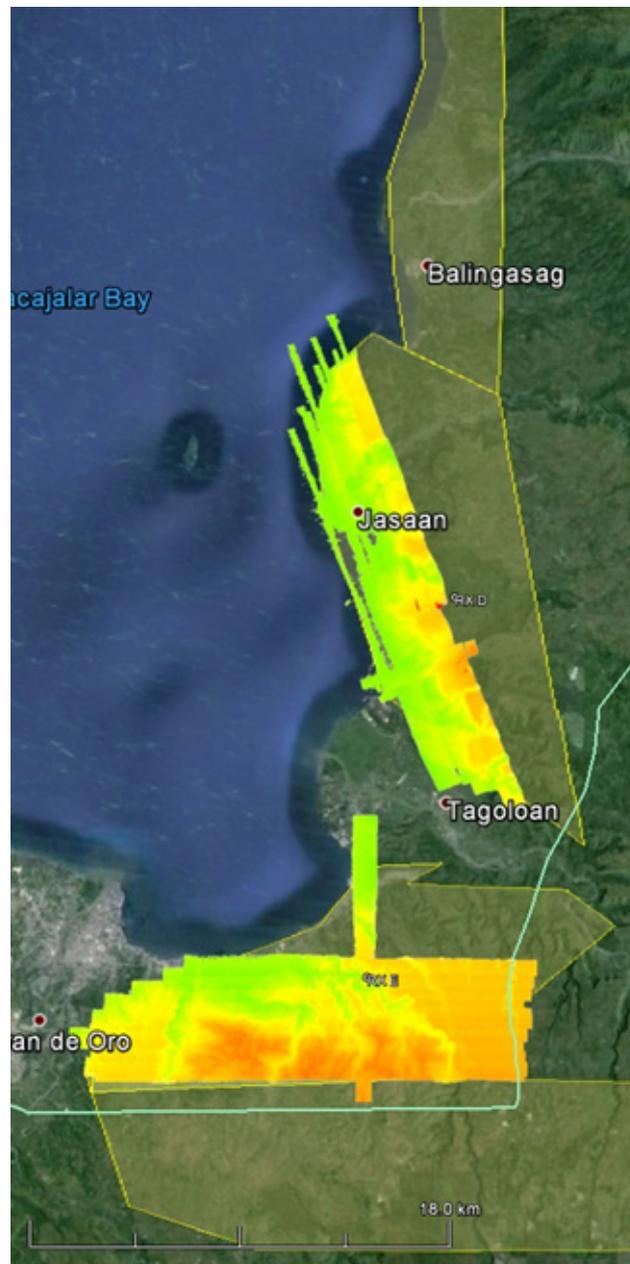
Flight No. : 1517P

Area: RX D, RX E

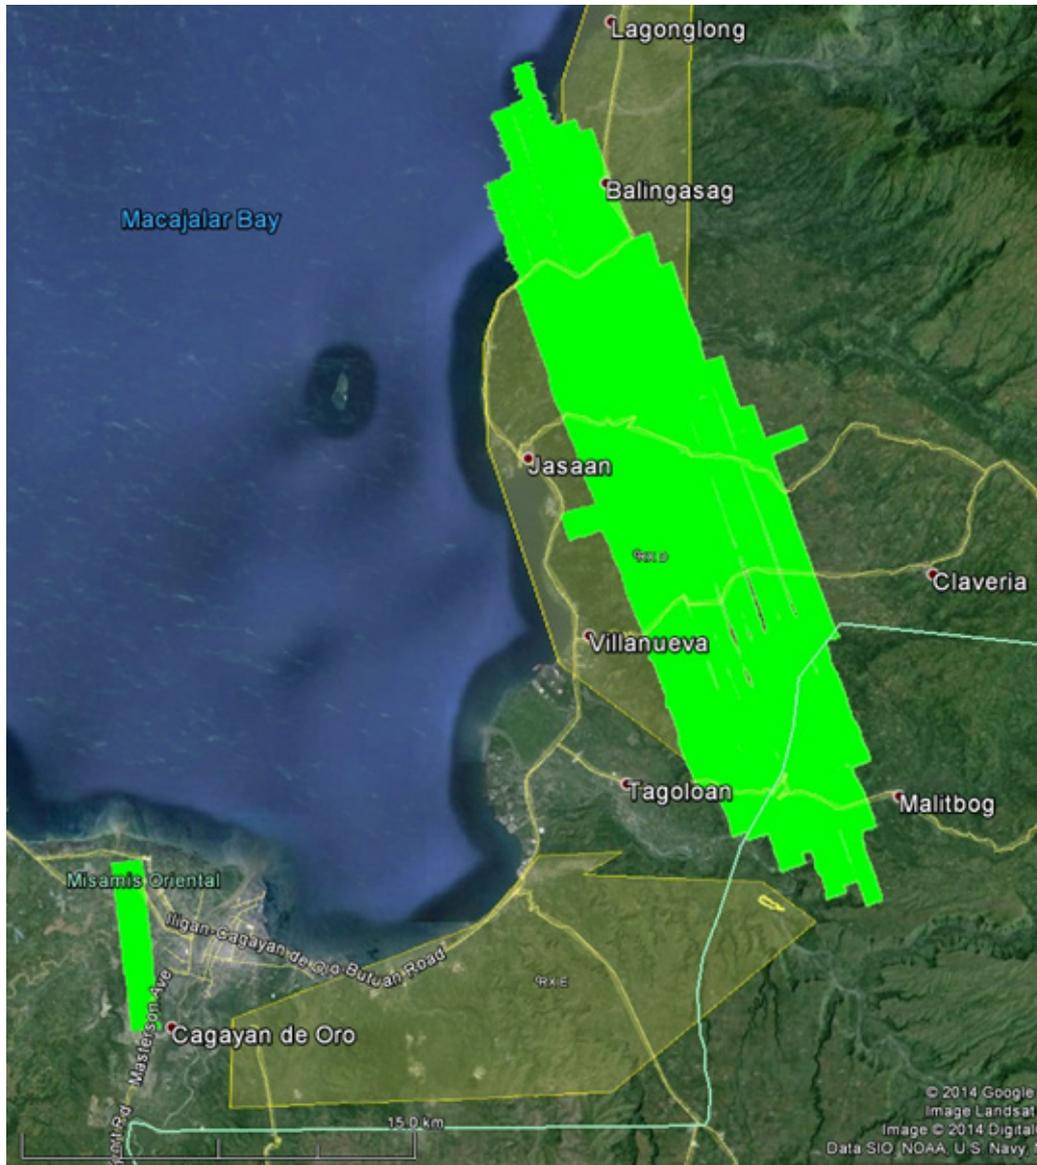
Flight No. : 1561P
Area: RX D
Mission Name: 1RXE158A
Parameters: Altitude: 1000 m; Scan Frequency: 30Hz;
Scan Angle: 25deg; Overlap: 30%

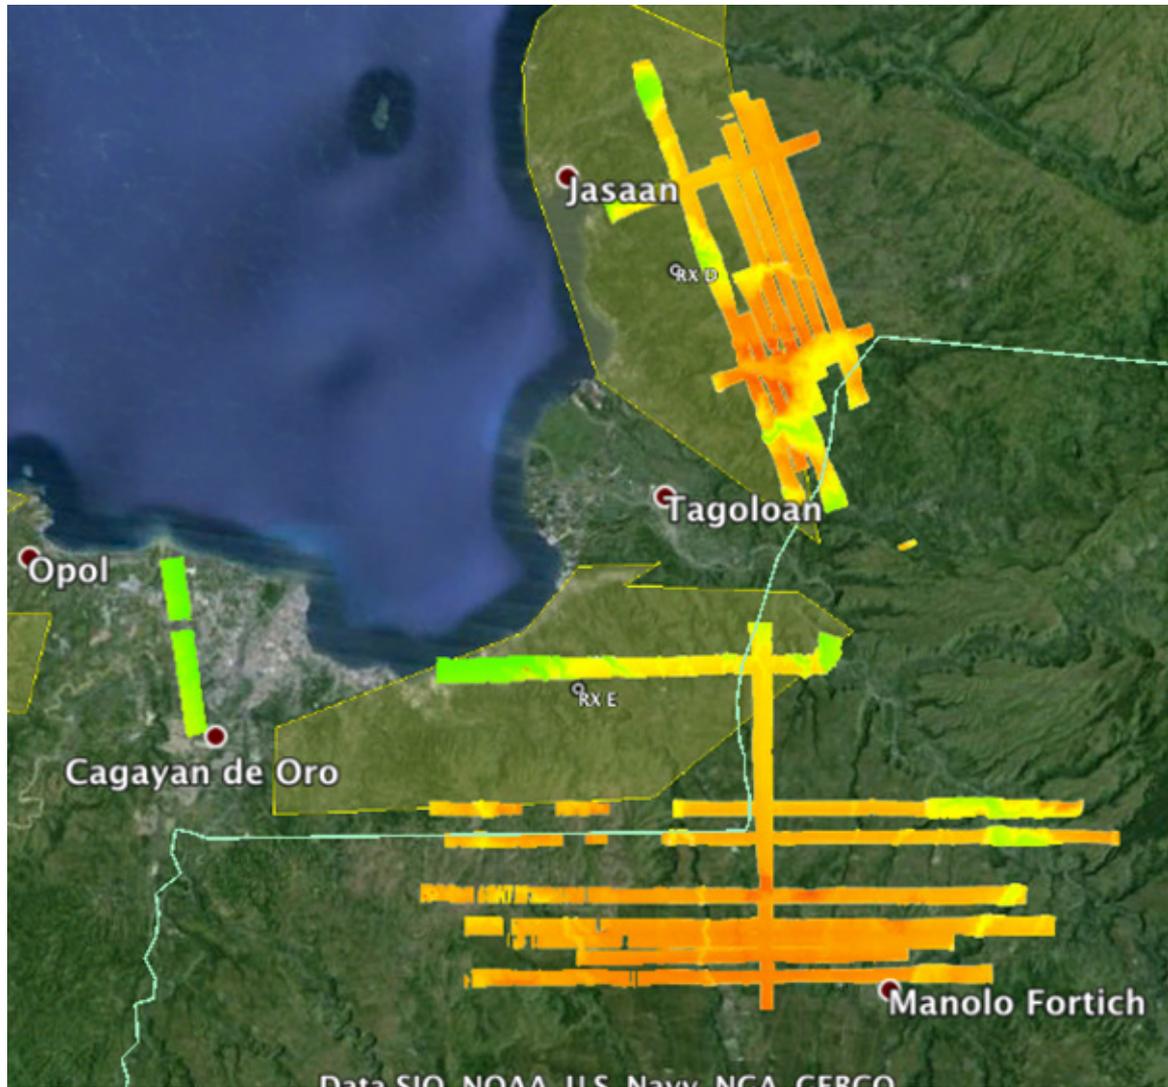
Flight No. : 1597P

Area: RX D, RX E

Scan Angle:25 deg; Overlap: 30%

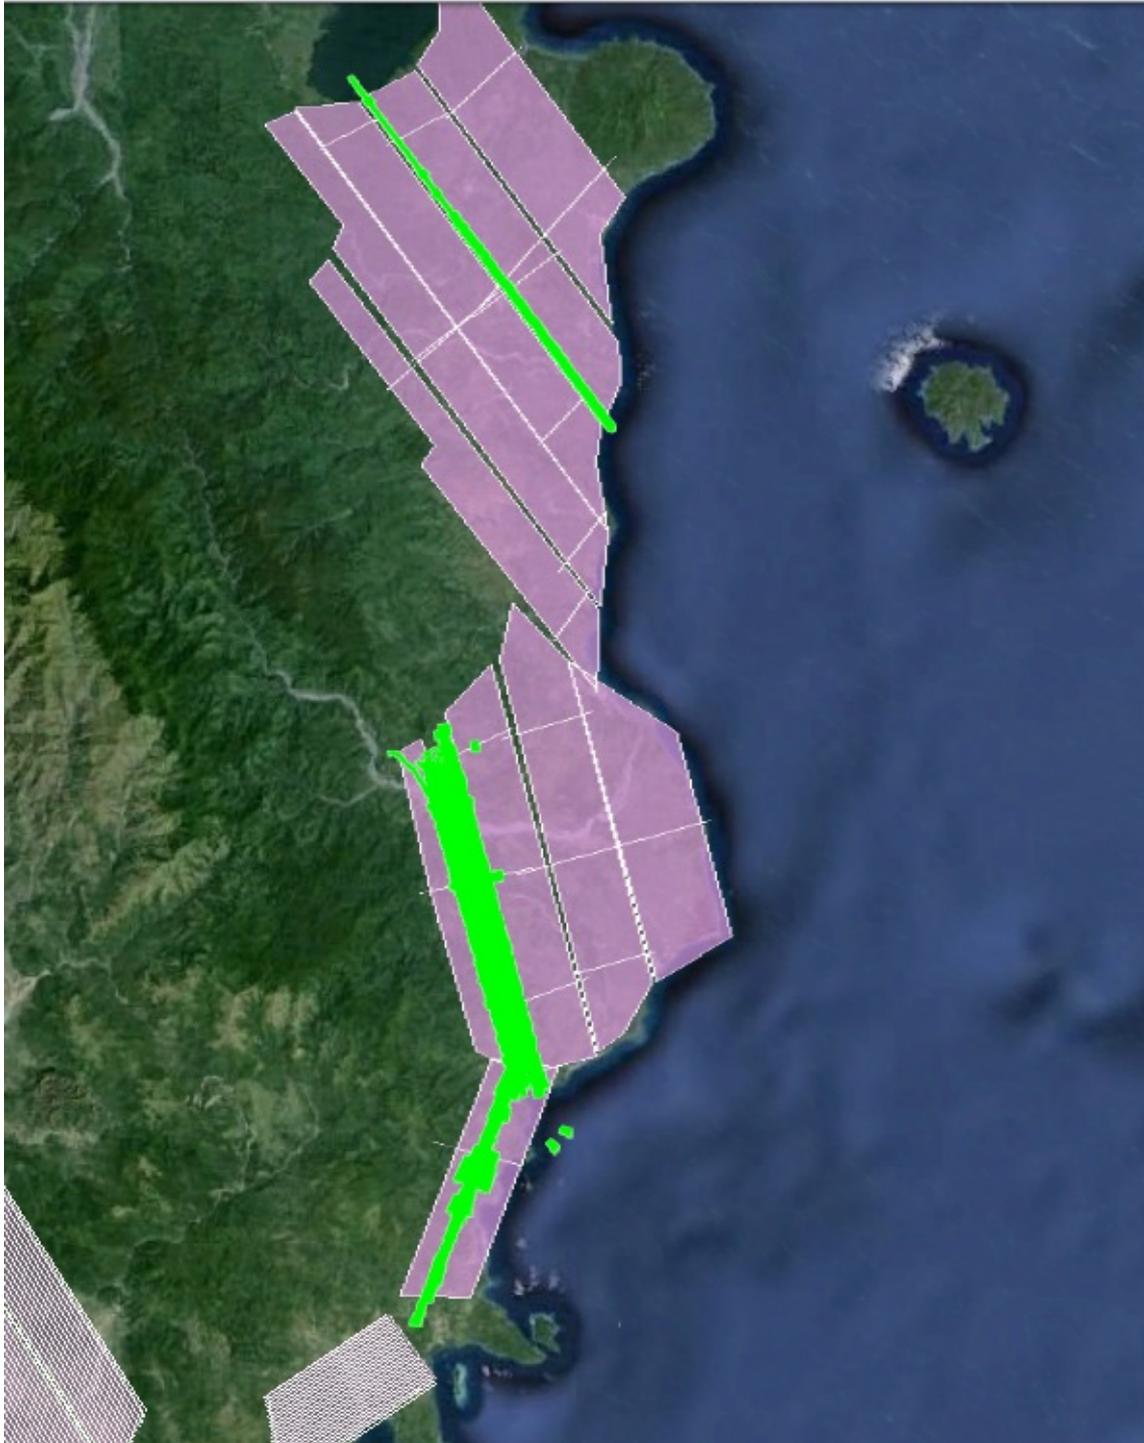
Flight No. : 1609P

Area: RX A, B, C

Scan Frequency: 30 kHz;

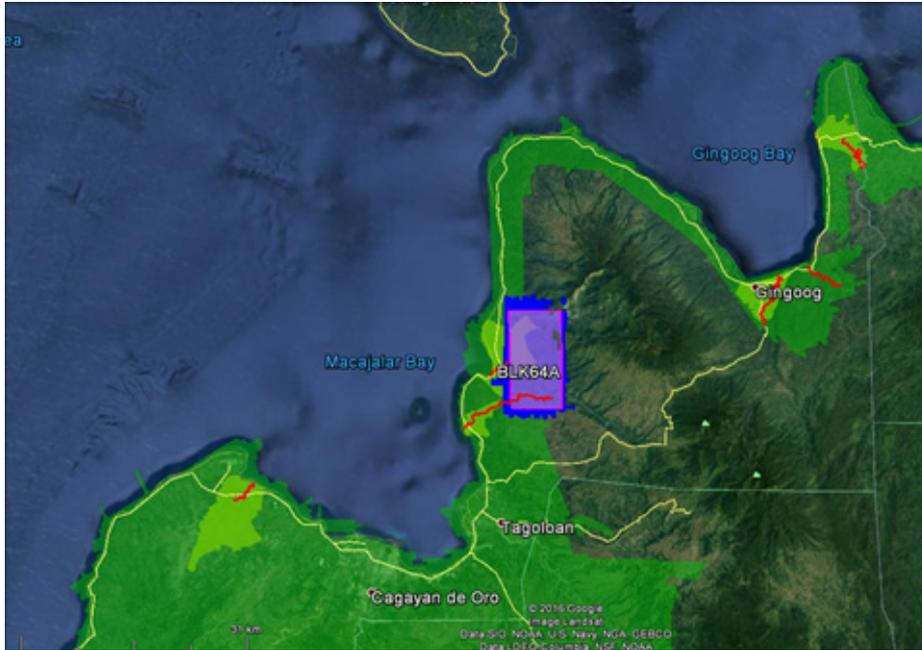
Flight No. : 23552P
Area: BLK 64A
Mission Name: 1BLK64A320A
Parameters: Altitude: 1200m; Scan Frequency: 30 kHz;
Scan Angle: 25 deg Overlap: 30%

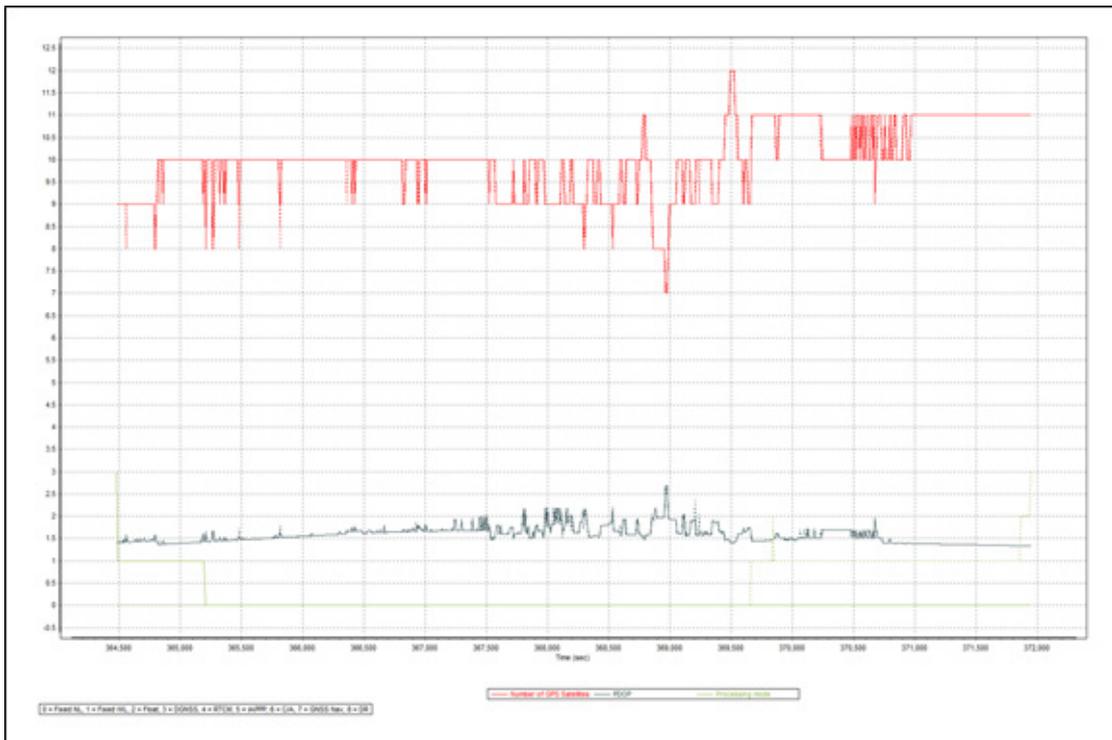
Flight Area	Northern Mindanao
Mission Name	Blk RX_C_supplement
Inclusive Flights	1609P
Range data size	22.1 GB
Base data size	7.07 MB
POS	259 MB
Image	45.3 GB
Transfer date	July 28, 2014
Solution Status	
Number of Satellites (>6)	Yes
PDOP (<3)	Yes
Baseline Length (<30km)	Yes
Processing Mode (<=1)	Yes
Smoothed Performance Metrics (in cm)	
RMSE for North Position (<4.0 cm)	1.2
RMSE for East Position (<4.0 cm)	2.1
RMSE for Down Position (<8.0 cm)	3.4
Boresight correction stdev (<0.001deg)	0.000218
IMU attitude correction stdev (<0.001deg)	0.000460
GPS position stdev (<0.01m)	0.0010
Minimum % overlap (>25)	30.50%
Ave point cloud density per sq.m. (>2.0)	4.28
Elevation difference between strips (<0.20 m)	Yes
Number of 1km x 1km blocks	148
Maximum Height	610.04 m
Minimum Height	65.41 m
Classification (# of points)	
Ground	74,863,357
Low vegetation	68,810,625
Medium vegetation	154,140,328
High vegetation	140,551,764
Building	2,051,193

Figure 1.1.1 Solution Status

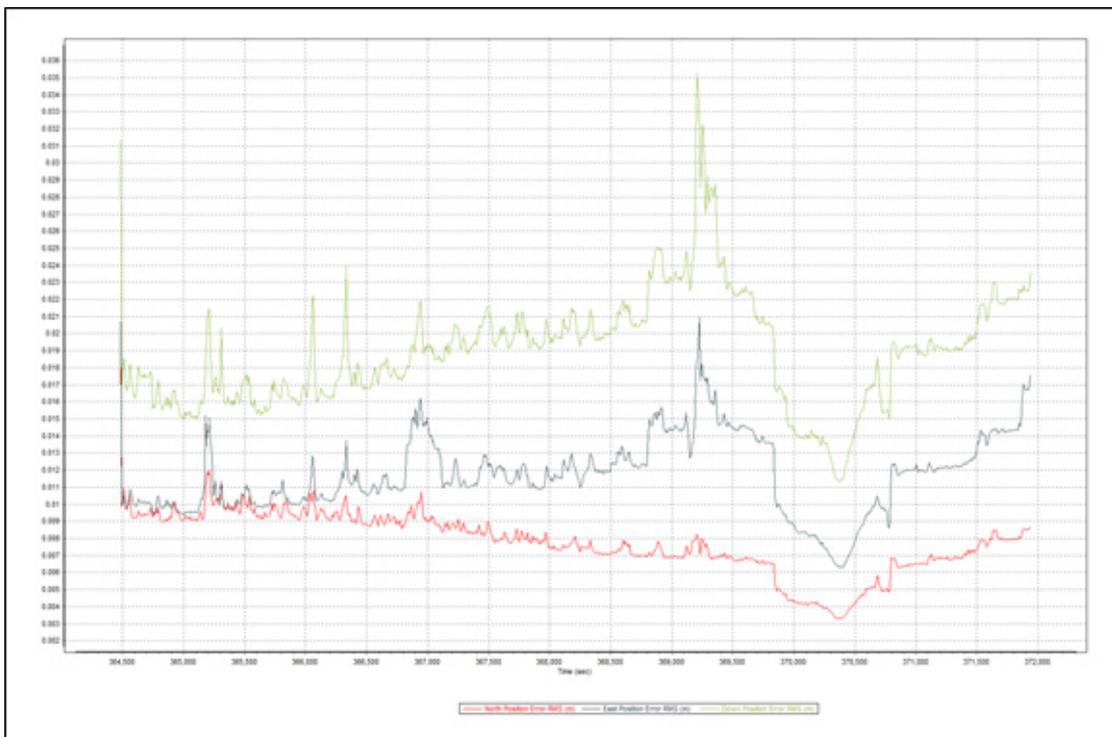
Figure 1.1.2 Smoothed Performance Metric Parameters

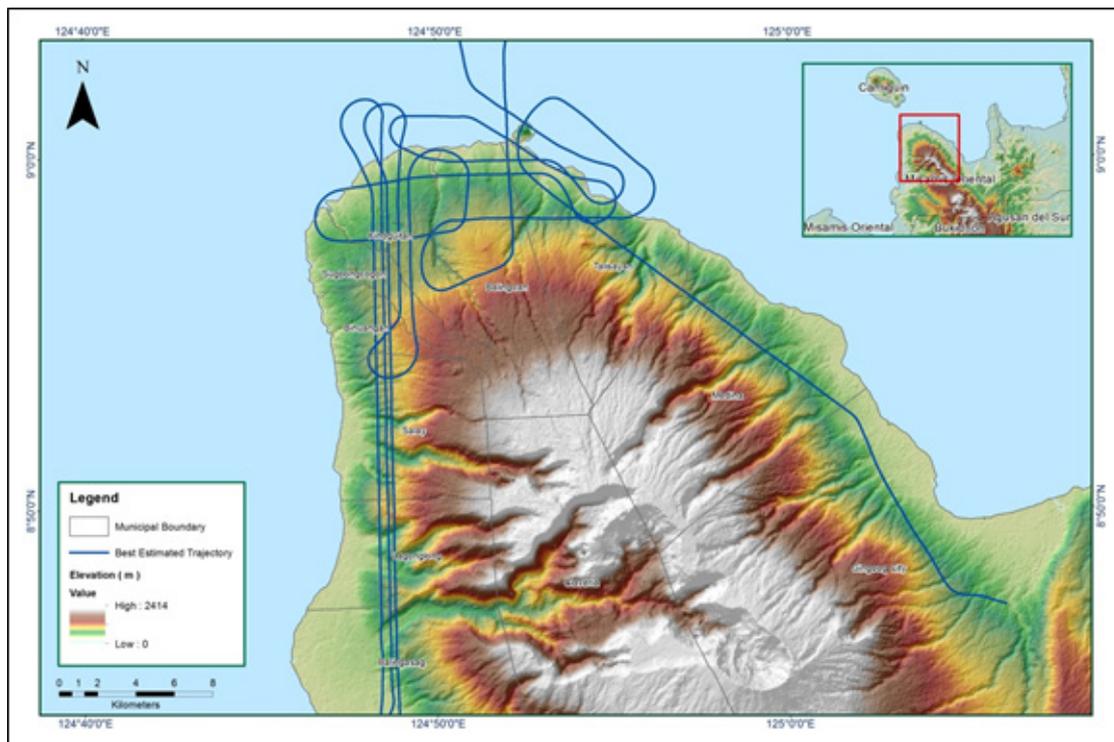
Figure 1.1.3 Best Estimated Trajectory

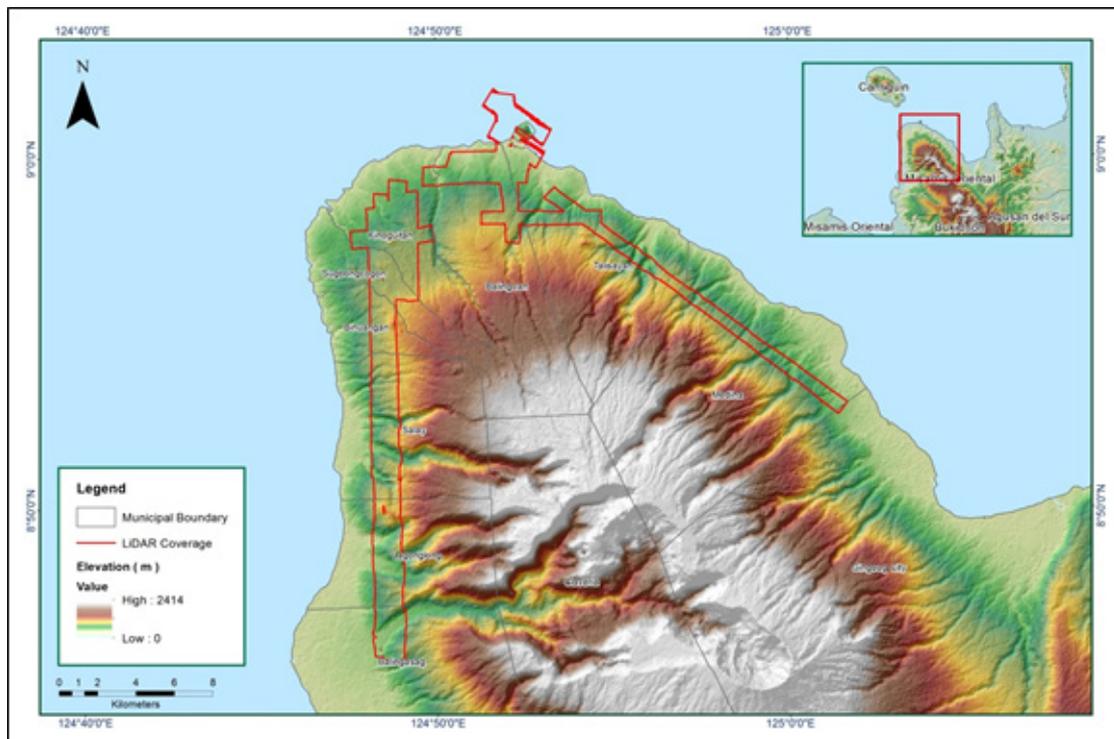
Figure 1.1.4 Coverage of LiDAR data

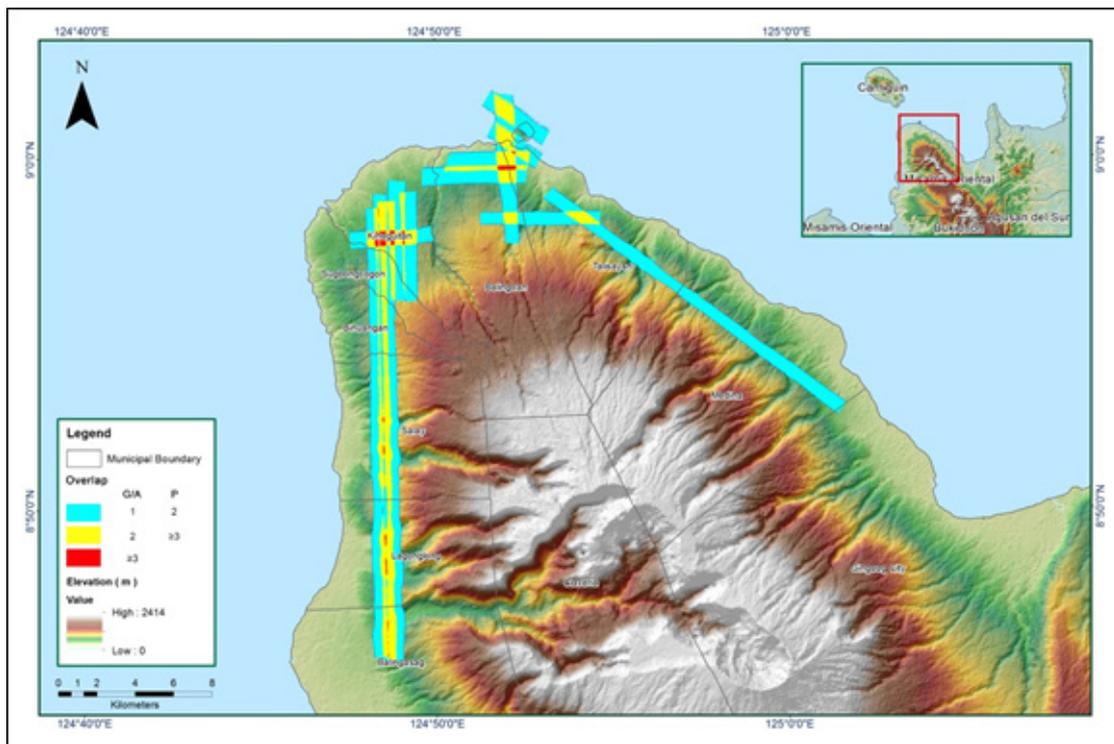
Figure 1.1.5 Image of data overlap

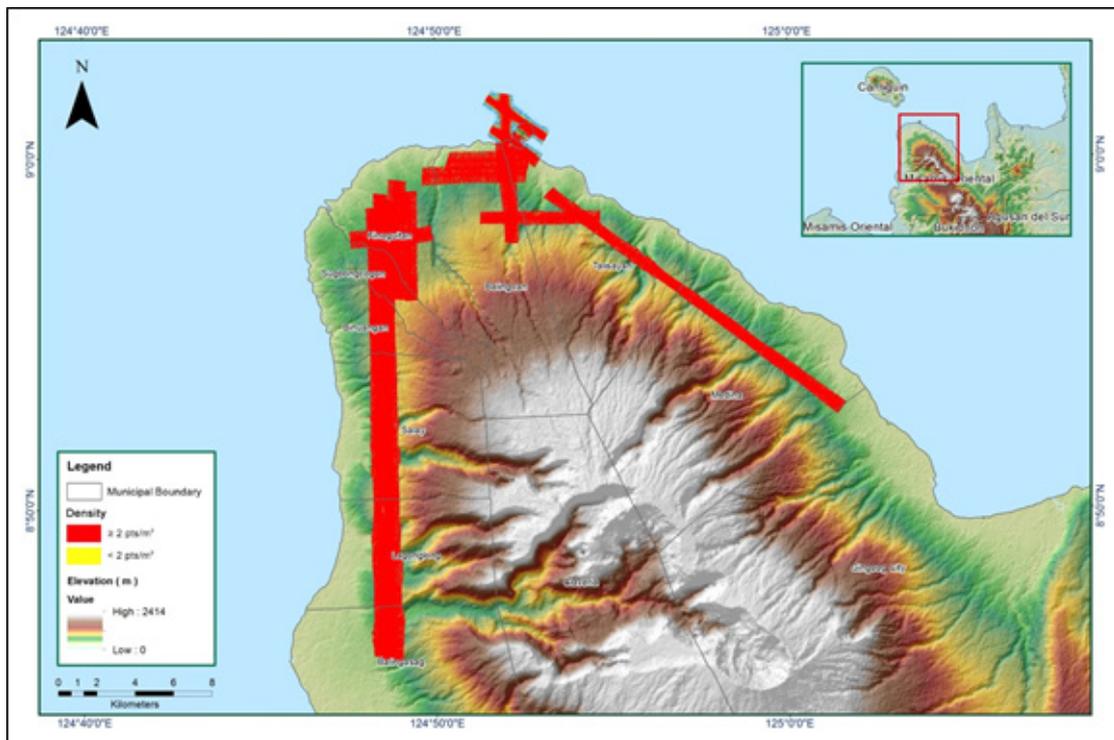
Figure 1.1.6 Density map of merged LiDAR data

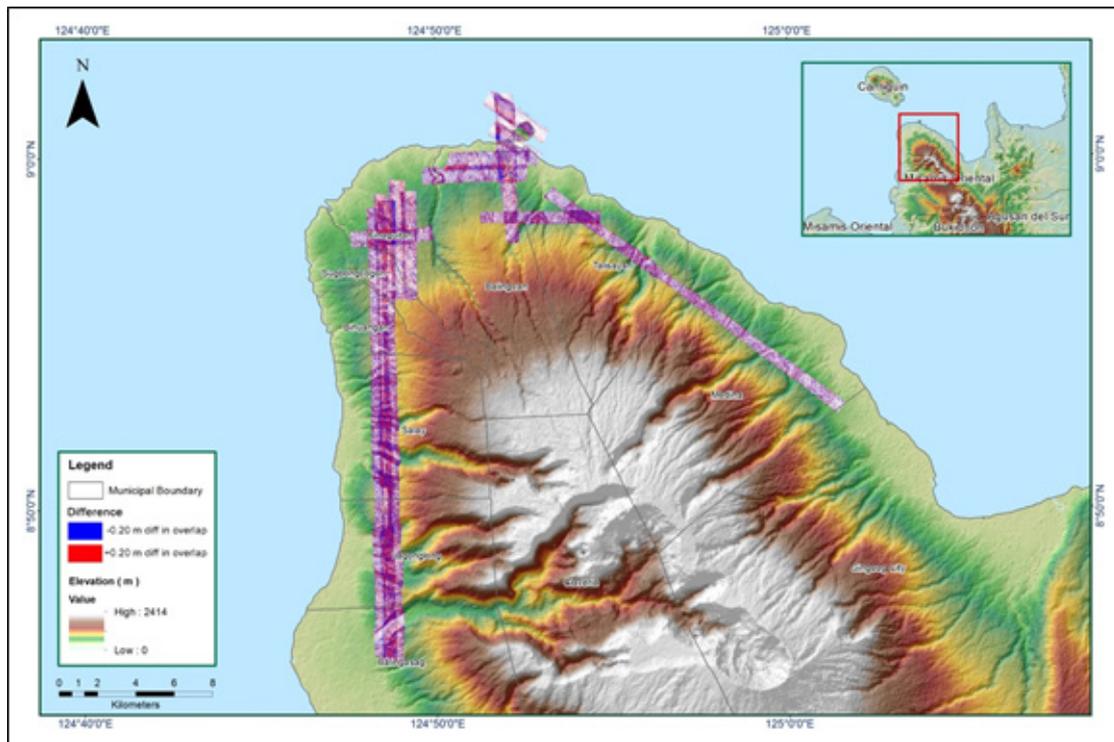
Figure 1.1.7 Elevation difference between flight lines

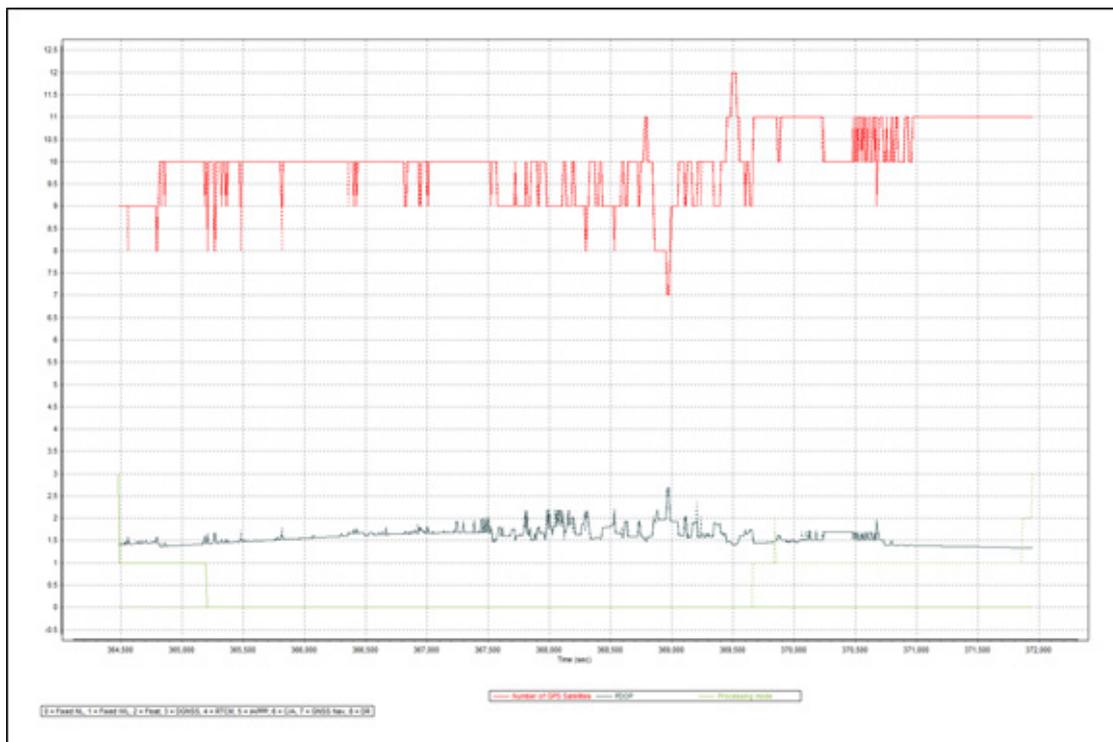
Flight Area	Northern Mindanao
Mission Name	Blk RX_supplement
Inclusive Flights	1609P
Range data size	22.1 GB
Base data size	7.07 MB
POS	259 MB
Image	45.3 GB
Transfer date	July 28, 2014
Solution Status	
Number of Satellites (>6)	Yes
PDOP (<3)	Yes
Baseline Length (<30km)	No
Processing Mode (<=1)	Yes
Smoothed Performance Metrics (in cm)	
RMSE for North Position (<4.0 cm)	1.2
RMSE for East Position (<4.0 cm)	2.1
RMSE for Down Position (<8.0 cm)	3.5
Boresight correction stdev (<0.001deg)	0.000218
IMU attitude correction stdev (<0.001deg)	0.000460
GPS position stdev (<0.01m)	0.0010
Minimum % overlap (>25)	33.39%
Ave point cloud density per sq.m. (>2.0)	5.40
Elevation difference between strips (<0.20 m)	Yes
Number of 1km x 1km blocks	132
Maximum Height	678.91 m
Minimum Height	68.96 m
Classification (# of points)	
Ground	50,885,013
Low vegetation	47,864,075
Medium vegetation	170,807,118
High vegetation	161,481,667
Building	1,560,519

Figure 1.2.1 Solution Status

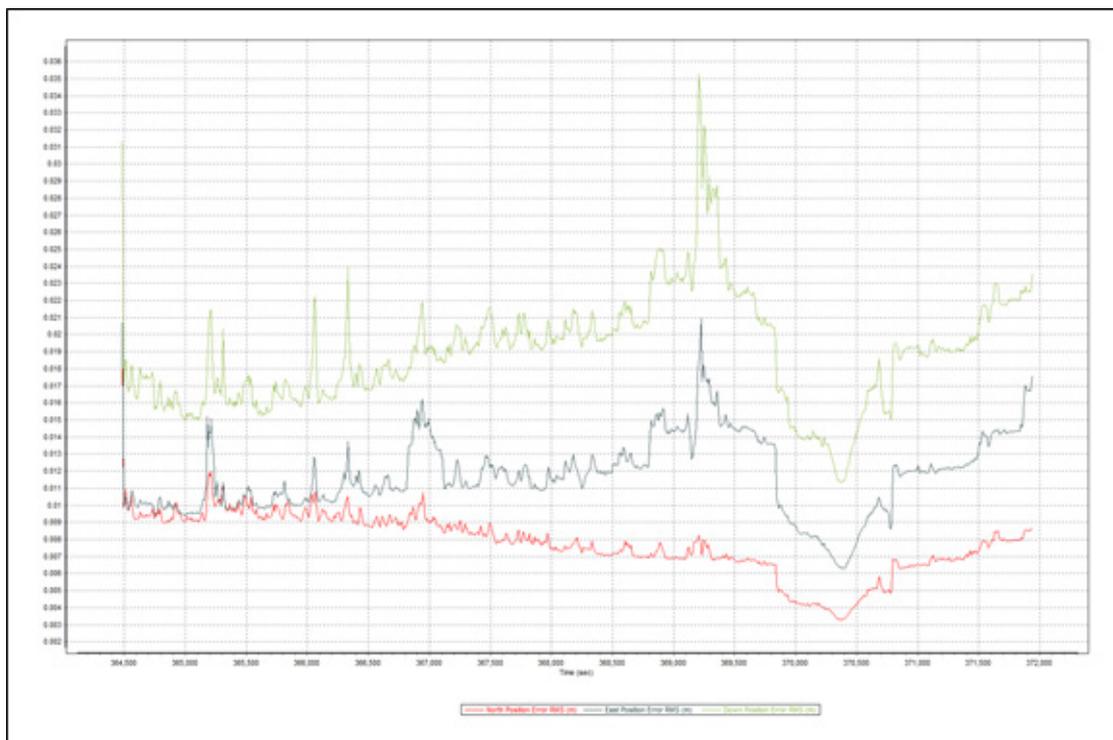
Figure 1.2.2 Smoothed Performance Metric Parameters

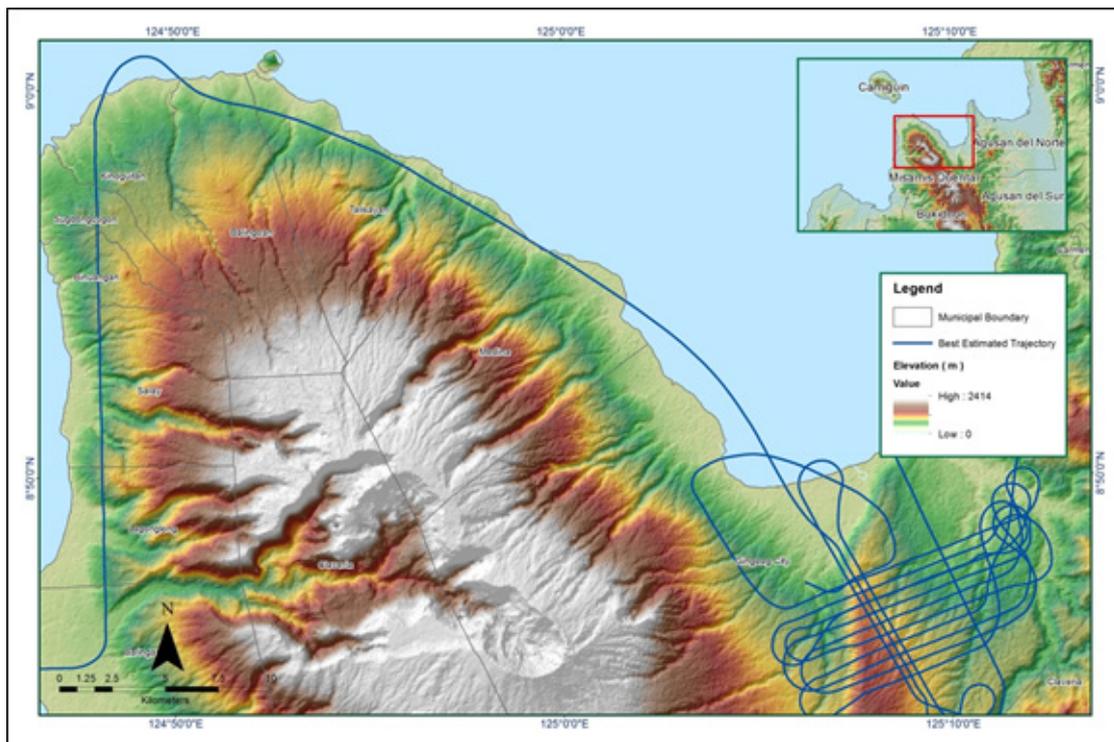
Figure 1.2.3 Best Estimated Trajectory

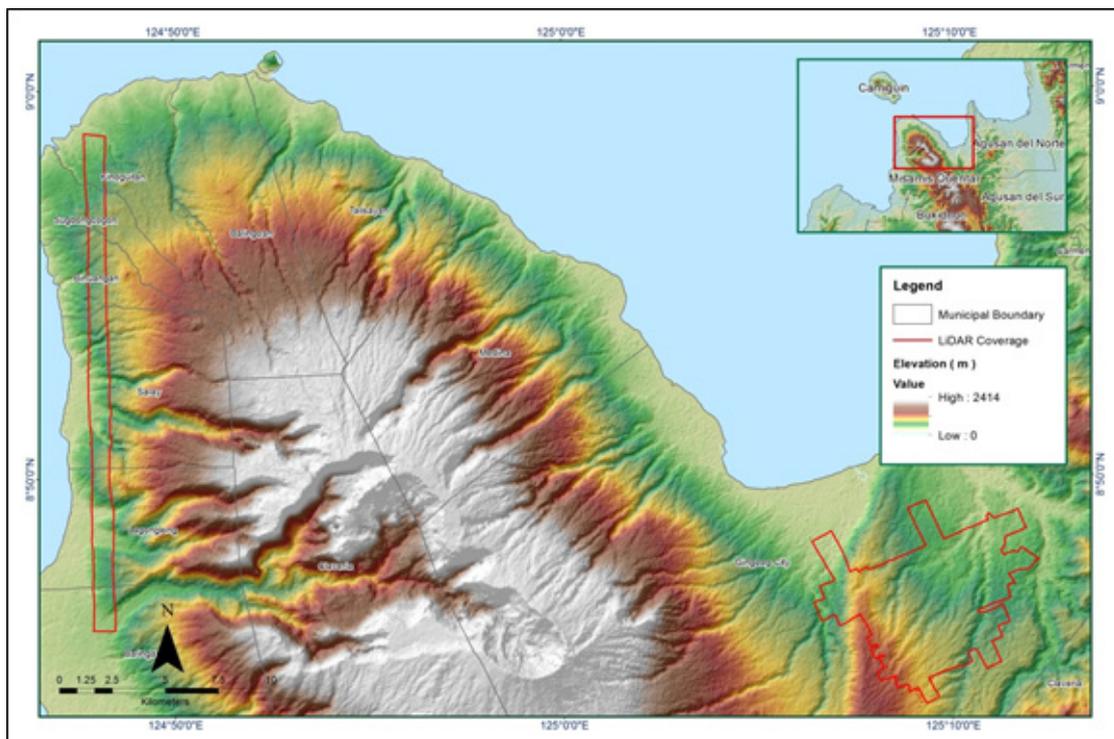
Figure 1.2.4 Coverage of LiDAR data

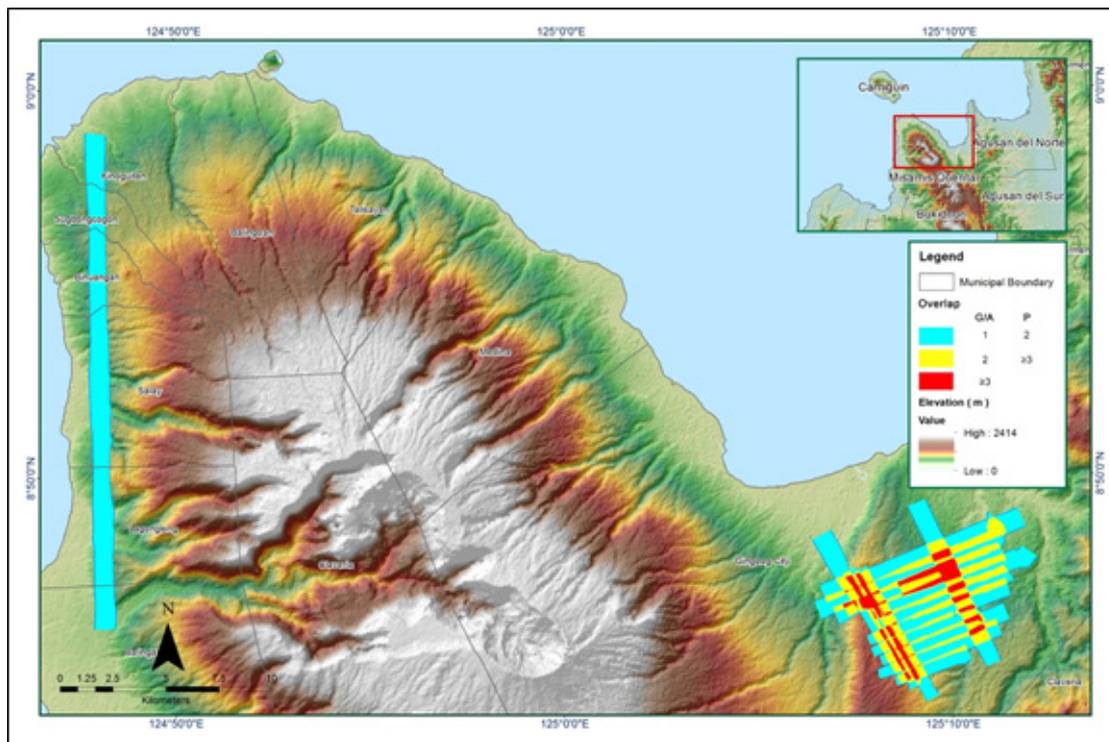
Figure 1.2.5 Image of data overlap

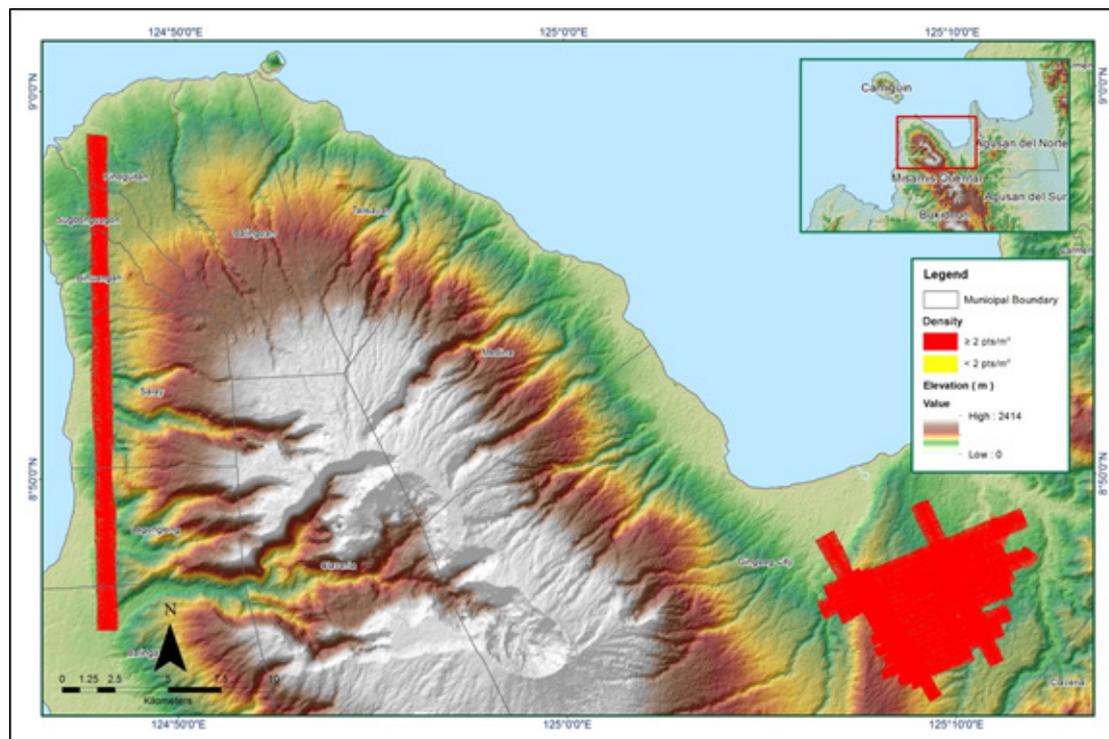
Figure 1.2.6 Density map of merged LiDAR data

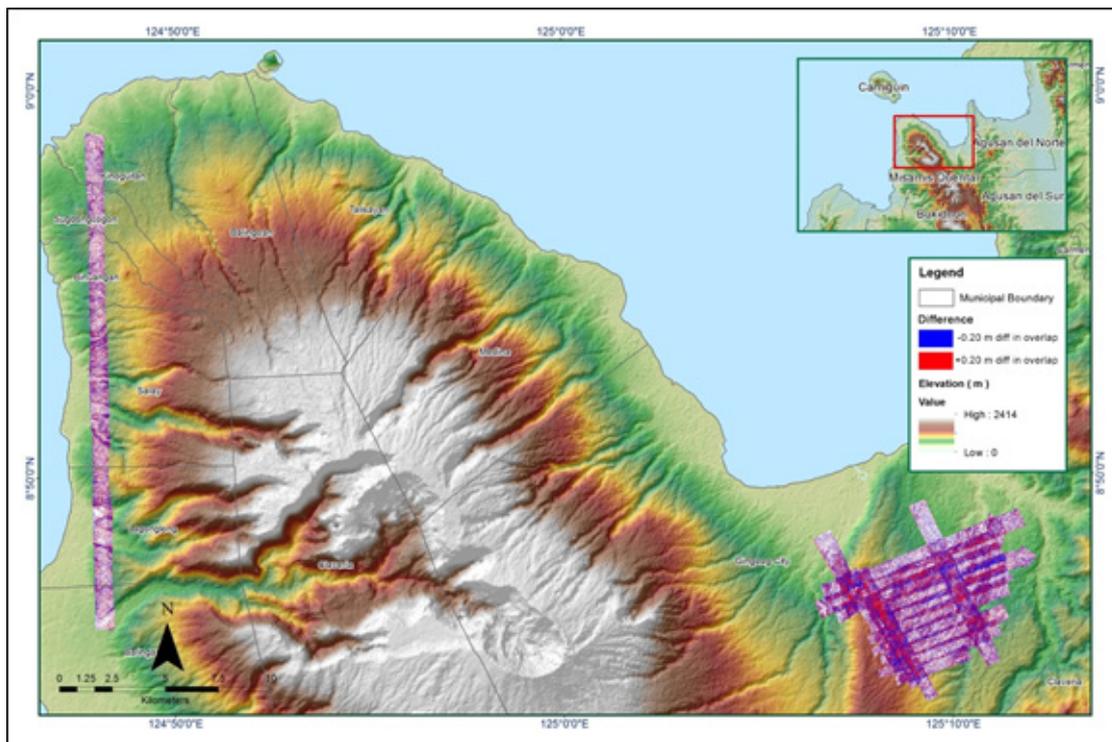
Figure 1.2.7 Elevation difference between flight lines

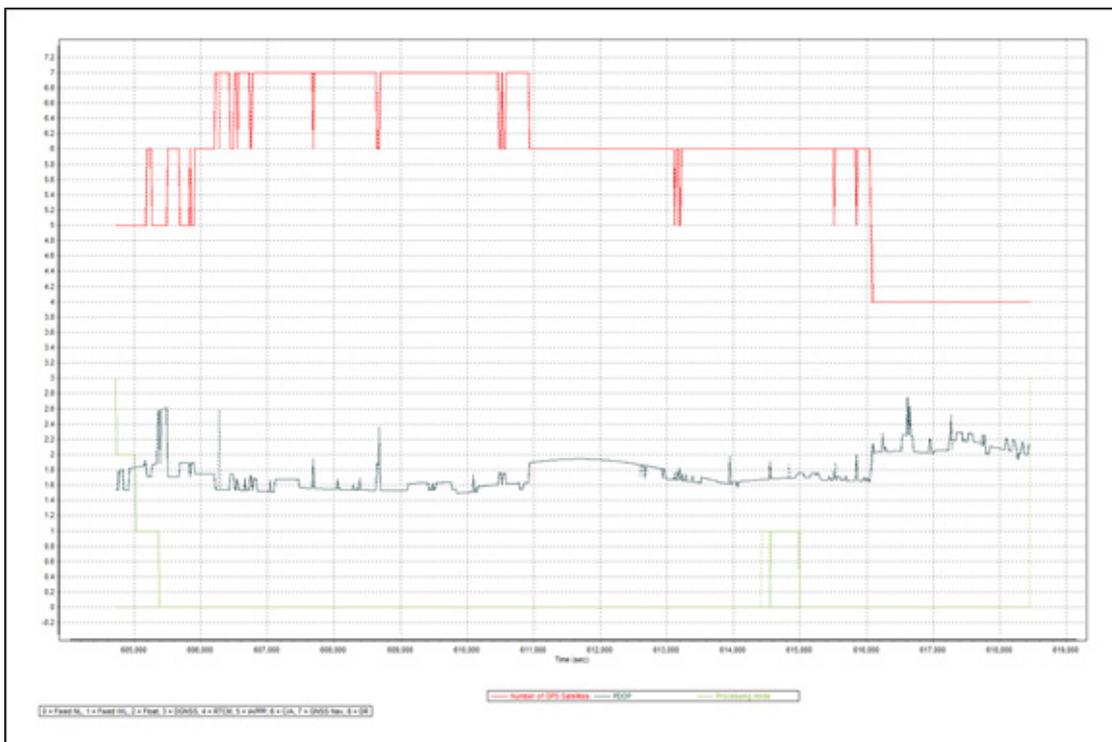
Flight Area	Northern Mindanao
Mission Name	RX_C
Inclusive Flights	1509P
Range data size	26.2 GB
Base data size	4.96 MB
POS	254 MB
Image	53.6 GB
Transfer date	June 10, 2014
Solution Status	
Number of Satellites (>6)	Yes
PDOP (<3)	Yes
Baseline Length (<30km)	Yes
Processing Mode (<=1)	Yes
Smoothed Performance Metrics (in cm)	
RMSE for North Position (<4.0 cm)	1.4
RMSE for East Position (<4.0 cm)	1.8
RMSE for Down Position (<8.0 cm)	3.0
Boresight correction stdev (<0.001deg)	0.000264
IMU attitude correction stdev (<0.001deg)	0.004243
GPS position stdev (<0.01m)	0.0069
Minimum % overlap (>25)	38.61%
Ave point cloud density per sq.m. (>2.0)	4.28
Elevation difference between strips (<0.20 m)	Yes
Number of 1km x 1km blocks	185
Maximum Height	531.69 m
Minimum Height	65.50 m
Classification (# of points)	
Ground	122,191,837
Low vegetation	148,368,596
Medium vegetation	208,375,236
High vegetation	193,794,857
Building	10,741,701
Orthophoto	No

Figure 1.3.1 Solution Status

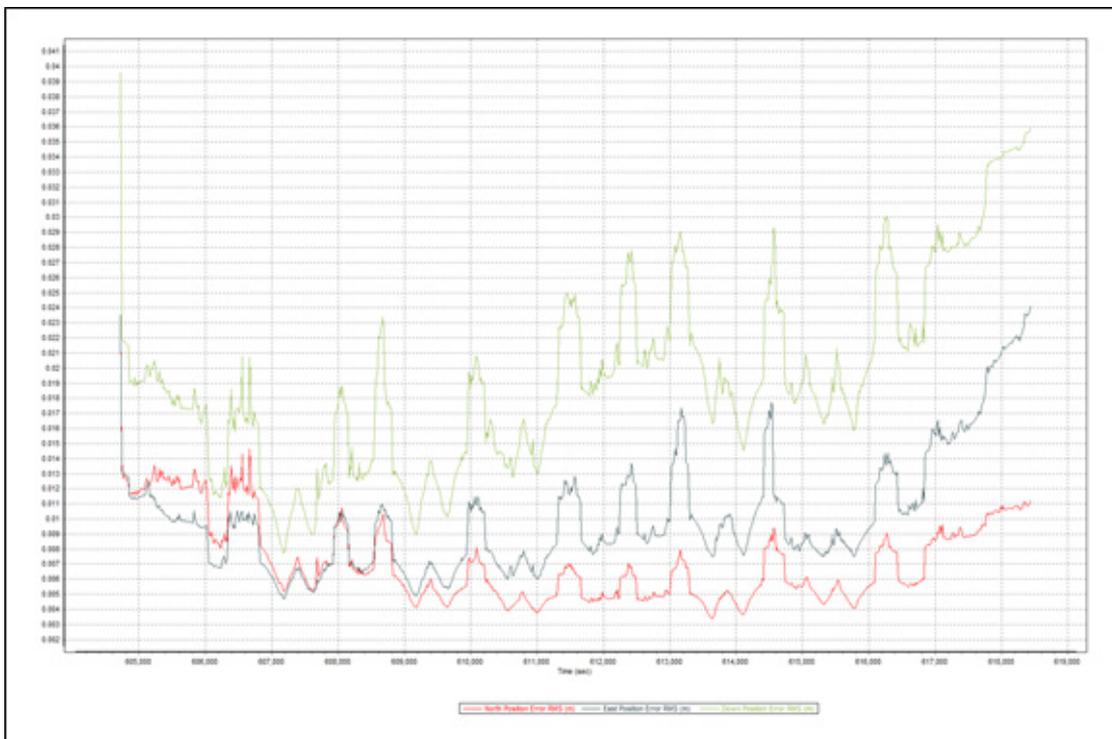
Figure 1.3.2 Smoothed Performance Metric Parameters

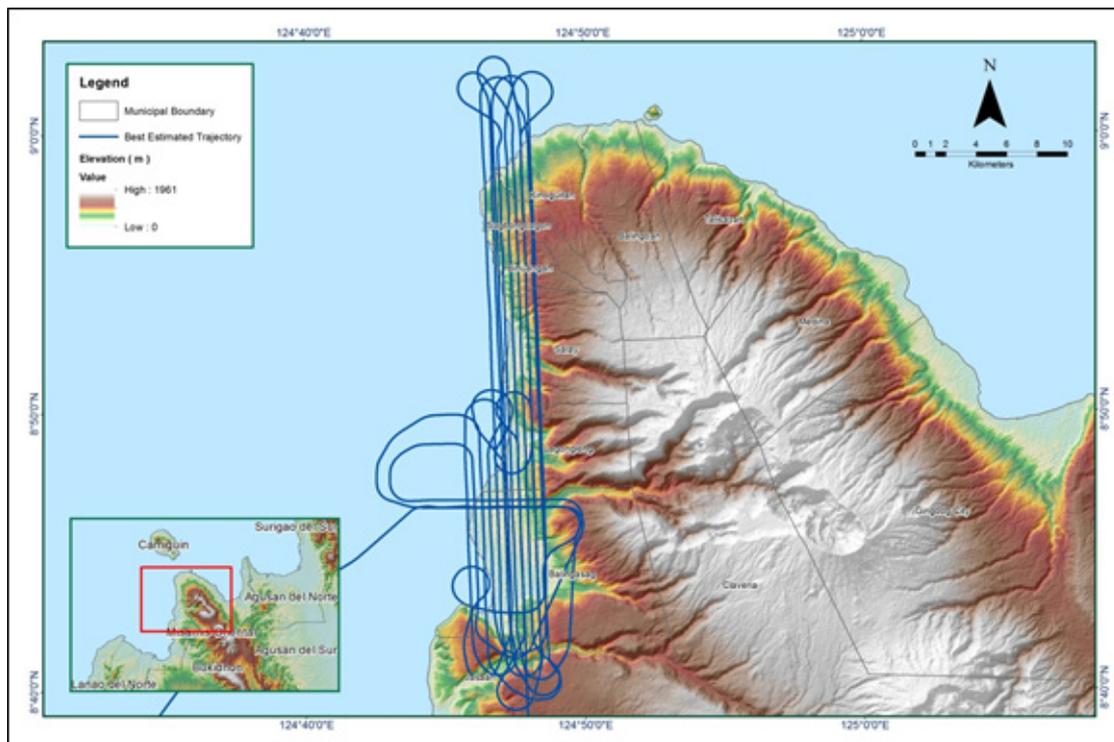
Figure 1.3.3 Best Estimated Trajectory

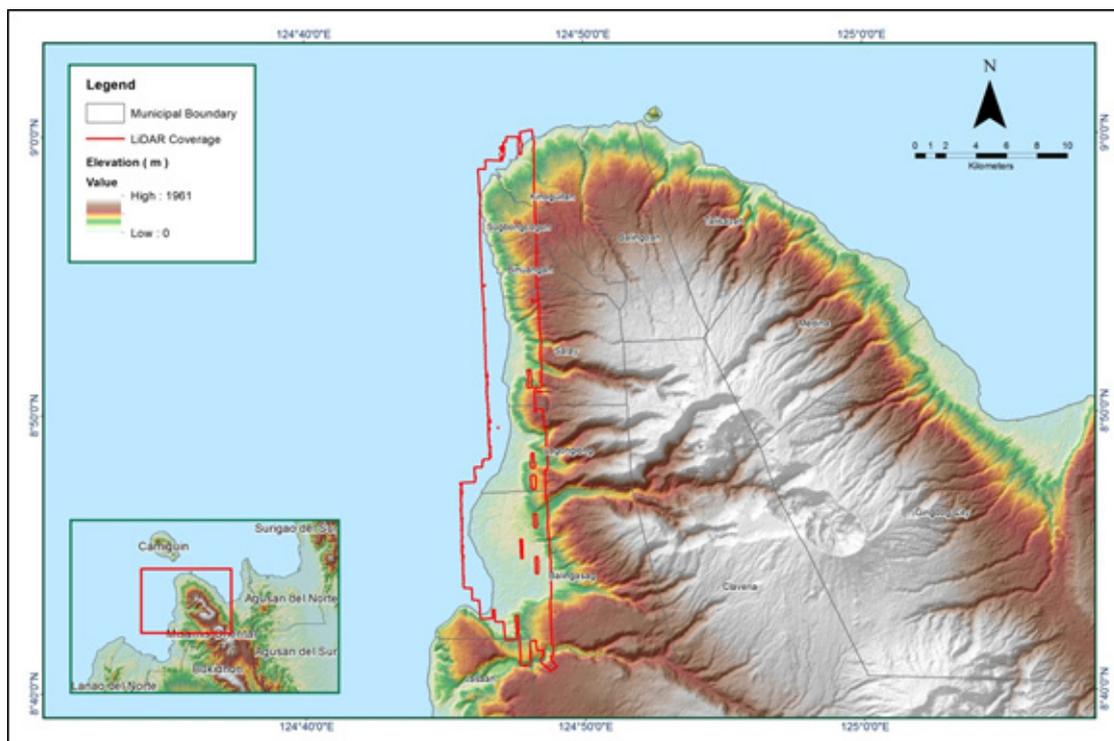
Figure 1.3.4 Coverage of LiDAR data

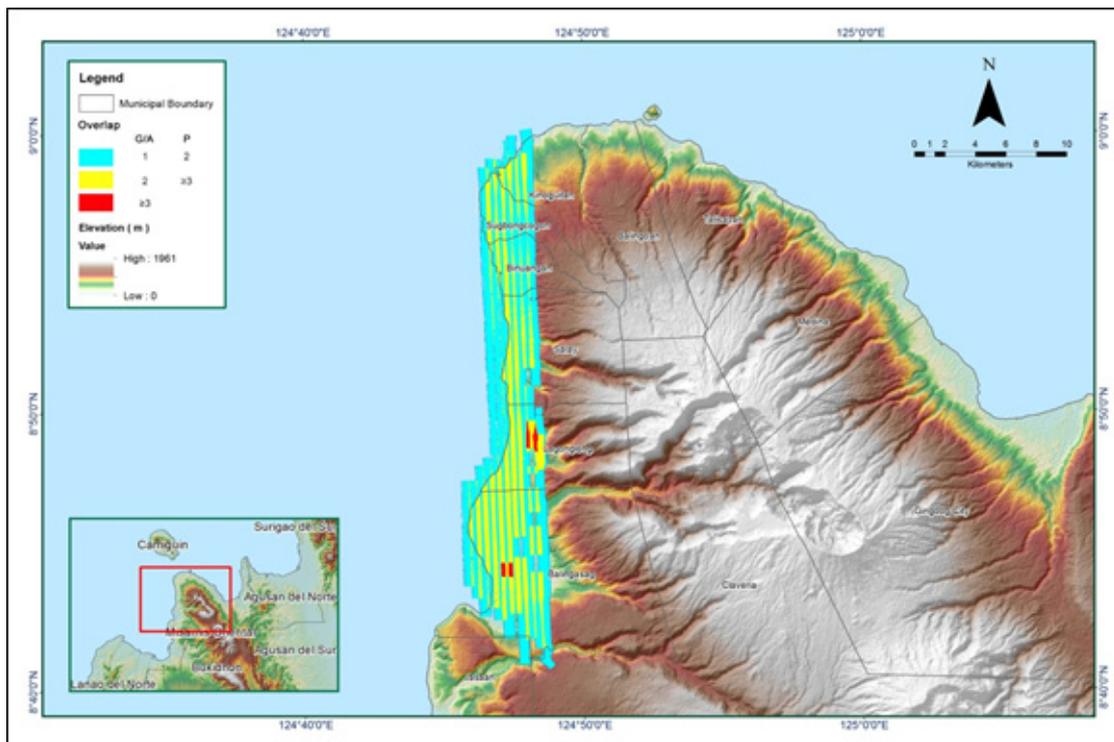
Figure 1.3.5 Image of data overlap

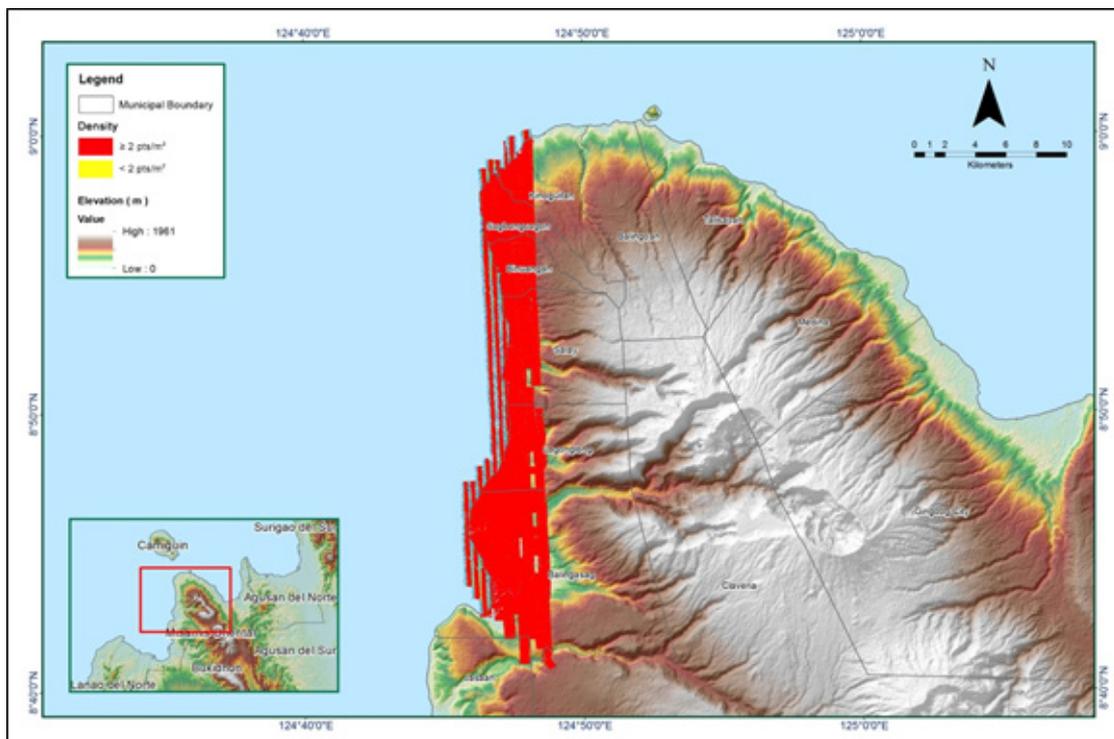
Figure 1.3.6 Density map of merged LiDAR data
