Hazard Mapping of the Philippines Using LIDAR (Phil-LIDAR 1)

LiDAR Surveys and Flood Mapping of Musi-Musi River

University of the Philippines Training Center
for Applied Geodesy and Photogrammetry
Central Mindanao University (CMU)

APRIL 2017

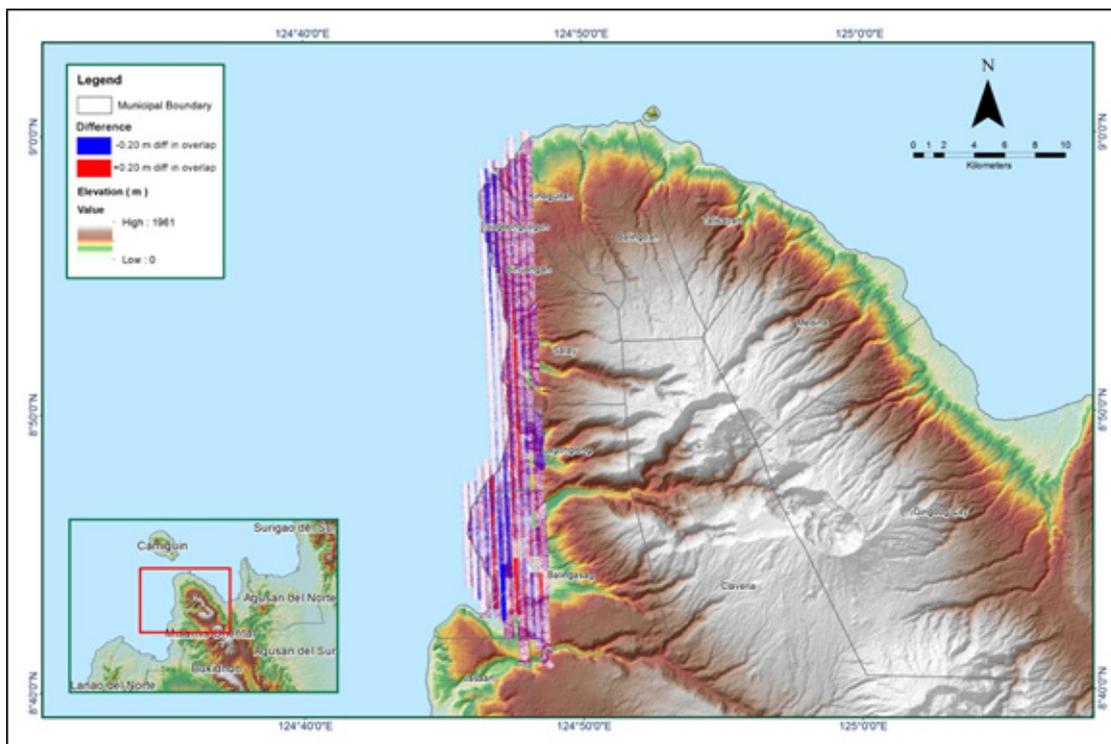
Figure 1.3.7 Elevation difference between flight lines

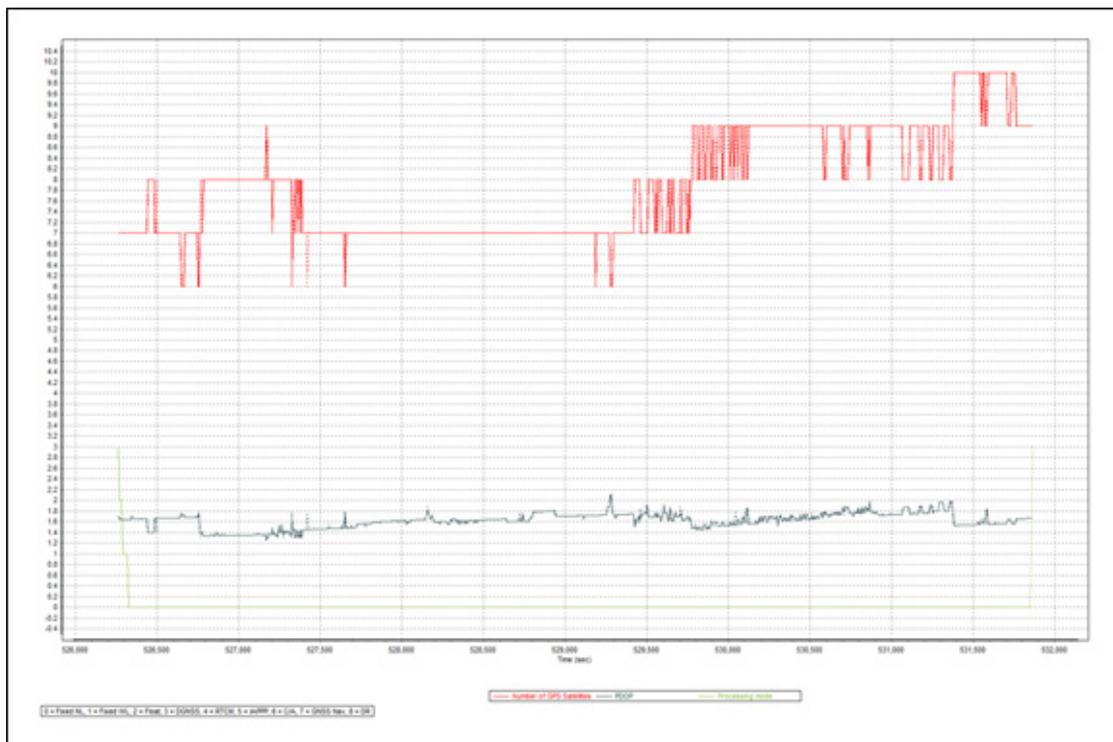
Flight Area	Northern Mindanao
Mission Name	RX_D
Inclusive Flights	1561P
Range data size	22 GB
Base data size	8.1 MB
POS	187 MB
Image	n/a
Transfer date	June 23, 2014
Solution Status	
Number of Satellites (>6)	Yes
PDOP (<3)	Yes
Baseline Length (<30km)	No
Processing Mode (<=1)	Yes
Smoothed Performance Metrics (in cm)	
RMSE for North Position (<4.0 cm)	1.3
RMSE for East Position (<4.0 cm)	1.05
RMSE for Down Position (<8.0 cm)	3.2
Boresight correction stdev (<0.001deg)	0.000179
IMU attitude correction stdev (<0.001deg)	0.001266
GPS position stdev (<0.01m)	0.0058
Minimum % overlap (>25)	33.38%
Ave point cloud density per sq.m. (>2.0)	3.85
Elevation difference between strips (<0.20 m)	Yes
Number of 1km x 1km blocks	297
Maximum Height	747.65 m
Minimum Height	66.39
Classification (# of points)	
Ground	242,066,972
Low vegetation	216,117,519
Medium vegetation	359,141,389
High vegetation	333,494,074
Building	15,951,611
Orthophoto	
Processed by	Engr. Jommer Medina, Engr. Kenneth Solidum, Engr. Christy Lubiano, Engr. Gladys Apat

Figure 1.4.1 Solution Status

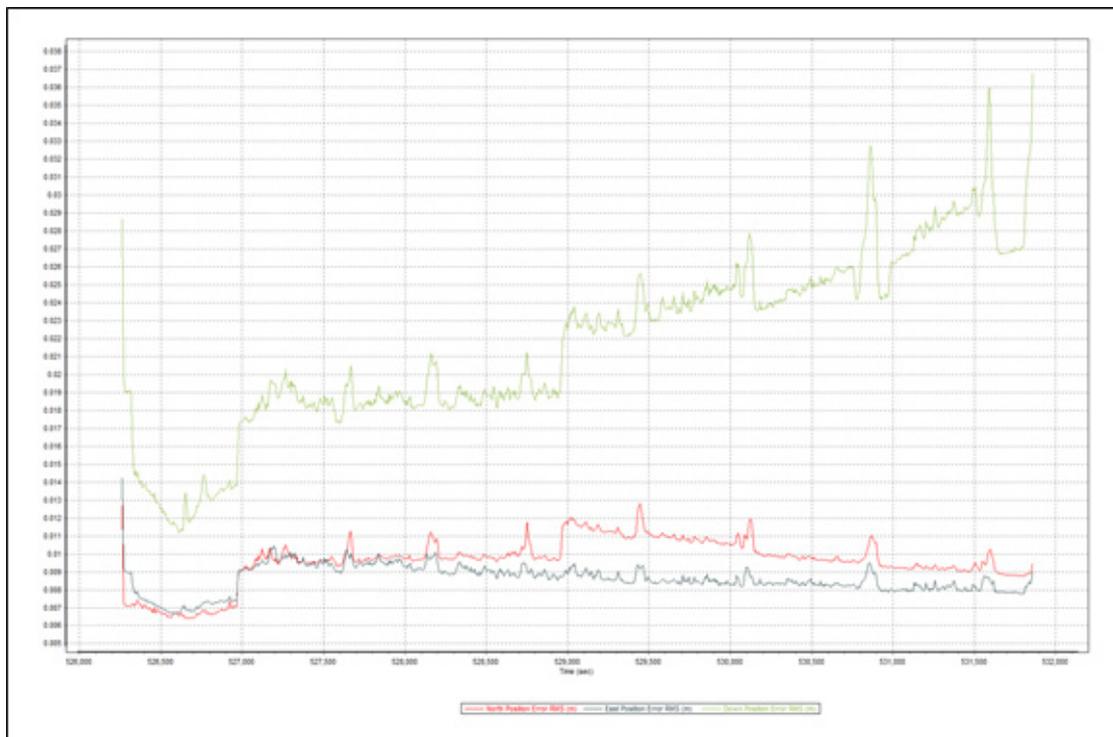
Figure 1.4.2 Smoothed Performance Metric Parameters

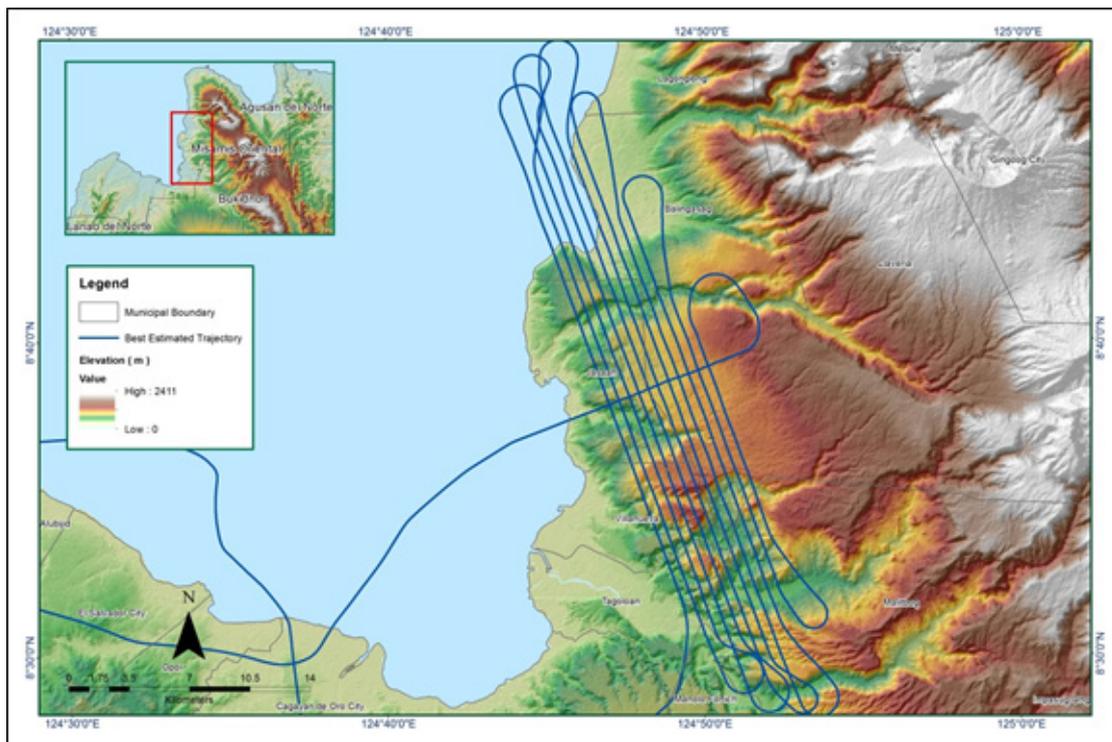
Figure 1.4.3 Best Estimated Trajectory

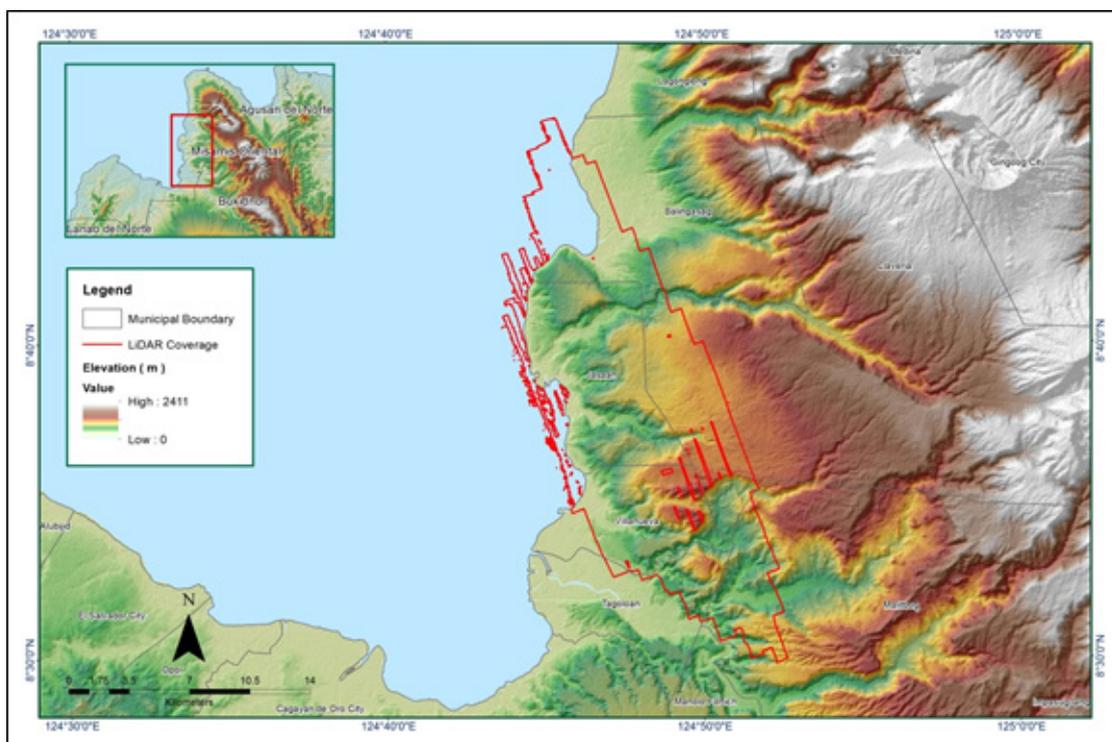
Figure 1.4.4 Coverage of LiDAR data

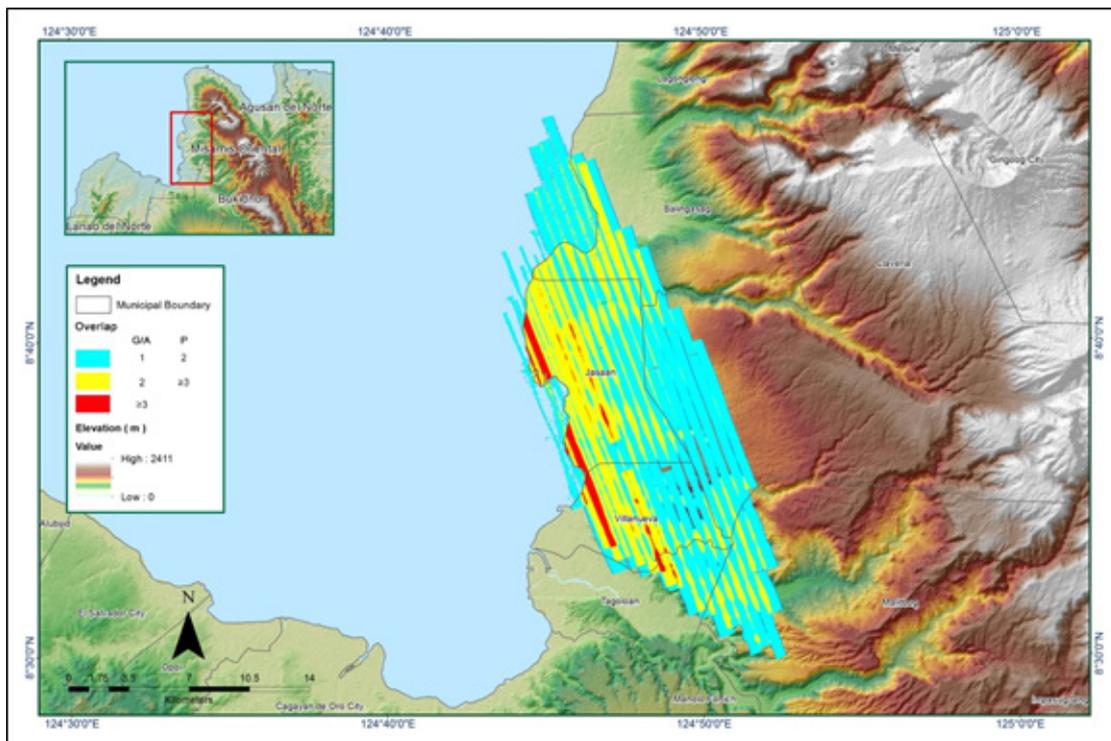
Figure 1.4.5 Image of data overlap

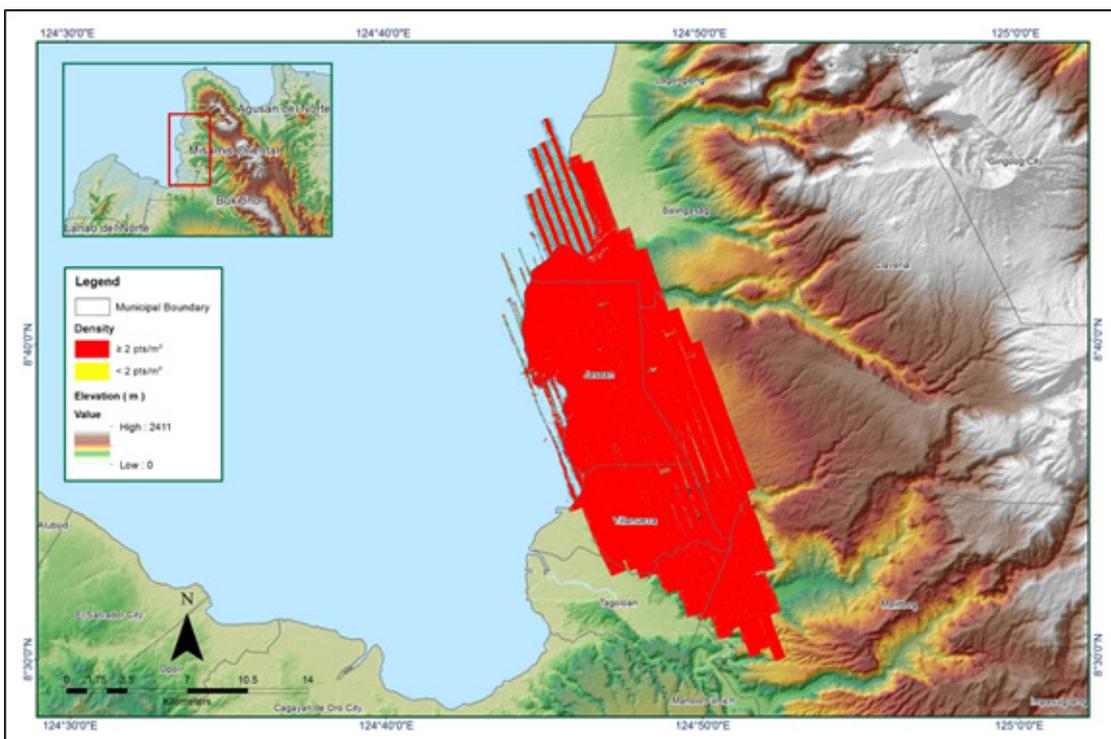
Figure 1.4.6 Density map of merged LiDAR data

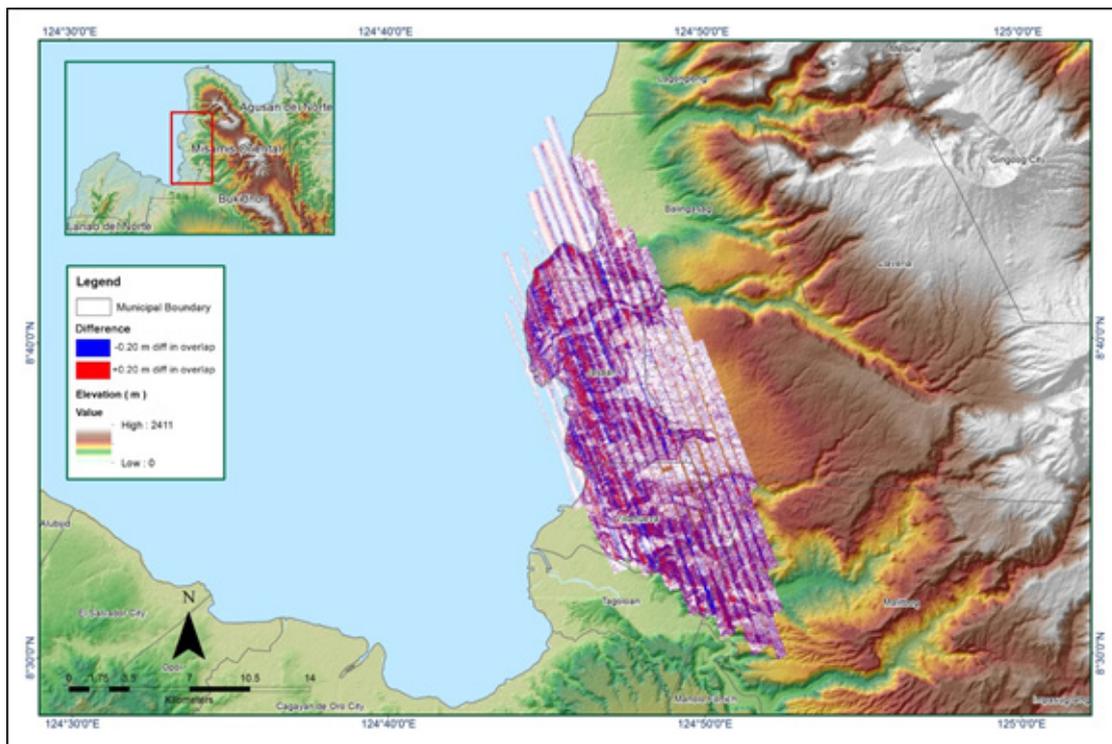
Figure 1.4.7 Elevation difference between flight lines

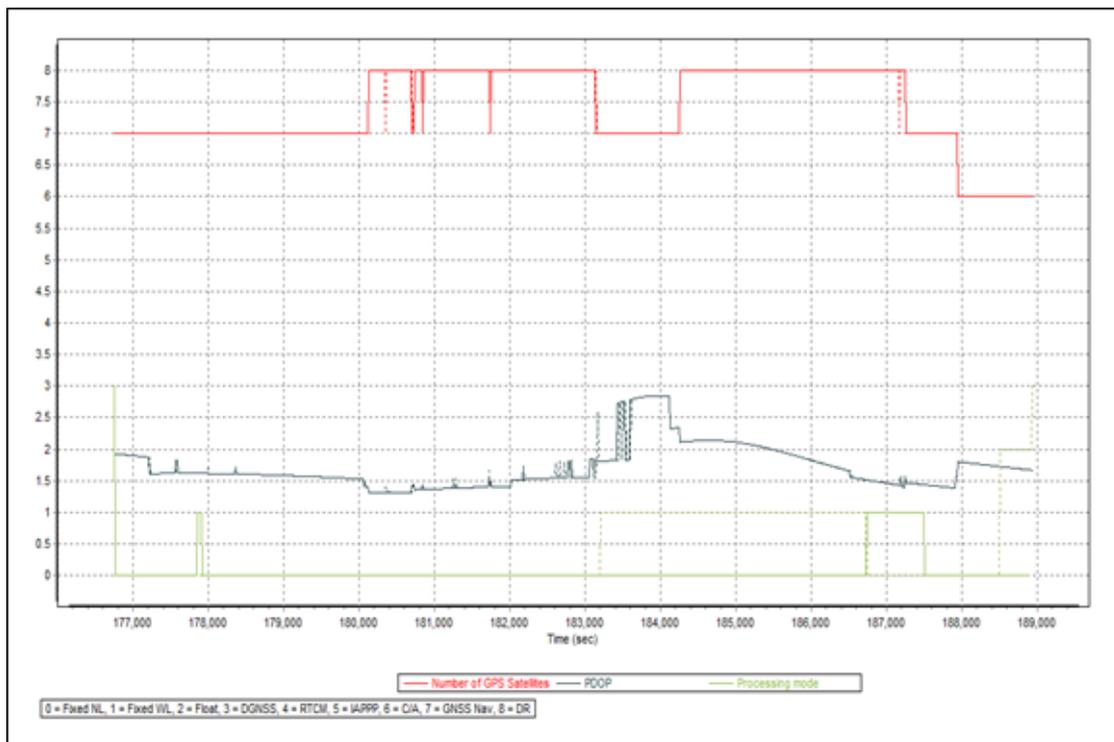
Flight Area	Bukidnon
Mission Name	Block 64F
Inclusive Flights	23552P
Range data size	20.6 GB
Base data size	131 MB
POS	261 MB
Image	N/A
Transfer date	November 24, 2016
Solution Status	
Number of Satellites (>6)	Yes
PDOP (<3)	Yes
Baseline Length (<30km)	No
Processing Mode (<=1)	Yes
Smoothed Performance Metrics (in cm)	
RMSE for North Position (<4.0 cm)	1.492
RMSE for East Position (<4.0 cm)	1.474
RMSE for Down Position (<8.0 cm)	3.170
Boresight correction stdev (<0.001deg)	0.000182
IMU attitude correction stdev (<0.001deg)	0.010301
GPS position stdev (<0.01m)	0.0027
Minimum % overlap (>25)	54.18
Ave point cloud density per sq.m. (>2.0)	5.01
Elevation difference between strips (<0.20 m)	Yes
Number of 1km x 1km blocks	156
Maximum Height	1396.06 m
Minimum Height	68.22 m
Classification (# of points)	
Ground	124,368,997
Low vegetation	128,062,833
Medium vegetation	343,670,586
High vegetation	634,413,336
Building	35,123,927
Orthophoto	No

Figure 1.5.1 Solution Status

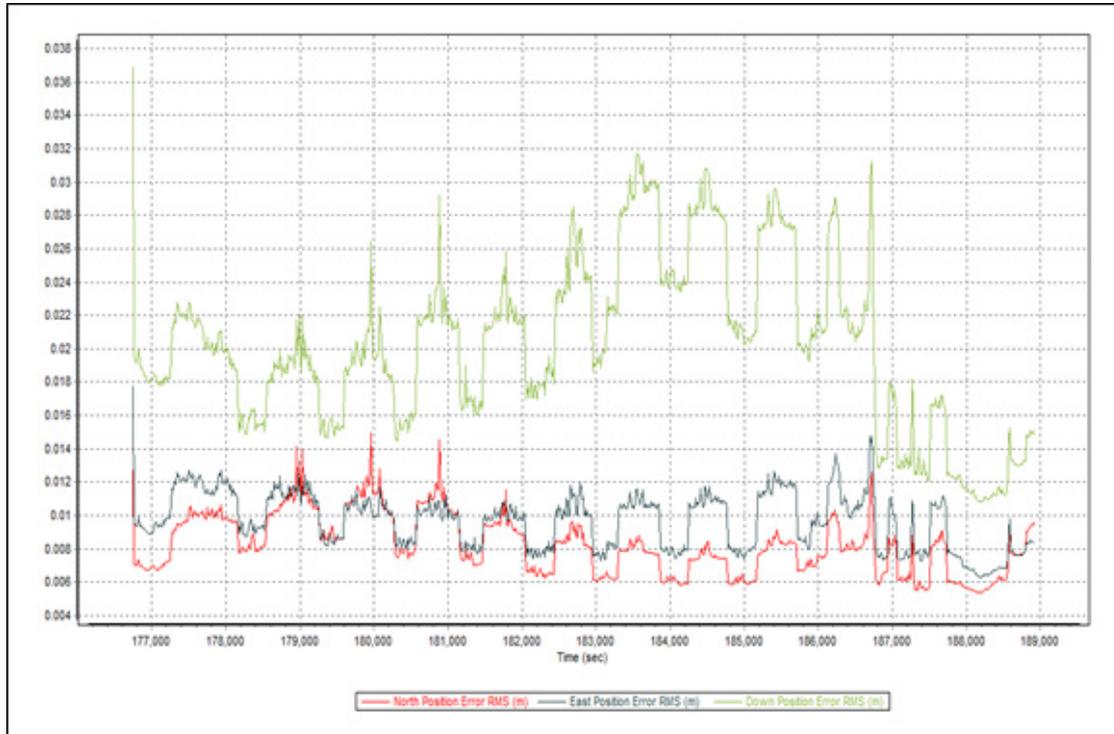
Figure 1.5.2 Smoothed Performance Metric Parameters

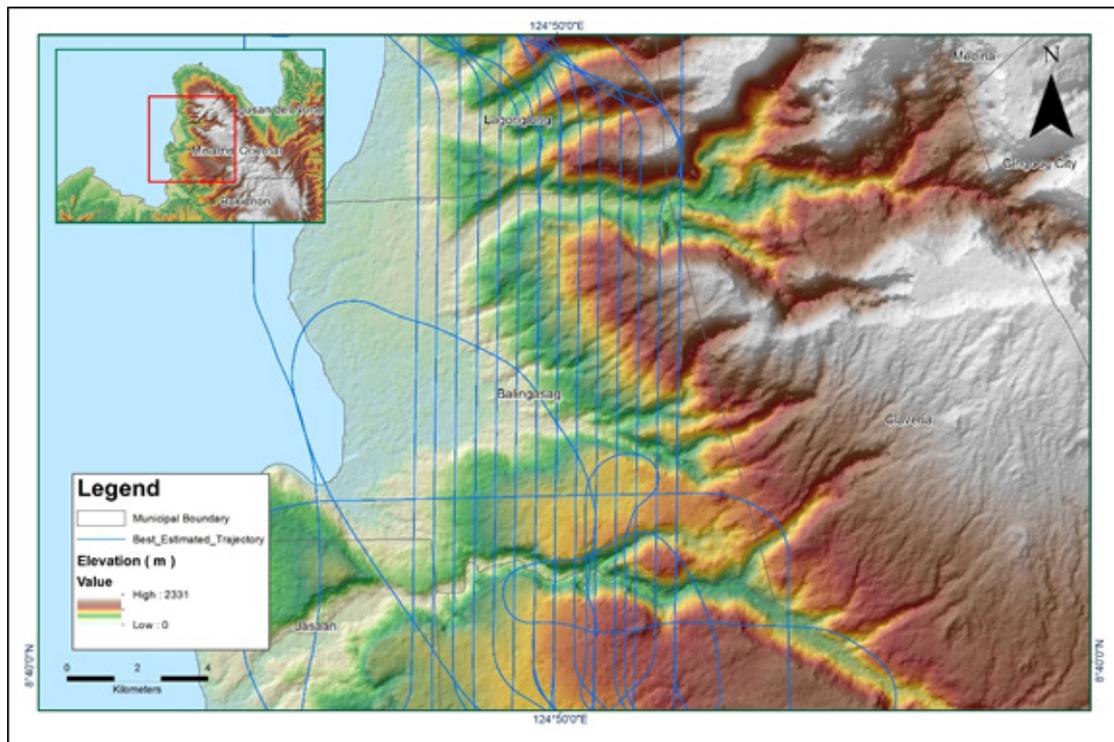
Figure 1.5.3 Best Estimated Trajectory
