Hazard Mapping of the Philippines Using LIDAR (Phil-LIDAR 1)

LiDAR Surveys and Flood Mapping of Labo River

University of the Philippines Training Center
for Applied Geodesy and Photogrammetry
Mapua Institute of Technology

APRIL 2017

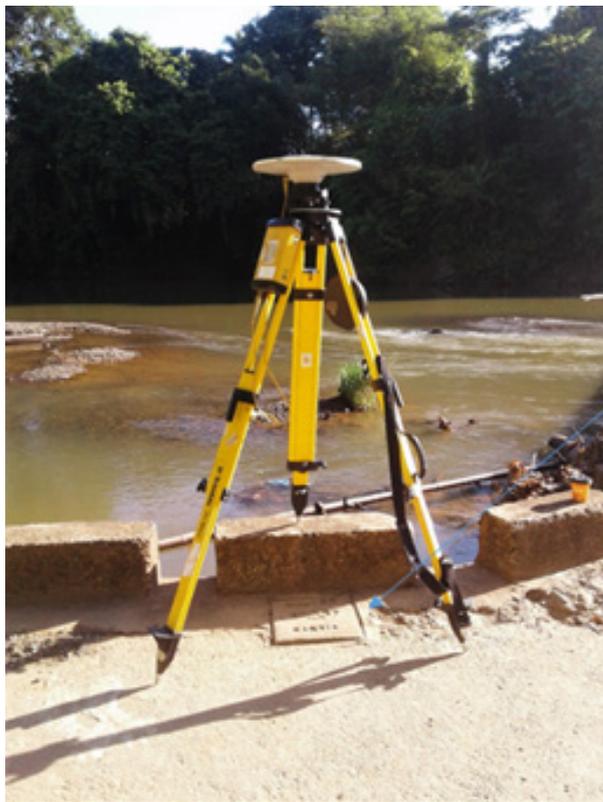
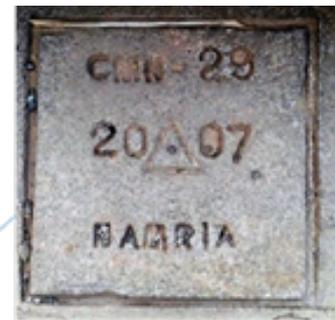
Figure 5. GPS set-up over CMN-29 at Barangay Malibago, Labo, Camarines Norte (a) and NAMRIA reference point CMN-29 (b) as recovered by the field team.

Figure 3 to Figure 6 show the recovered NAMRIA reference points and established ground control points within the area. In addition, Table 2 to Table 7 show the details about the NAMRIA reference point and established control point, while Table 8 shows the list of all ground control points occupied during the acquisition together with the corresponding dates of utilization.

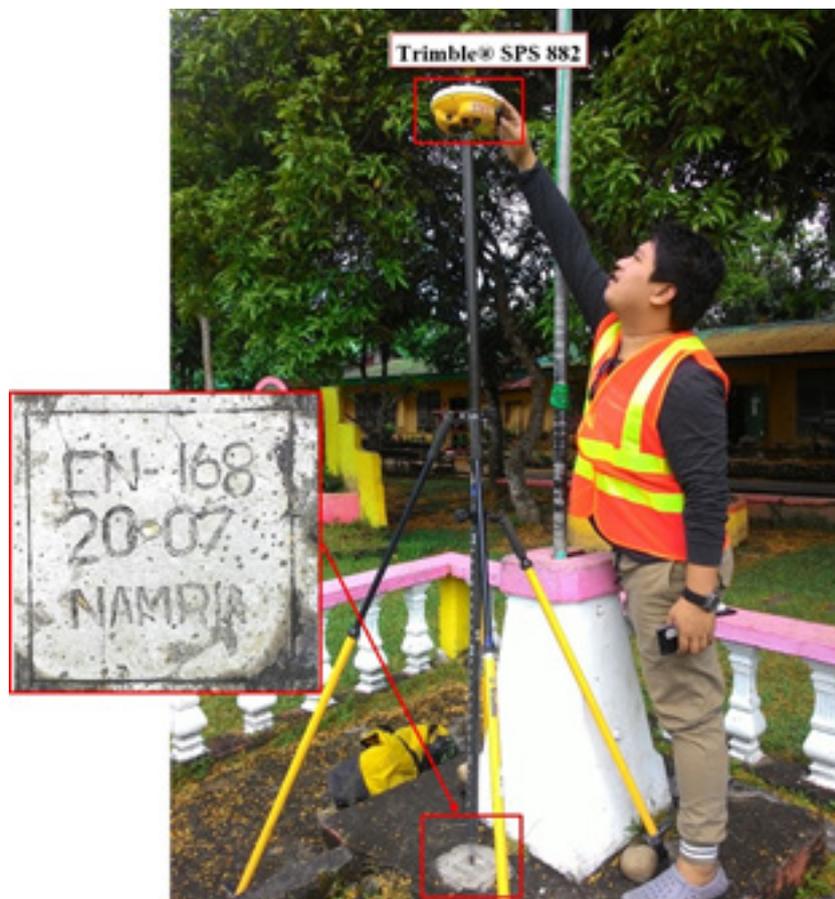
Figure 32. GNSS receiver set up, Trimble® SPS 882, at CN-168, a first-order BM, located near the flag pole inside Sto. Domingo Elementary School in Brgy. Sto. Domingo, Vinzons, Camarines Norte

The GNSS set up made in the location of the reference and control points are exhibited are shown in Figure 32 to Figure 34.

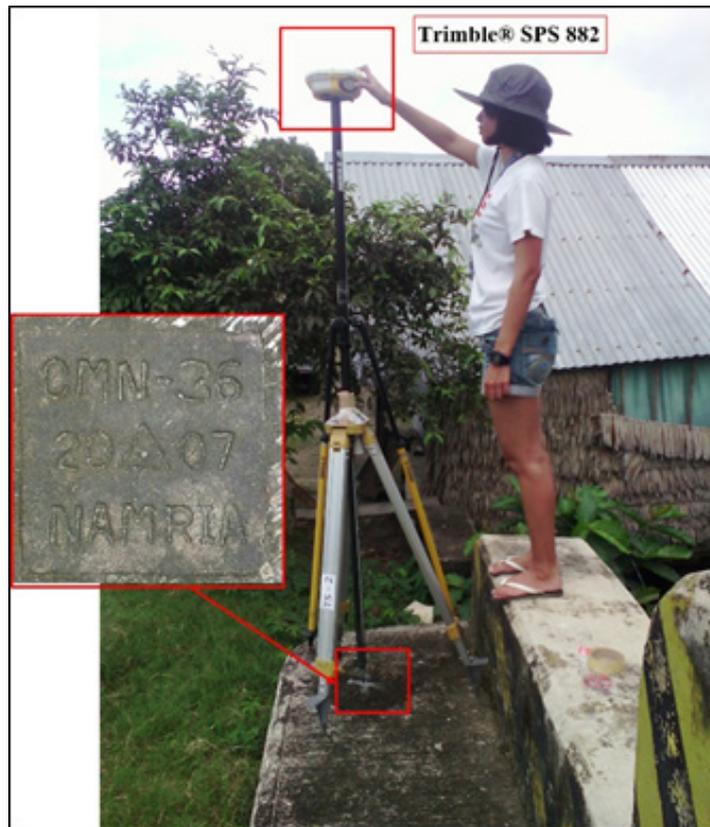
Figure 33. GNSS receiver set up, Trimble® SPS 882, at CMN-36, a second-order GCP located at the approach of Manlicogan Bridge in Brgy. Mampungo, Municipality of Paracale, Camarines Norte

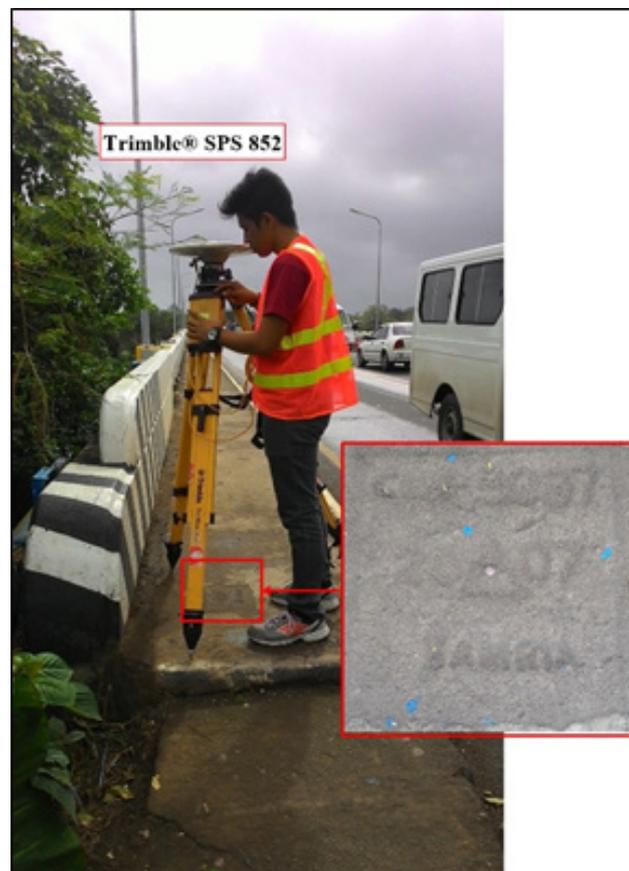
Figure 34. GNSS base set up, Trimble® SPS 852, at CMN-3087, a GCP used as a marker, located at Lobo Bridge along Maharlika Highway in Brgy. Gumamela, Municipality of Lobo, Camarines Norte

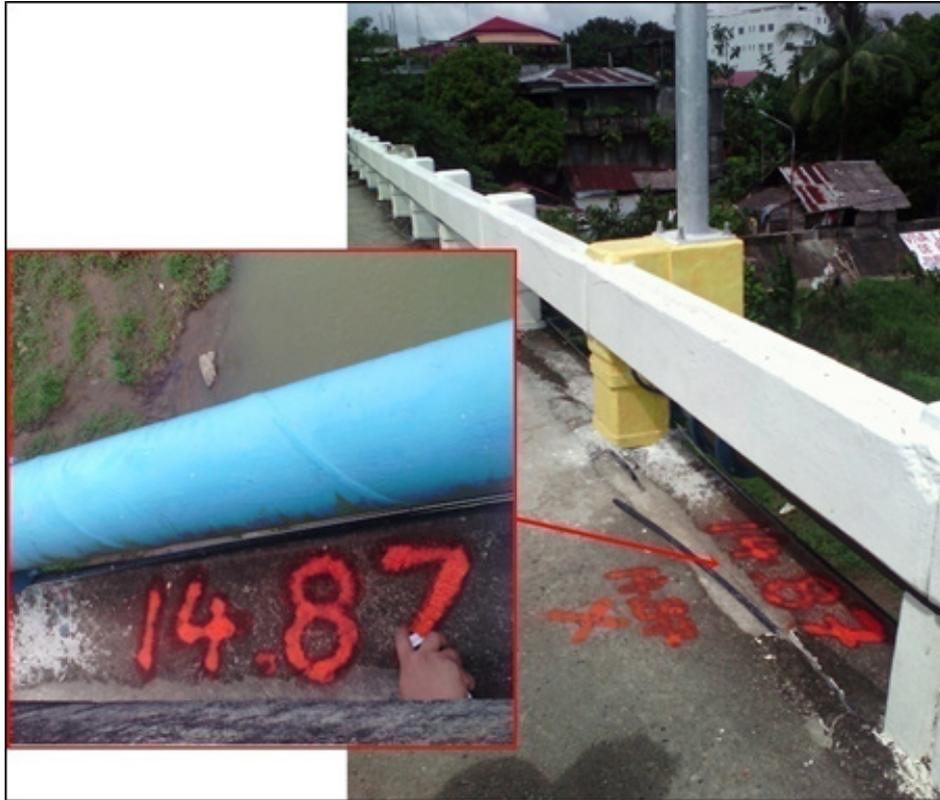
Figure 39. Water-level marking at Labo Bridge

Water surface elevation in MSL of Labo River was determined using Trimble® SPS 882 in PPK mode technique on January 30, 2016 at 03:04 PM with a value of 2.177 m in MSL. This was translated onto marking on one of the bridge's deck with the value of 14.87 m MSL which was used by Mapúa PHIL-LiDAR 1 as shown in Figure 39. The marking served as their reference for flow data gathering and depth gauge deployment for Labo River.

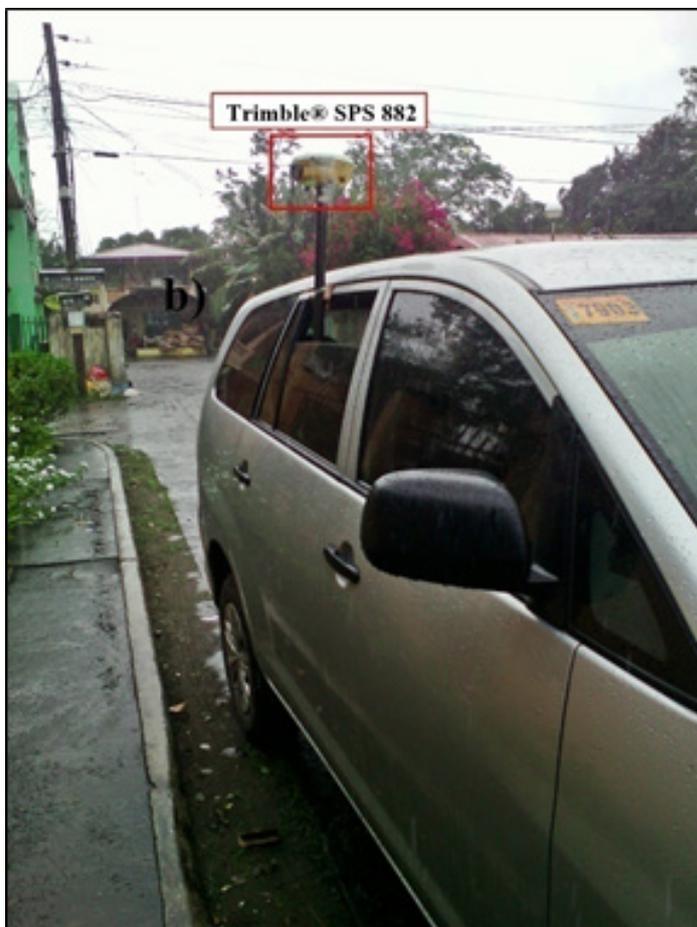
Figure 40. Validation points acquisition survey set up

Validation points acquisition survey was conducted on January 29 & 31, 2015 using a survey-grade GNSS Rover receiver, Trimble® SPS 882, mounted on a pole which was attached to the side of vehicle as shown in Figure 40. It was secured with a nylon rope to ensure that it was horizontally and vertically balanced. The antenna height was 1.96 m and measured from the ground up to the bottom of notch of the GNSS Rover receiver. The PPK technique utilized for the conduct of the survey was set to continuous topo mode with CMN-3087 occupied as the GNSS base stations in the conduct of the survey.

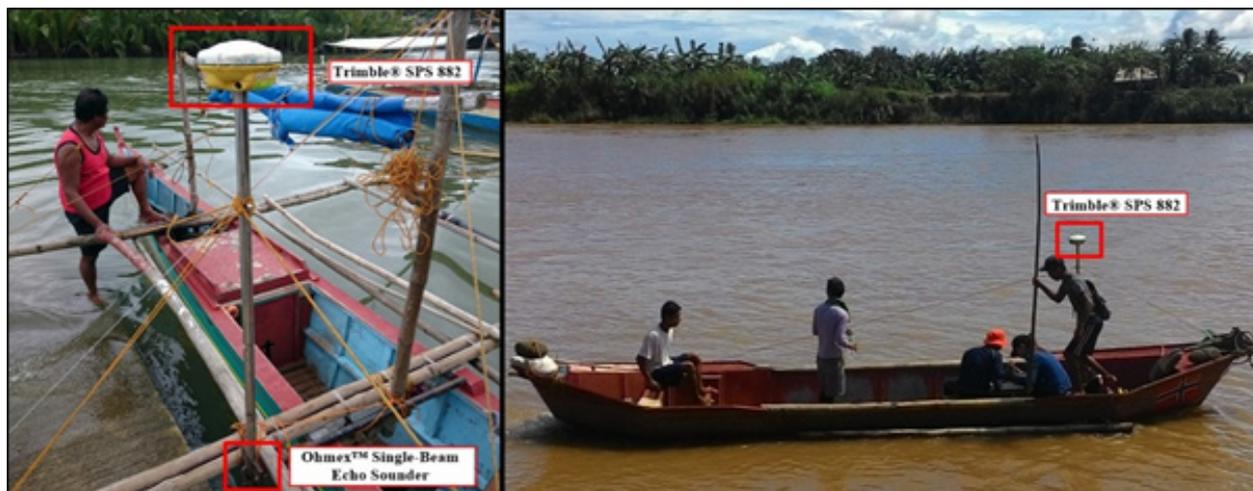
Figure 42. Bathymetry set up for Labo River survey

Bathymetric survey was executed on January 29 to 30, 2016 using a Trimble® SPS 882 in GNSS PPK survey technique and Ohmex™ single beam echo sounder, as demonstrated in Figure 42. The extent of the survey is from the upstream in Brgy. Gumamela in the Municipality of Labo with coordinates 14°10'12.92495"N 122°51'42.35280"E, down to the mouth of the river in Brgy. Sula in the Municipality of Vinzon with coordinates 14°13'08.52066"N 122°55'00.02442"E, as illustrated in Figure 43. The control point CMN-3087 was used as the GNSS base station throughout this survey.

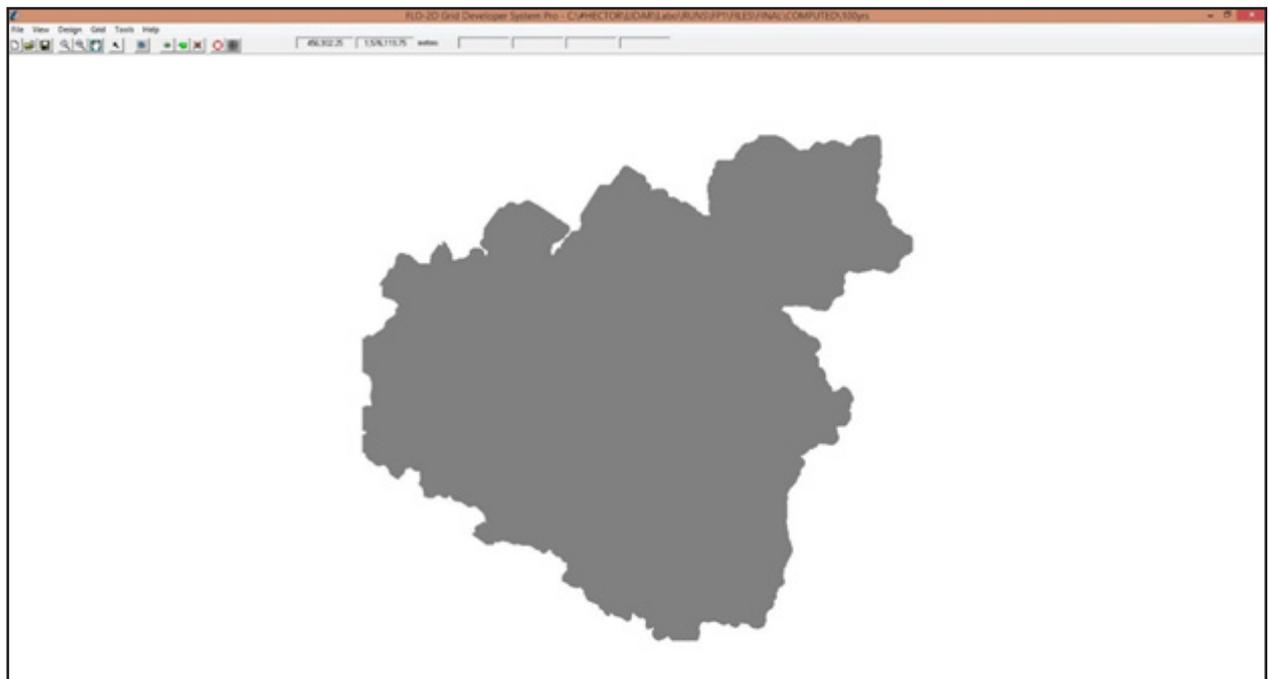
Based on the elevation and flow direction, it is seen that the water will generally flow from the west of the model to the east and northeast, following the main channel. As such, boundary elements in those particular regions of the model were assigned as inflow and outflow elements respectively.

Figure 57. Screenshot of subcatchment with the computational area to be modeled in FLO-2D GDS Pro

The automated modelling process allowed for the creation of a model with boundaries that are almost exactly coincidental with that of the catchment area. As such, they have approximately the same land area and location. The entire area was divided into square grid elements, 10 meter by 10 meter in size. Each element was assigned a unique grid element number which serves as its identifier, then attributed with the parameters required for modelling such as x-and y-coordinate of centroid, names of adjacent grid elements, Manning coefficient of roughness, infiltration, and elevation value. The elements were arranged spatially to form the model, allowing the software to simulate the flow of water across the grid elements and in eight directions (north, south, east, west, northeast, northwest, southeast, southwest).

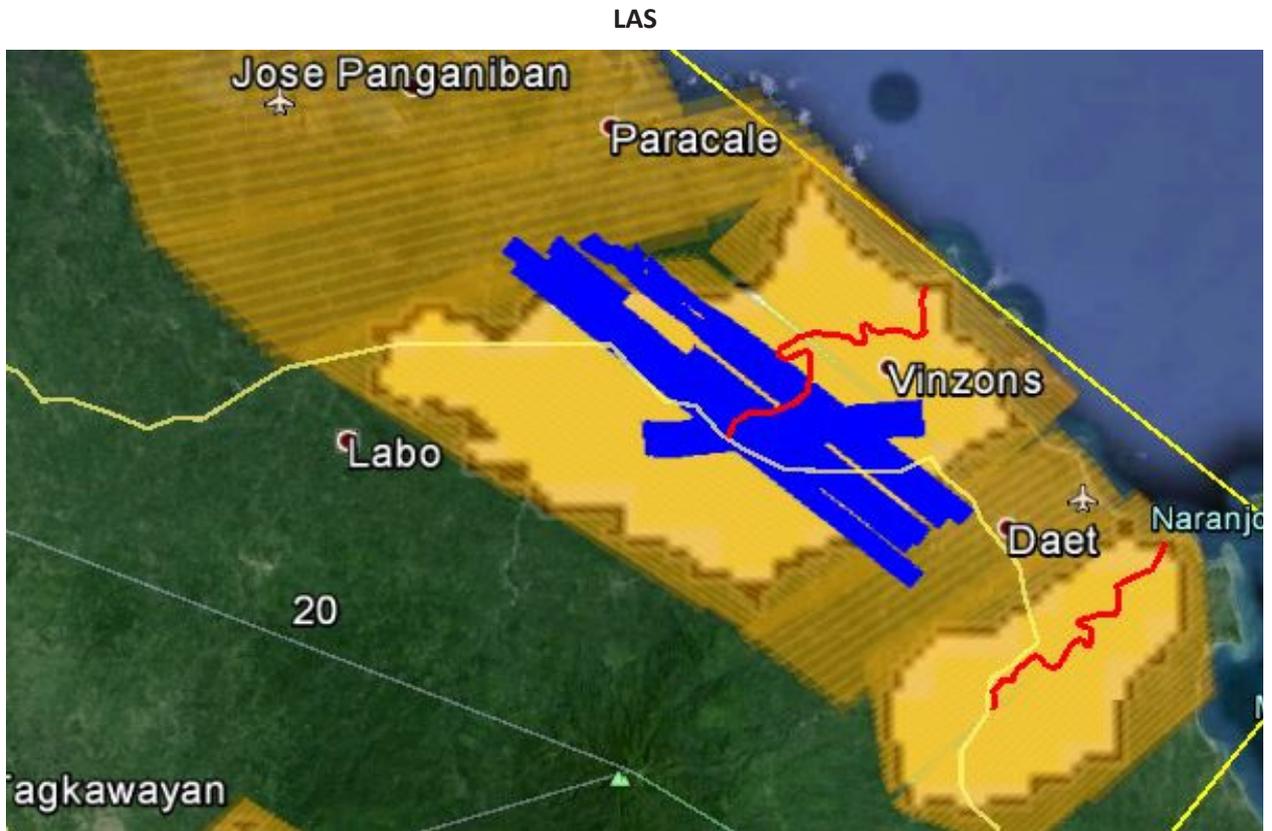
Figure A-7.3. Swath Coverage of Mission 1BLK20B70B

FLIGHT NO.: 23176
AREA: Bagasbas
MISSION NAME: 1BLK20B70B
ALT: 600-1100m SCAN FREQ: 30 SCAN ANGLE: 50
SURVEYED AREA: 89.79

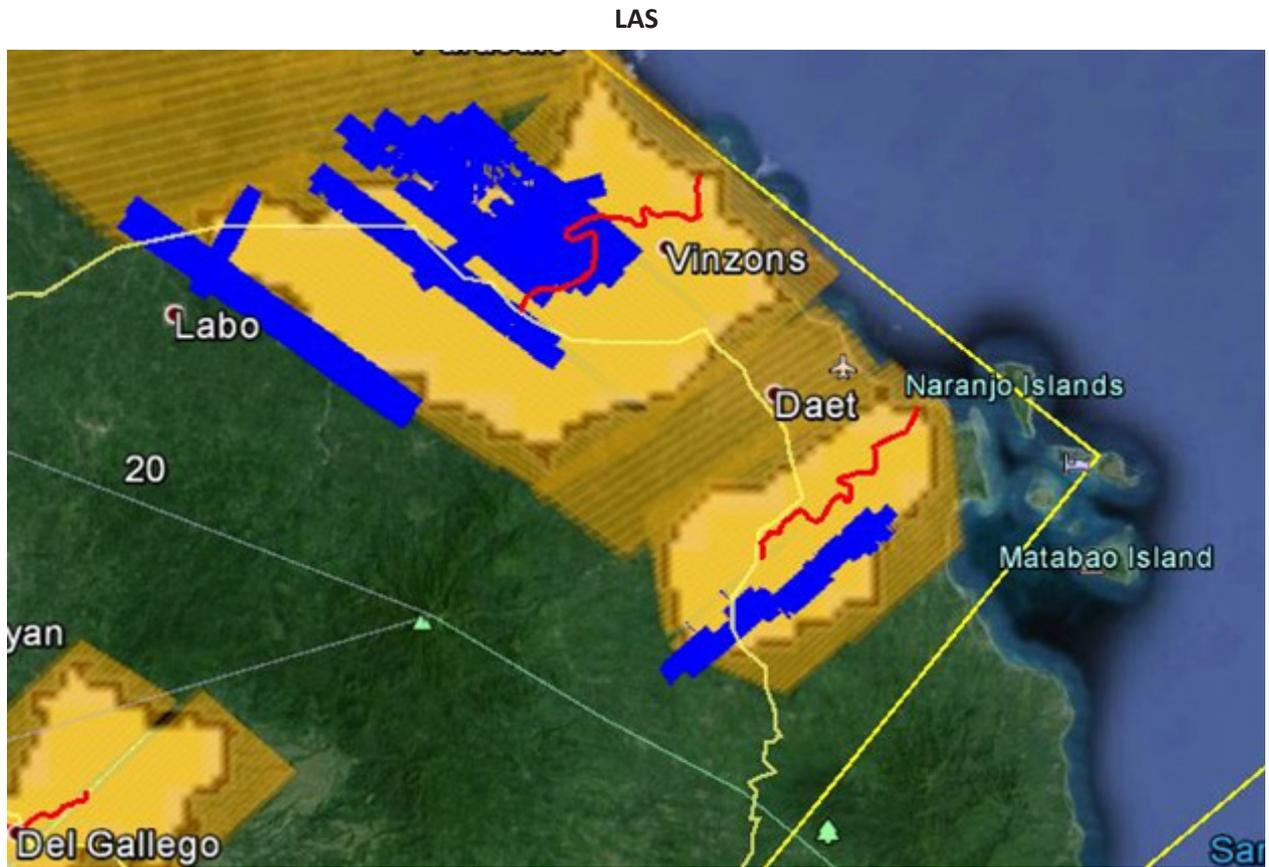
Figure A-7.5. Swath Coverage of Mission IBLK20BS74A

FLIGHT NO.: 23190
AREA: Bagasbas
MISSION NAME: 1BLK20BS74A
ALT: 600-1100 m SCAN FREQ: 30 SCAN ANGLE: 50
SURVEYED AREA: 151.12

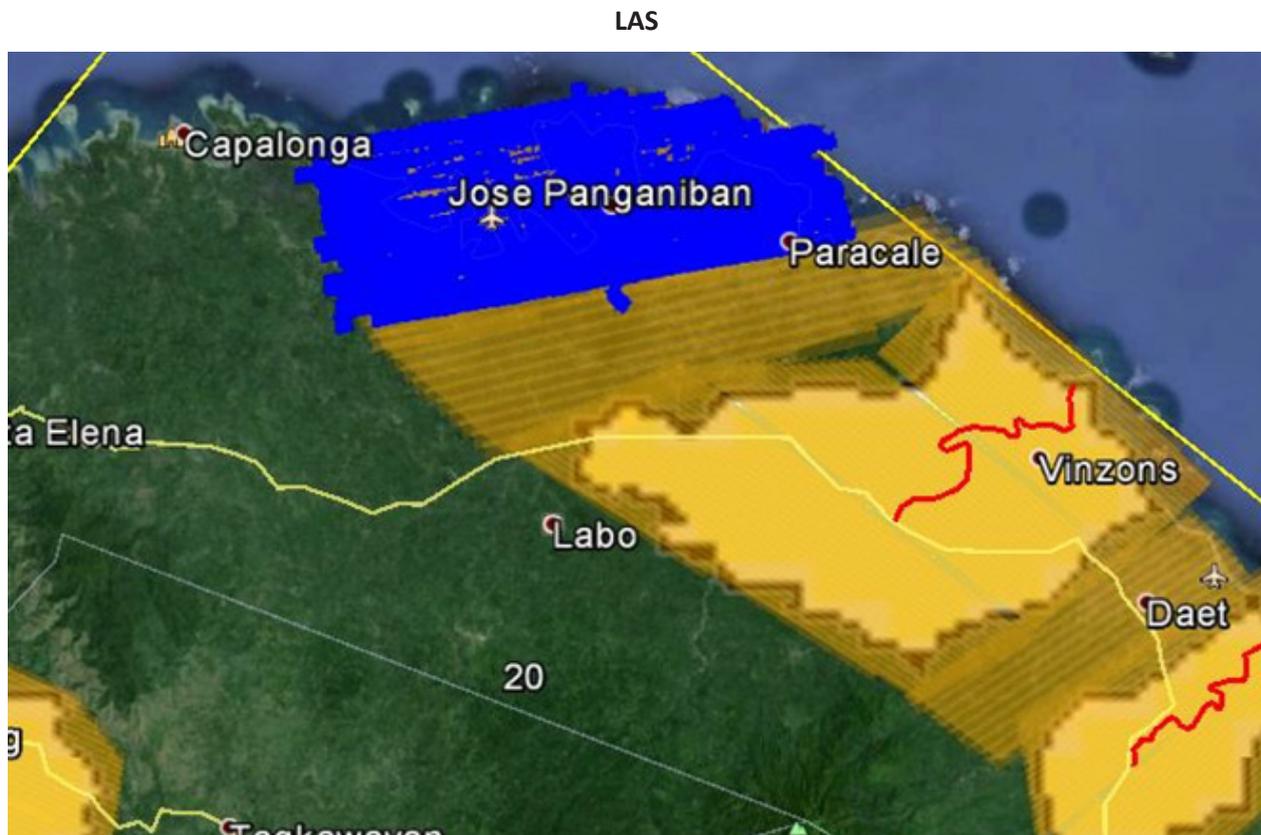
Figure A-7.6. Swath Coverage of Mission 1BLK20N77A

FLIGHT NO.: 23202P
AREA: Bagasbas
MISSION NAME: 1BLK20N77A
ALT: 600-1100 m SCAN FREQ: 30 SCAN ANGLE: 50
SURVEYED AREA: 232.46

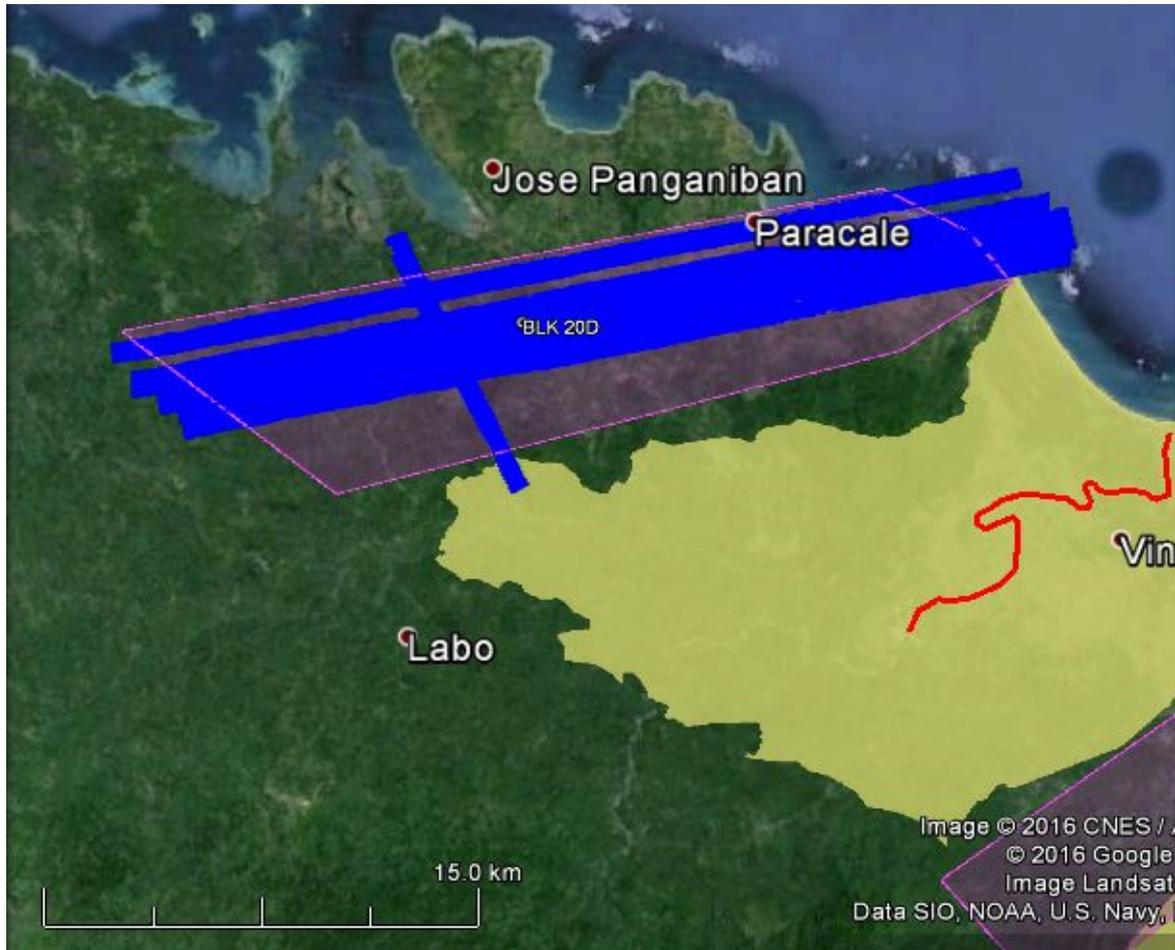
Figure A-7.9. Swath Coverage of Mission

Flight No. : 23264P
Parameters: PRF 200 SF 30 FOV 50
