HAZARD MAPPING OF THE PHILIPPINES USING LIDAR (PHIL-LIDAR I)

LiDAR Surveys and Flood Mapping of Digos River

University of the Philippines Training Center
for Applied Geodesy and Photogrammetry
University of the Philippines Mindanao

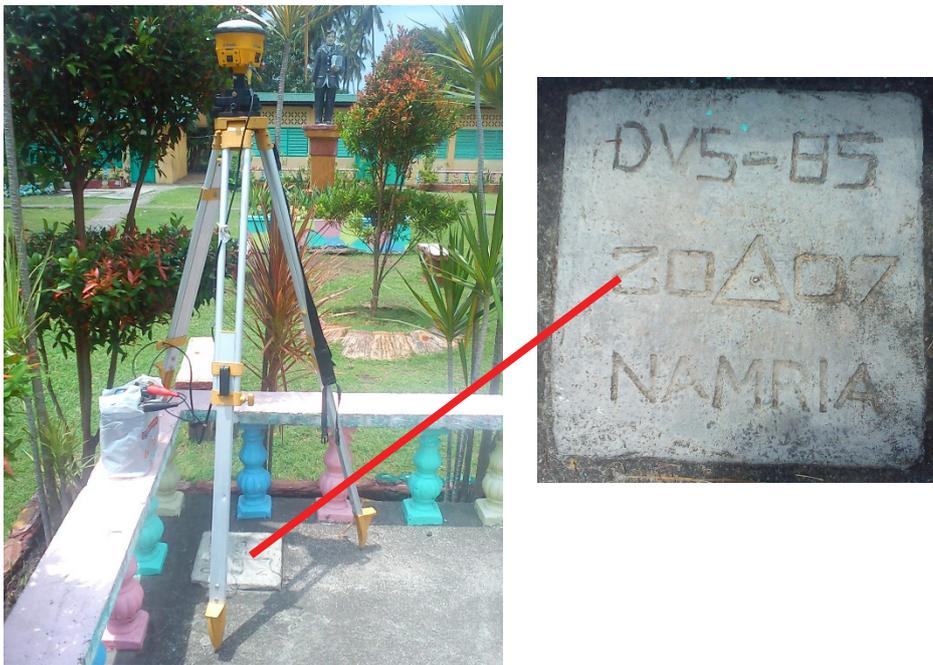
Figure 3. GPS set-up over DVS-85 located inside Mariano Sarona Elementary School, inside the fence of the flagpole (a) and NAMRIA reference point DVS-85 (b) as recovered by the field team.

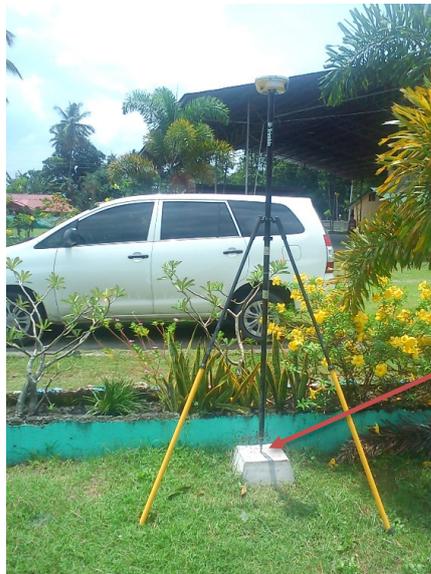
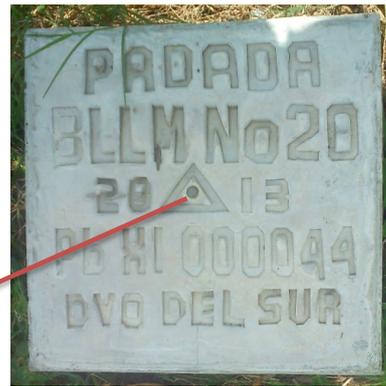
Figure 4. GPS set-up over BLLM-20 located inside Mariano Saron Elementary School, inside the fence of the flagpole (a) and NAMRIA reference point BLLM-20 (b) as recovered by the field team

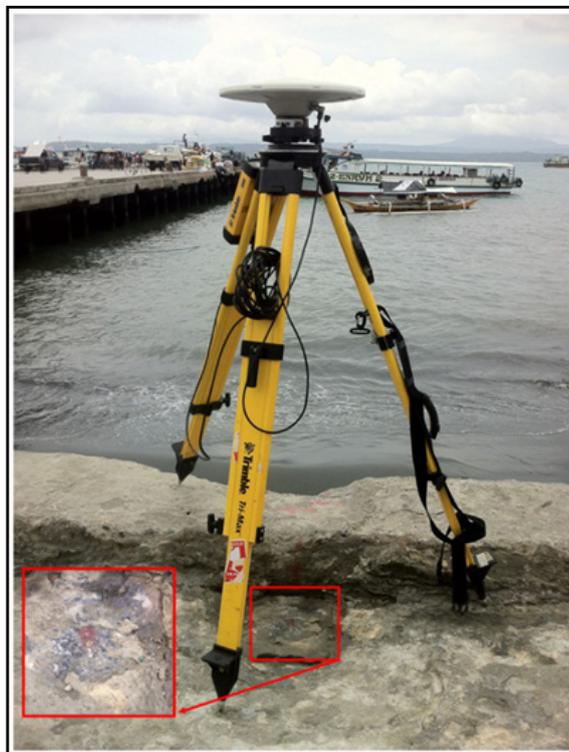
Figure 28. GNSS base receiver setup, Trimble® SPS 852 at DVS-1 at the east side of Pier, in Brgy. Leon Garcia Sr., Davao City, Davao Del Sur

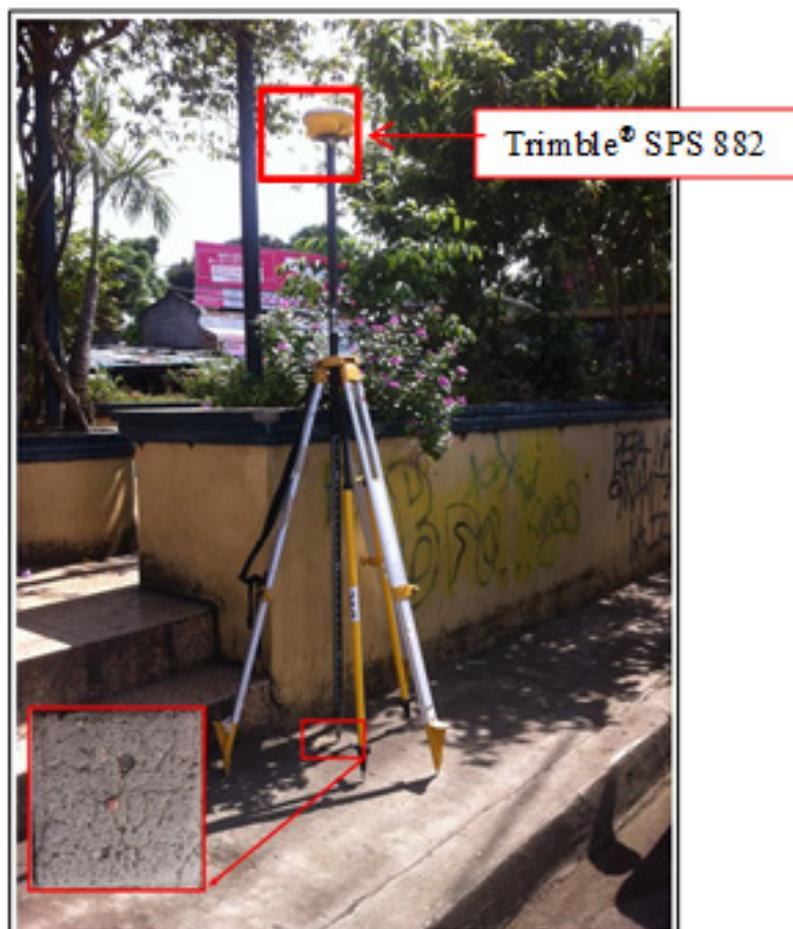
Figure 30. GNSS base receiver setup, Trimble® SPS 882 at DS-09 located at stair of Nograles Park along Mac Arthur Highway, in Brgy. Talomo, Davao City, Davao Del Sur

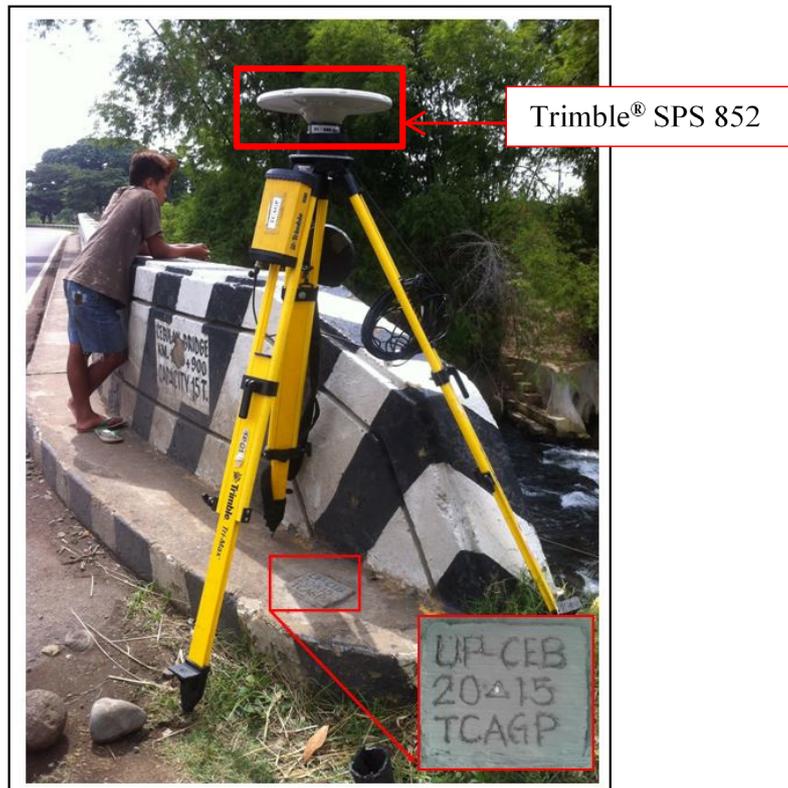
Figure 31. GNSS base receiver setup, Trimble® SPS 852 at UP-CEB on the right approach of Cebulan Bridge in Brgy Darong, Municipality of Santa Cruz, Davao Del Sur

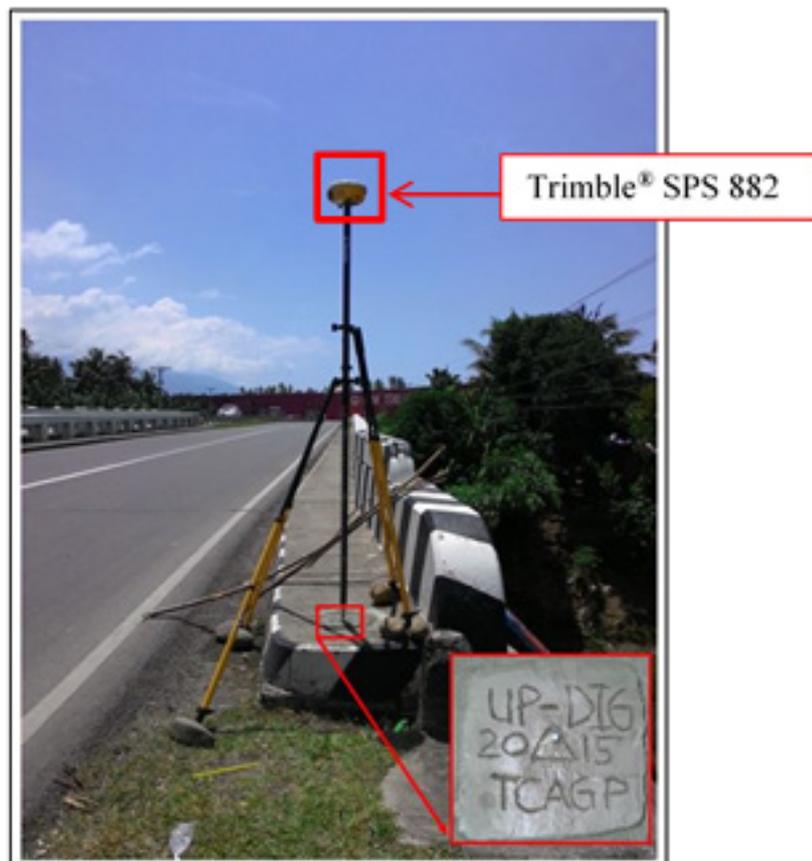
Figure 32. GNSS base receiver setup, Trimble® SPS 882 at UP-DIG, right approach of Digos Bridge in Brgy. Aplaya, Digos City, Davao Del Sur

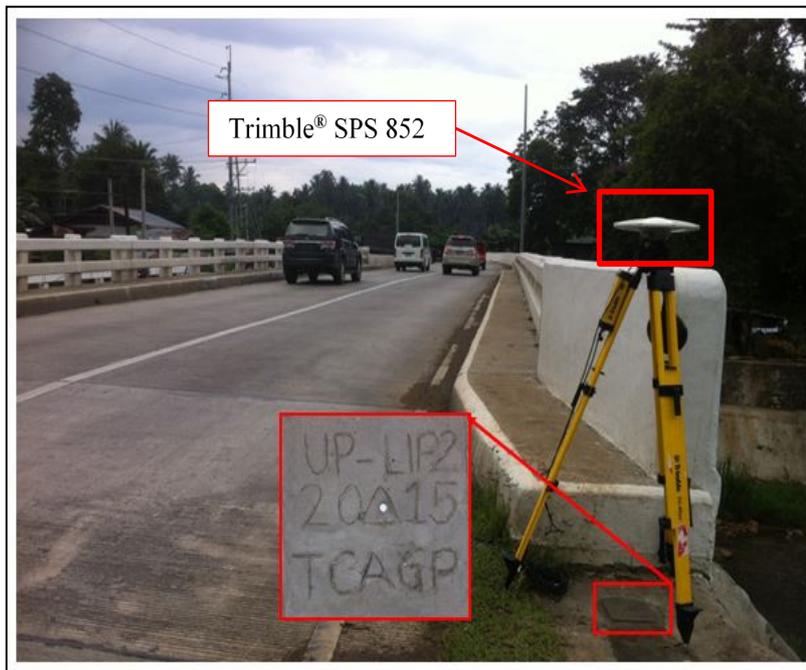
Figure 33. GNSS base receiver setup, Trimble® SPS 852 at UP-LIP2, on the right approach of Lipadas Bridge along National Highway in Brgy. Lizada, Toril District, Davao Del Sur

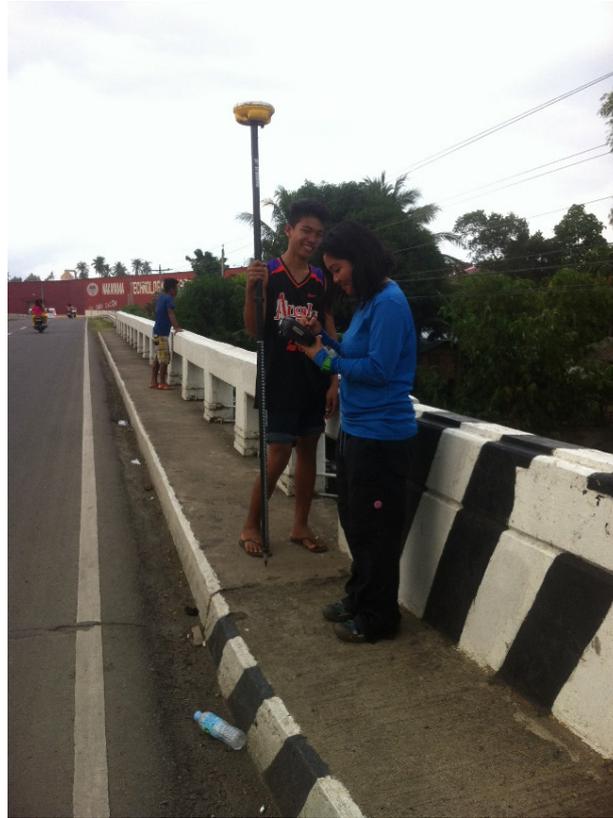
Cross-section and as-built surveys were conducted on July 6, 2015 in the downstream side of Digos Bridge in Brgy. Aplaya, Digos City Davao Del Sur using a GNSS receiver, Trimble® SPS 882, in PPK survey technique as shown in Figure 35. Bridge as-built features determination was also performed to get the distance of piers and abutments from the bridge approach. The bridge deck was measured using GNSS receiver Trimble® SPS 882 to get the high chord and meter tapes to get its low chord elevation.

Figure 35. Cross-section survey at the downstream side of Digos Bridge in Brgy. Aplaya, Digos City, Davao Del Sur

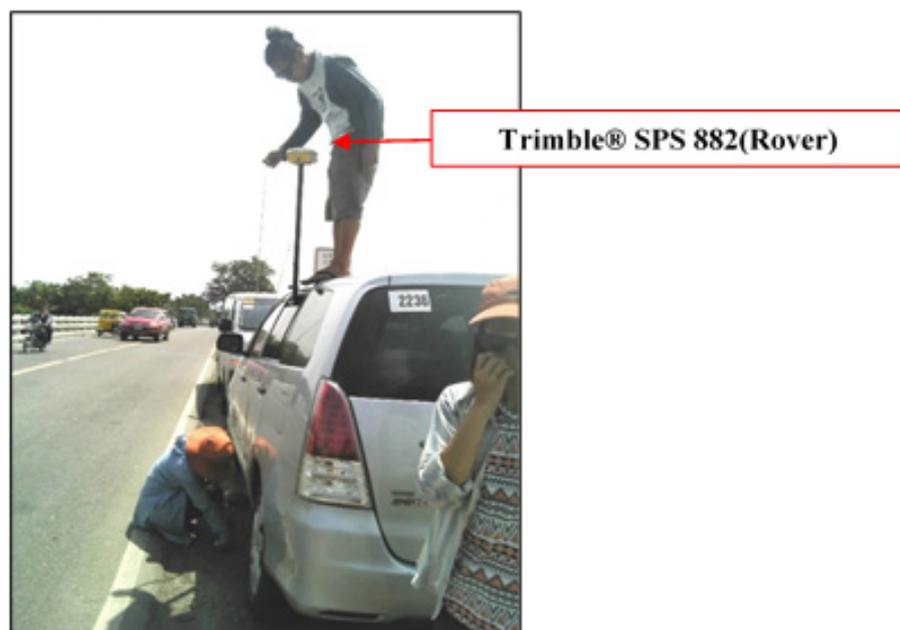
Validation Points Acquisition Survey was conducted on July 8 and 11, 2015 using a survey-grade GNSS Rover receiver, Trimble® SPS 882, mounted on a pole which was attached in front of the vehicle as shown in Figure 40. It was secured with a nylon rope to ensure that it was horizontally and vertically balanced. The antenna height of 1.426 m was measured from the ground up to the bottom of the notch of the GNSS SPS 882 Rover receiver on the first day. The second validation survey antenna height is measured to be 1.382m. The surveys were conducted using PPK technique on a continuous topography mode using UP-PAD as base station.

Figure 40. Validation points acquisition survey setup

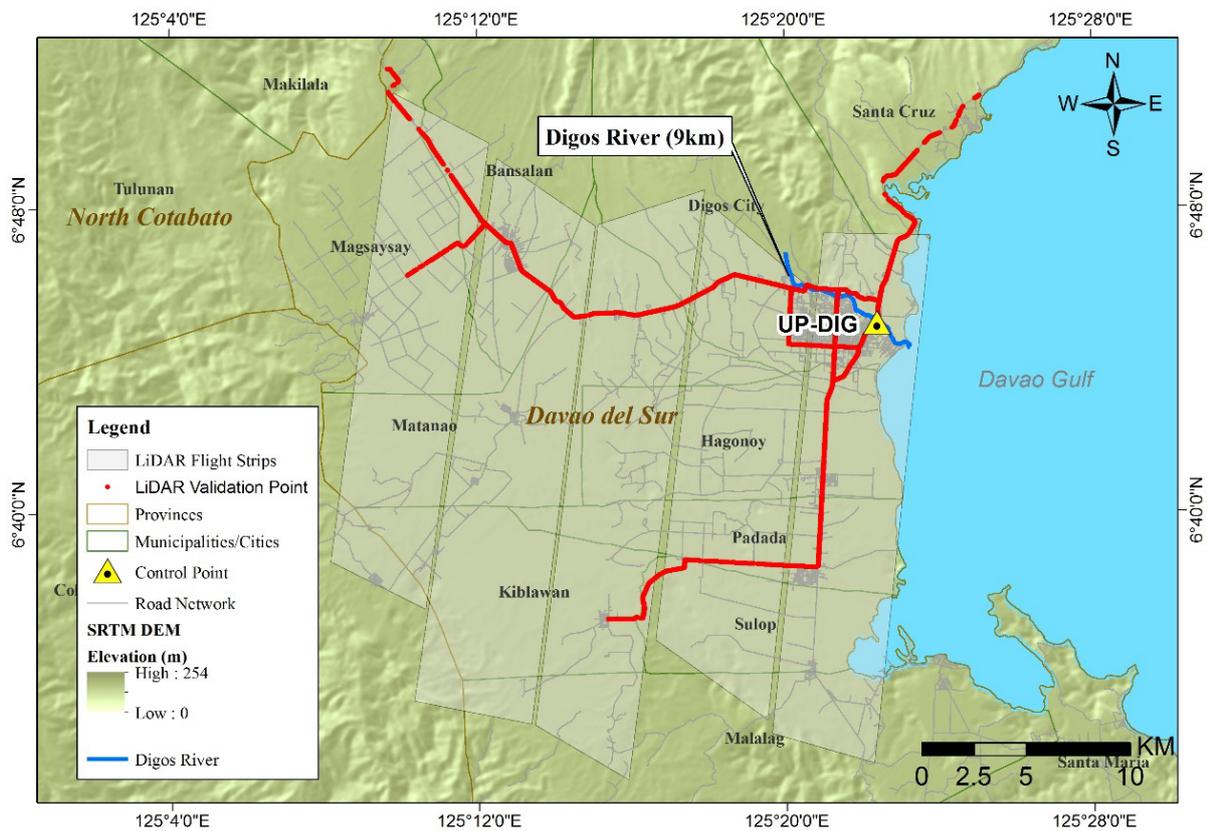
The first day of ground validation survey covered the major roads of Santa Cruz, Digos City, Hagonoy, Padada, Sulop, Kiblawan, and Matanao. The second day of the ground validation covered the major roads of Bansalan and Magsaysay. The survey acquired 12,851 ground validation points with an approximate length of 84.5 km as presented in Figure 41. The gaps in the validation line were due to some difficulties in receiving satellite signals because of the presence of obstruction such as dense canopy cover of trees along the roads.

Figure 41. LiDAR Ground validation survey along Digos River Basin

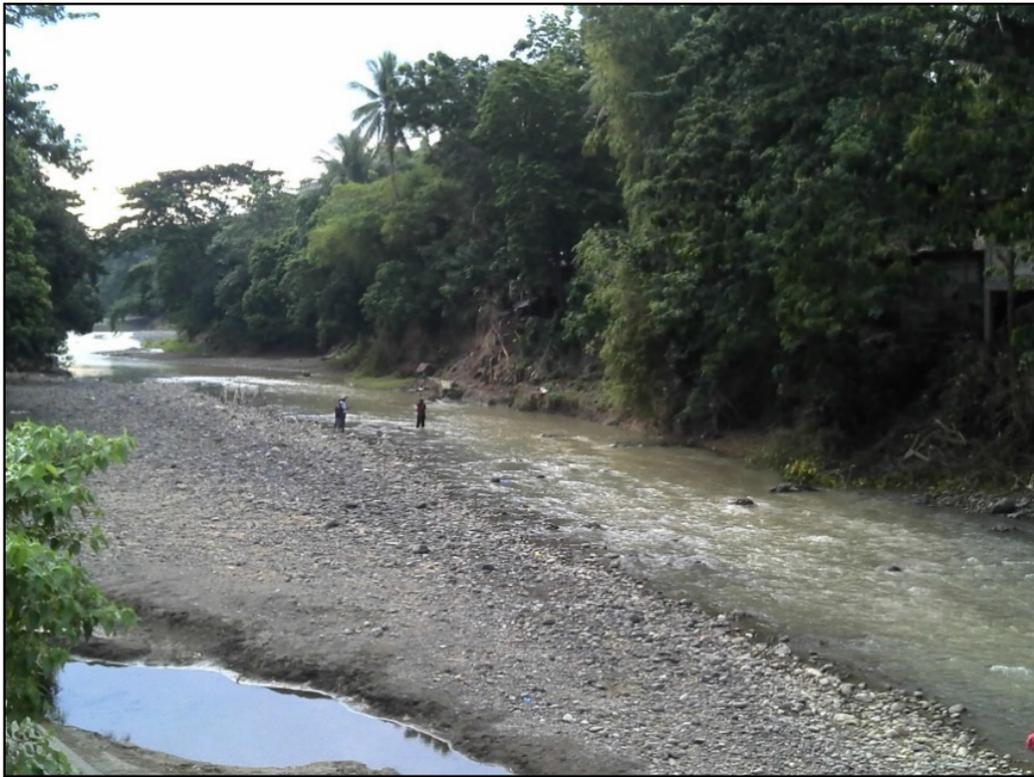
Manual bathymetric survey was conducted on July 6 to July 10, 2015 using Trimble® SPS 882 in GNSS PPK survey technique as shown in Figure 42. The survey started in the upstream part of the river in Brgy. Ruparan, Digos City with coordinates 6°46'46.28705" 125°20'01.70541", traversed down the river by foot and ended at the mouth part of the river in Brgy. Aplaya and Brgy. Cogon, also in Digos City, with coordinates 6°44'32.68265" 125°23'14.79631". The control point UP-DIG was used as the GNSS base station all throughout the survey.

Figure 42. Manual bathymetric survey in Digos River

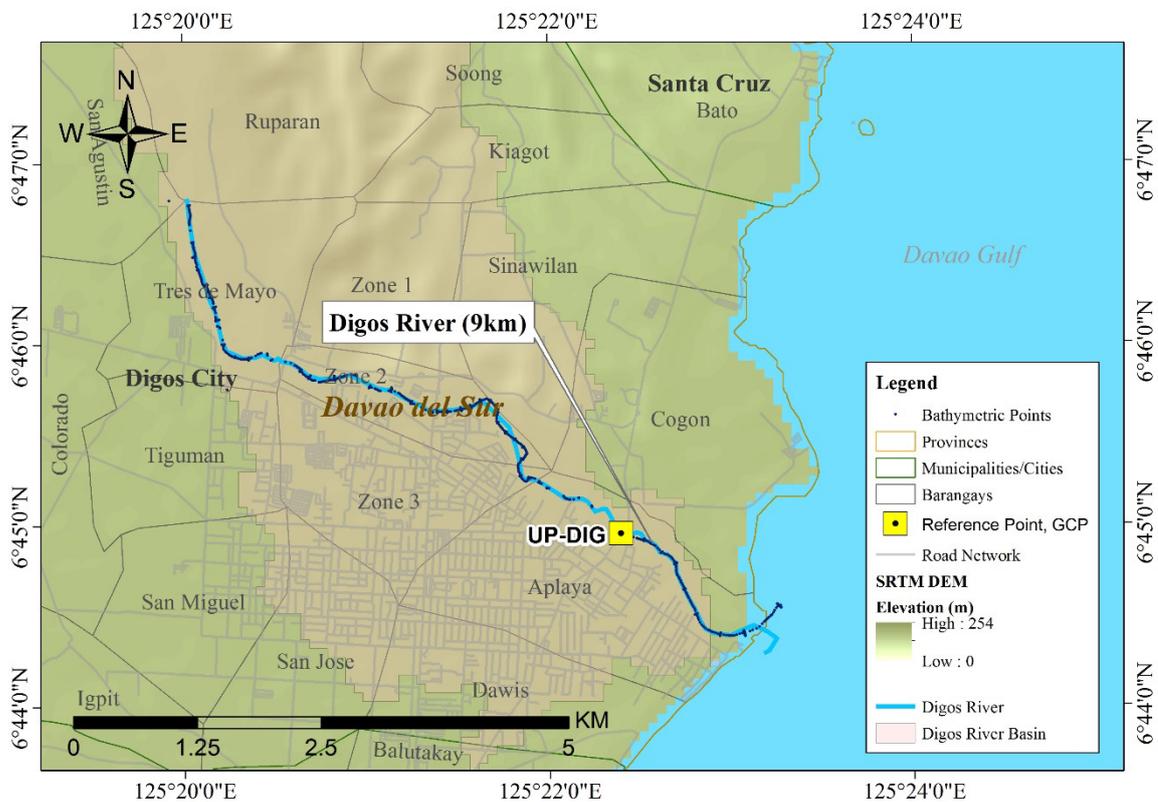
The bathymetry survey traverses the Barangays of Tres De Mayo and Brgy. Zone 2 and the Bridges of Canos and Digos, then ending at Brgy. Aplaya with an estimated length of 9 km with a total of 1,359 bathymetric points gathered. The gaps in the bathymetric line as shown in Figure 43 were due to some difficulties in acquiring satellite due to the presence of obstruction such as dense canopy cover of trees along the path traversed.

Figure 43. Bathymetric points gathered from Digos River

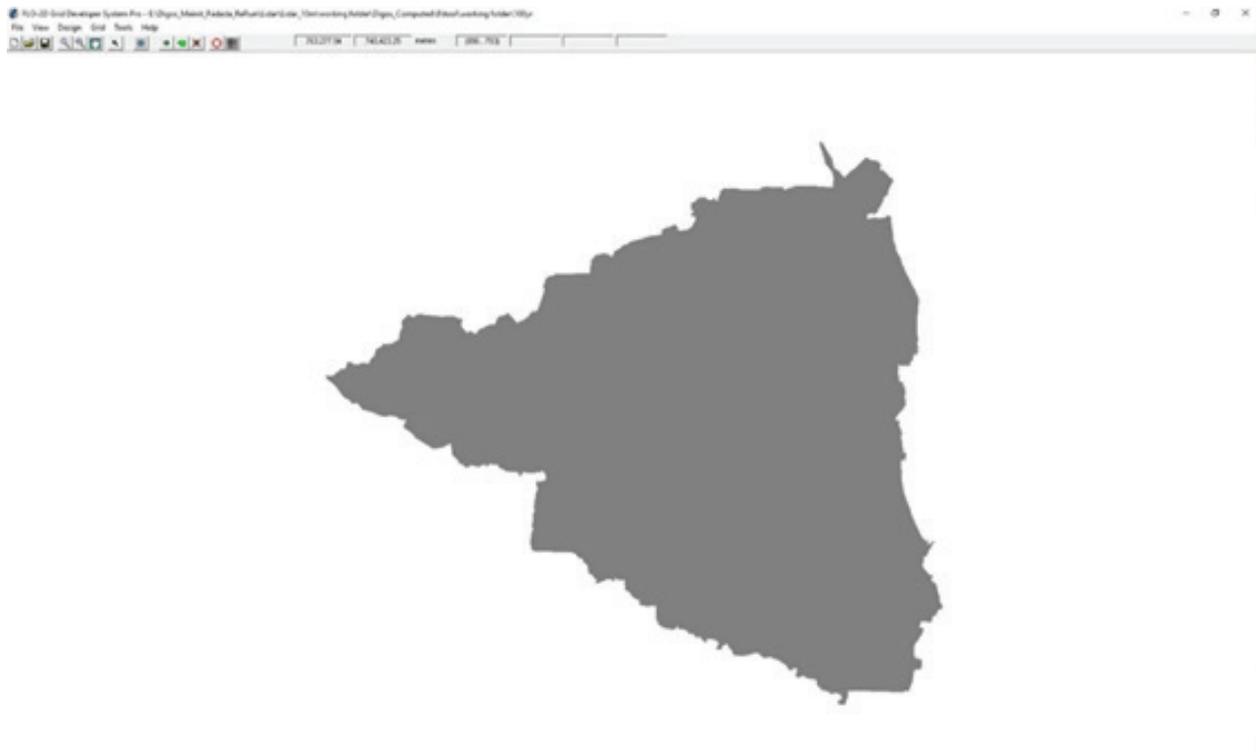
The automated modelling process allows for the creation of a model with boundaries that are almost exactly coincidental with that of the catchment area. As such, they have approximately the same land area and location. The entire area is divided into square grid elements, 10 meter by 10 meter in size. Each element is assigned a unique grid element number which serves as its identifier, then attributed with the parameters required for modelling such as x-and y-coordinate of centroid, names of adjacent grid elements, Manning coefficient of roughness, infiltration, and elevation value. The elements are arranged spatially to form the model, allowing the software to simulate the flow of water across the grid elements and in eight directions (north, south, east, west, northeast, northwest, southeast, southwest).

Based on the elevation and flow direction, it is seen that the water will generally flow from the west of the model to the east, following the main channel. As such, boundary elements in those particular regions of the model are assigned as inflow and outflow elements respectively.

Figure 57. Screenshot of subcatchment with the computational area to be modeled in FLO-2D GDS Pro

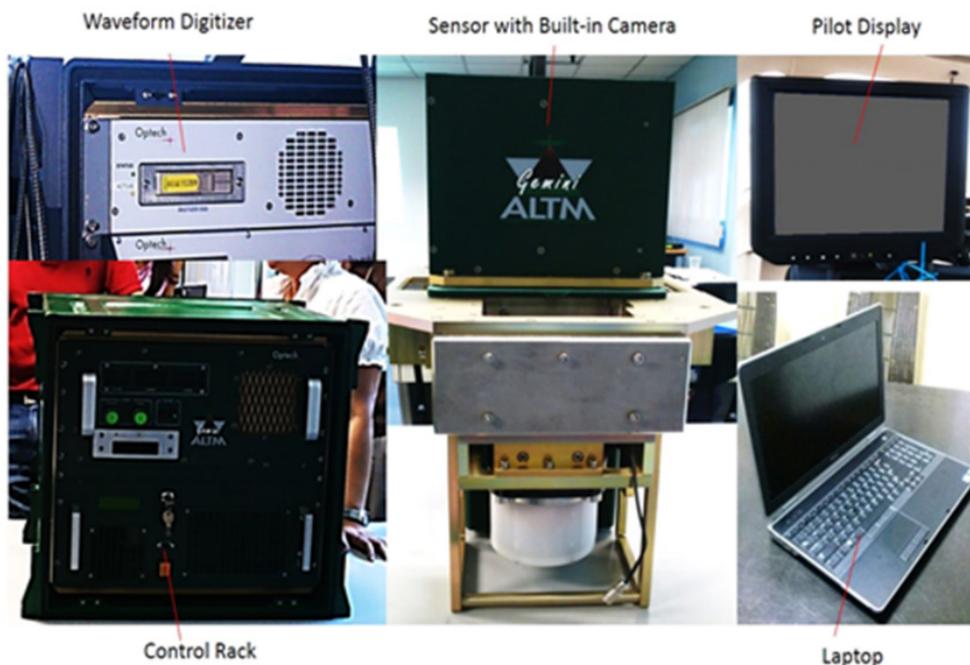
Figure A-1.1 Gemini Sensor

Data storage	Removable solid state disk SSD (SATA II)
Power requirements	28 V; 900 W; 35 A(peak)
Dimensions and weight	Sensor: 260 mm (w) x 190 mm (l) x 570 mm (h); 23 kg Control rack: 650 mm (w) x 590 mm (l) x 530 mm (h); 53 kg
Operating temperature	-10°C to +35°C (with insulating jacket)
Relative humidity	0-95% no-condensing

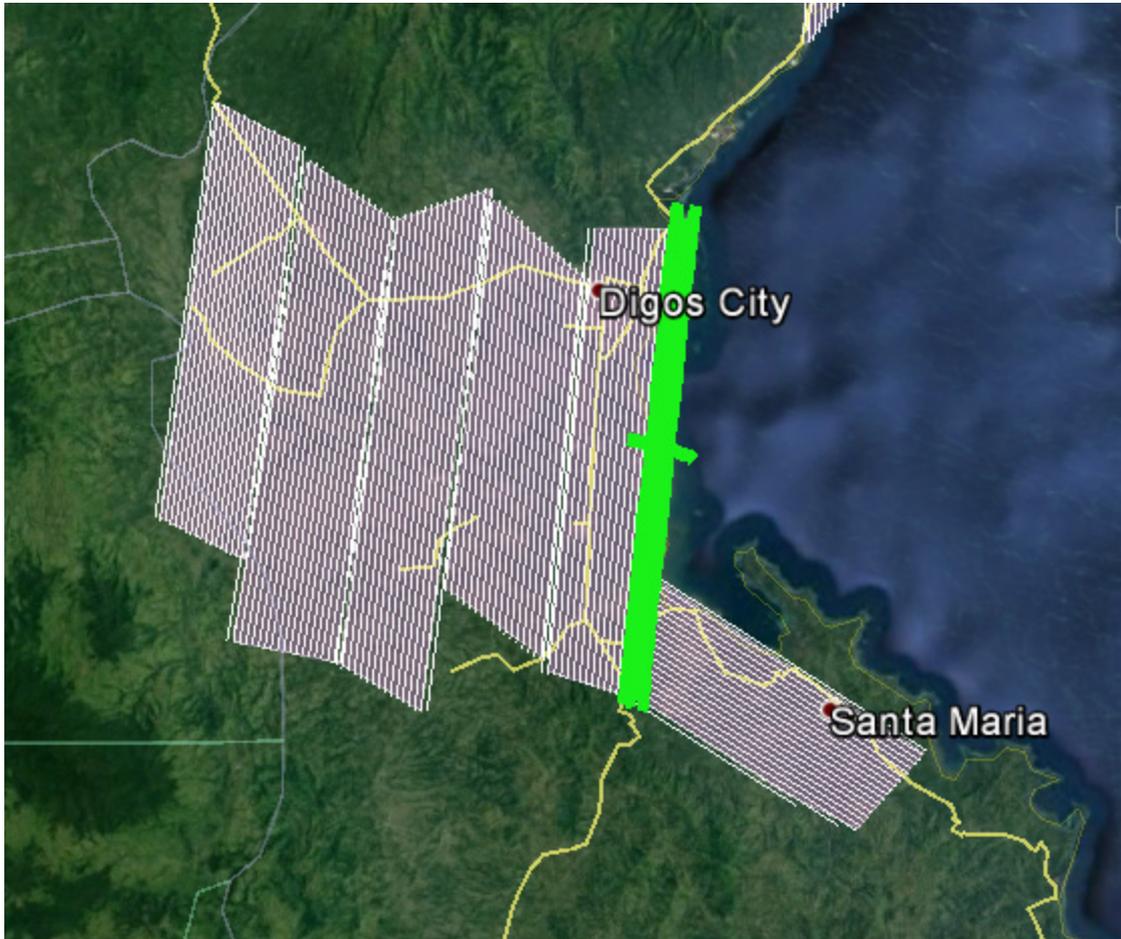
Flight No. :	7400GC	
Area:	BLK87A	
Mission name:	2LK87A210A	
Parameters:	Altitude: 1000/900 m;	Scan Frequency: 50/40 Hz;
	Scan Angle: 20/25 deg;	Overlap: 30 %
Area covered:	48.522 km ²

Figure A-7.1. Swath Coverage of Flight No. 7400GC

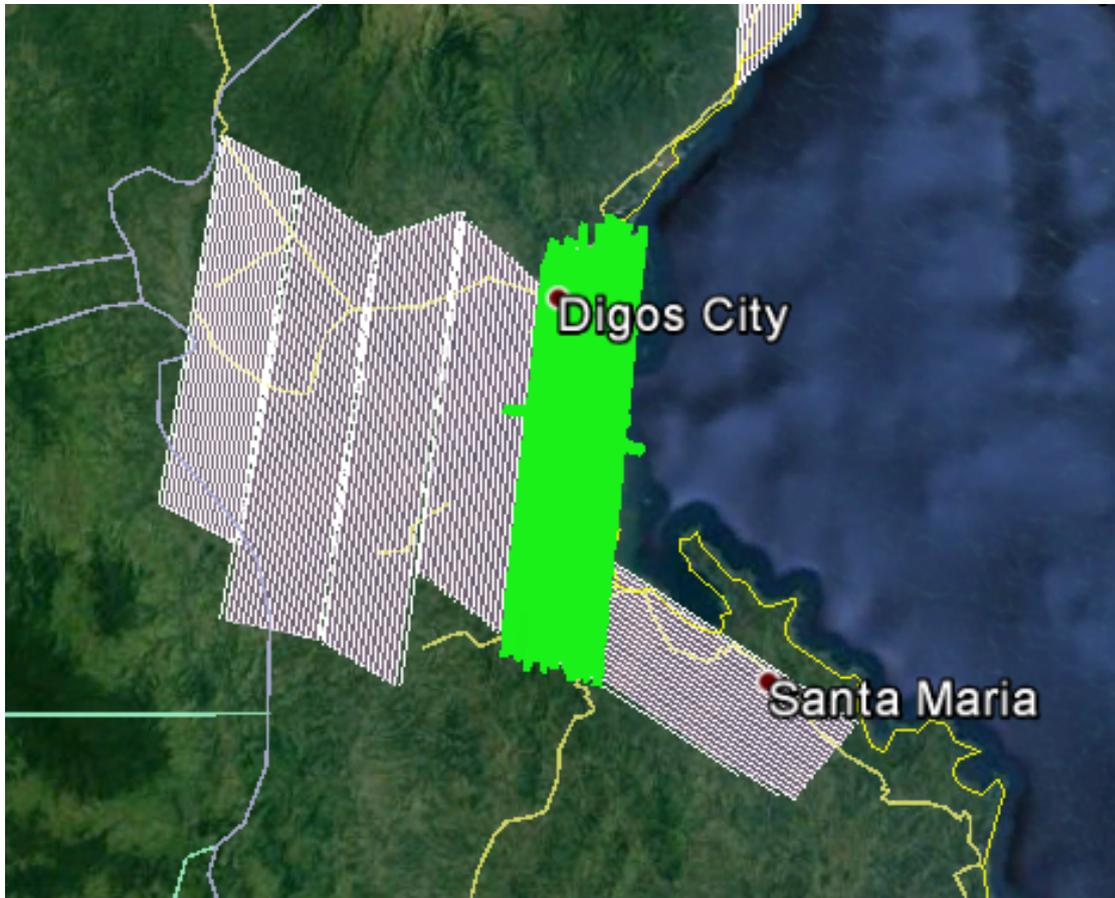
Flight No. :	7404GC	
Area:	BLK87A	
Mission name:	2BLK87AS212A	
Parameters:	Altitude: 1000 m;	Scan Frequency: 50 Hz;
	Scan Angle: 20 deg;	Overlap: 30 %
Area covered:	169.442 km2

Figure A-7.2. Swath Coverage of Flight No. 7404GC
