HAZARD MAPPING OF THE PHILIPPINES USING LIDAR (PHIL-LIDAR)

LiDAR Surveys and Flood Mapping of Padada River

University of the Philippines Training Center
for Applied Geodesy and Photogrammetry
University of the Philippines Mindanao

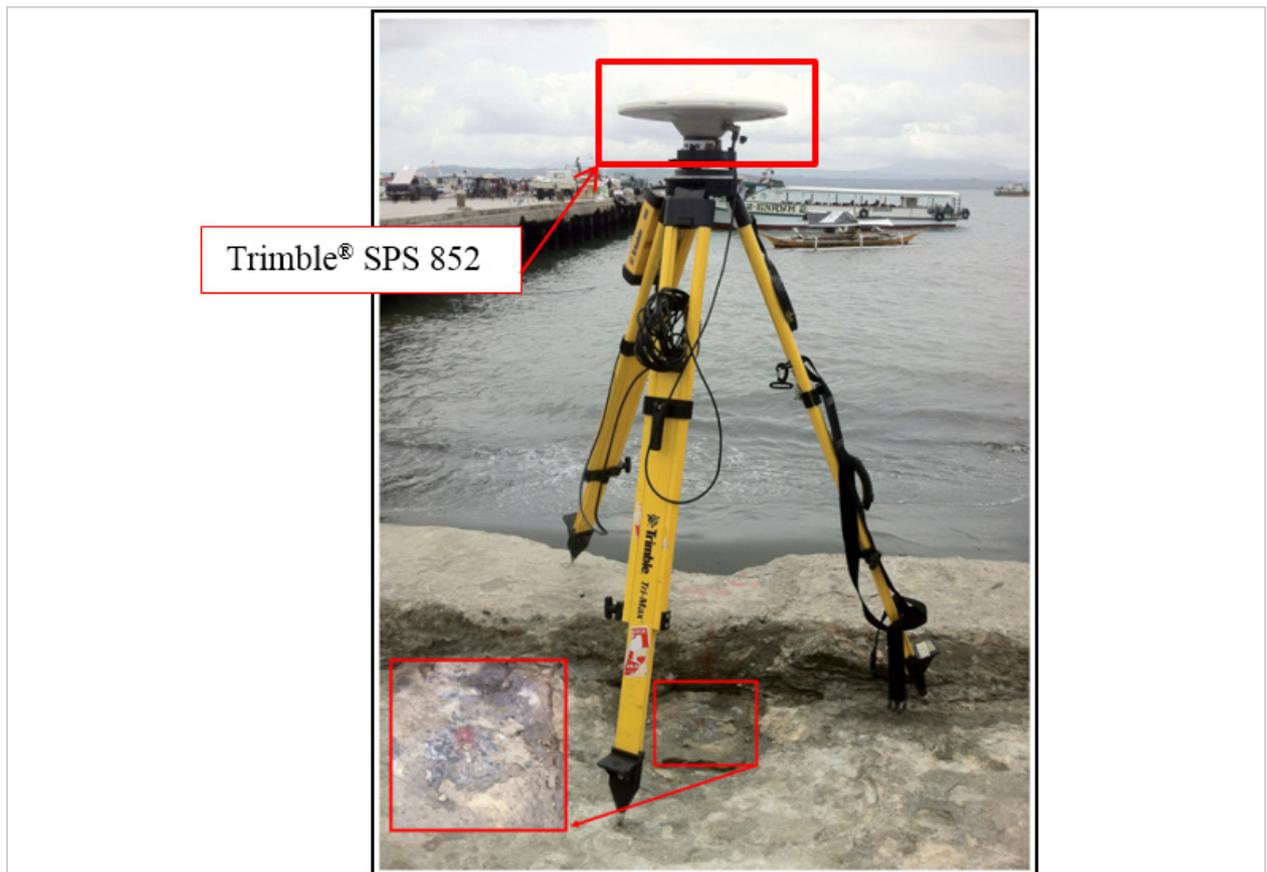
Figure 29. GNSS base receiver setup, Trimble® SPS 852 at DVS-1 at the east side of Pier, in Brgy. Leon Garcia Sr., Davao City, Davao Del Sur

The GNSS set up for control points used are shown in Figure 29 to Figure 35 respectively.

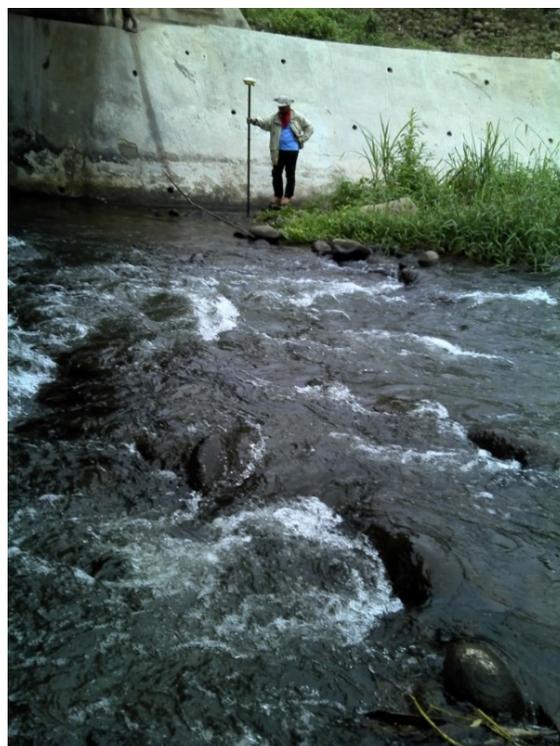
Figure 36. Cross-section and bridge as-built survey at the downstream side of Tologan Bridge, Brgy. Tologan, Hagonoy, Davao del Sur

Cross-section and as-built survey were conducted on July 8, 2015 at the downstream side of Tologan Bridge in Brgy. Tologan, Municipality of Hagonoy, Davao Del Sur using a GNSS receiver Trimble® SPS 882 in PPK survey technique as shown in Figure 36. The control point UP-PAD was used as the GNSS base station for both cross-section and bridge as-built surveys.

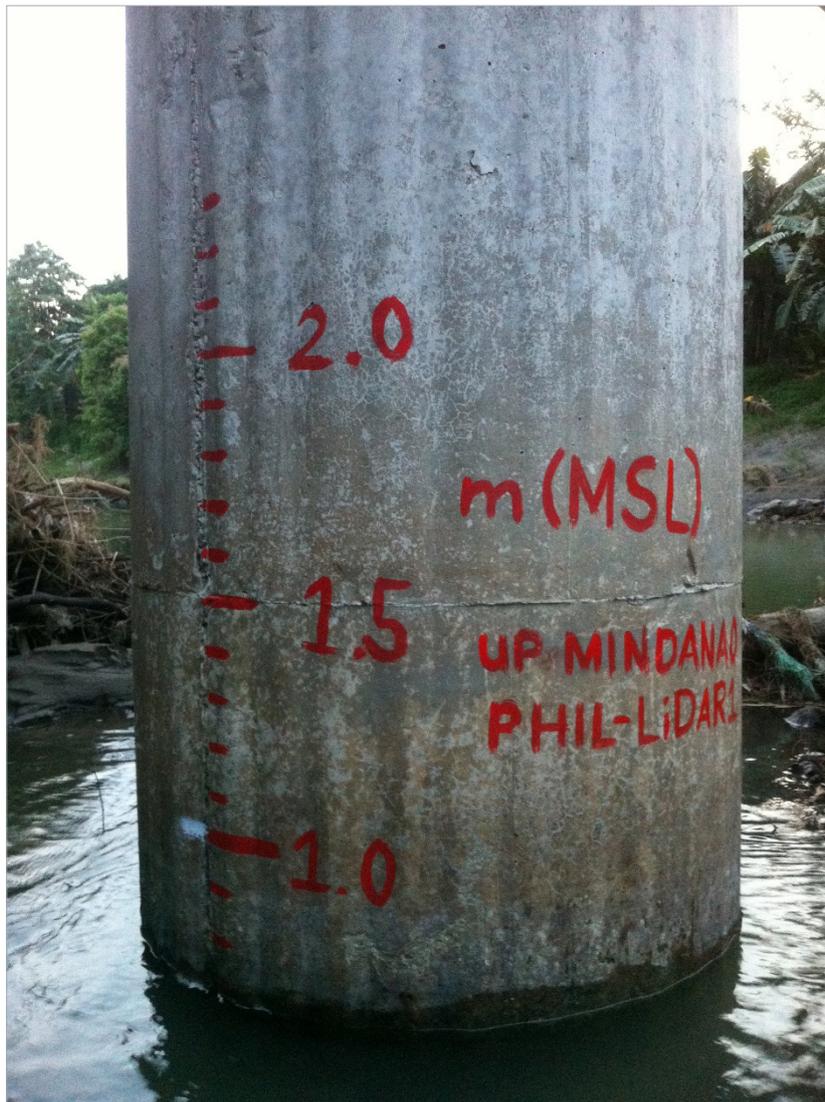
Figure 40. Water level markings on the post of Tologan Bridge

Water surface elevation in MSL of Tologan Bridge was determined using Trimble® SPS 882 in PPK mode survey on July 8, 2015 at 12:42 PM. This was translated onto marking the bridge's pier using a digital level. The marked pier, see Figure 40, shall serve as reference for flow data gathering and depth gauge deployment by the accompanying HEI, UP Mindanao, who is responsible for Padada-Mainit River.

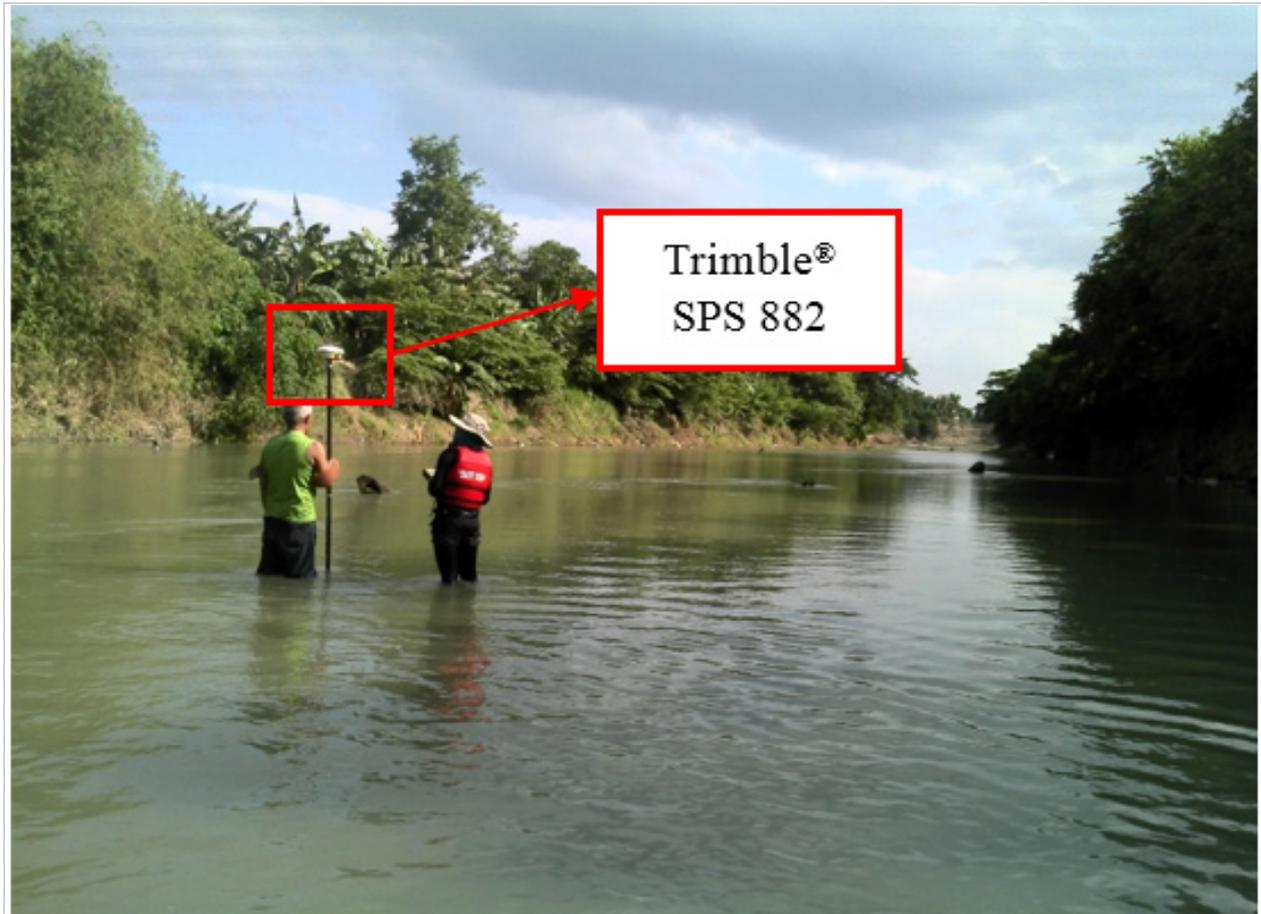
Figure 43. Bathymetric survey setup in Padada-Mainit River (upstream)

Bathymetric survey was conducted from July 3 and 10, 2015 using a survey grade GNSS Rover receiver Trimble® SPS 882 in PPK survey technique as shown in Figure 43. The control point UP-PAD was used as base station for the survey. The river was traversed manually which started at the upstream portion of the river in Brgy. Son Sergio Osmeña Sr., Municipality of Padada with coordinates $6^{\circ}39'59.70560''$ $125^{\circ}18'02.19947''$, down to the mouth of the river in Brgy. Guihing Aplaya, also in Padada with coordinates $6^{\circ}41'23.82323''$ $125^{\circ}22'44.41592''$.

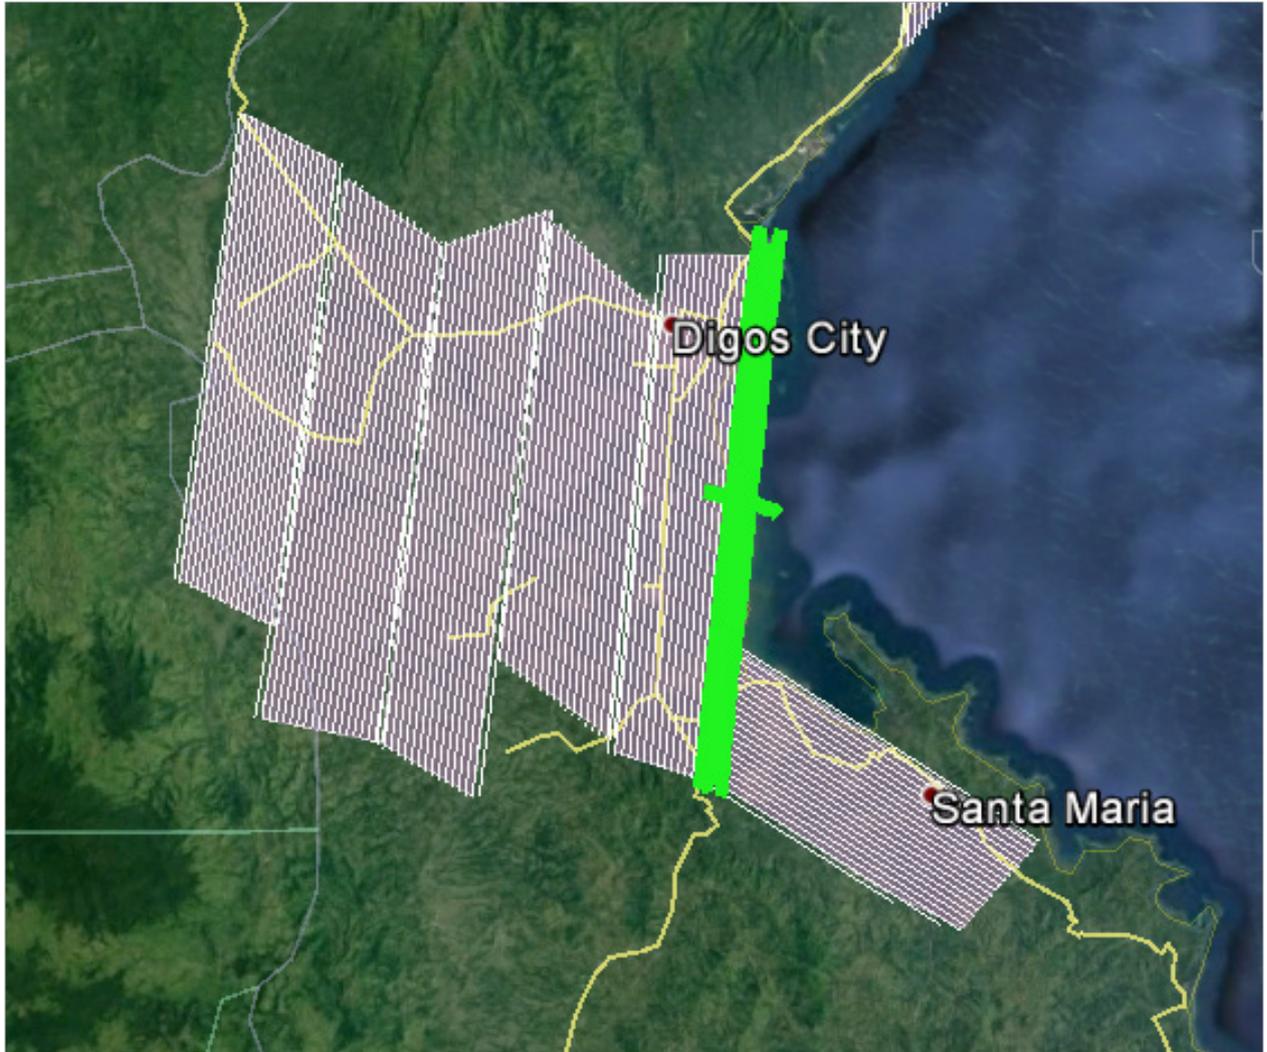
Flight No. : 7404GC
Area: BLK87A
Mission name: 2BLK87AS212A
Parameters:
Altitude: 1000 m;
Scan Frequency: 50 Hz;
Scan Angle: 20 deg;
Overlap: 30 %
Area covered: 169.442 km²

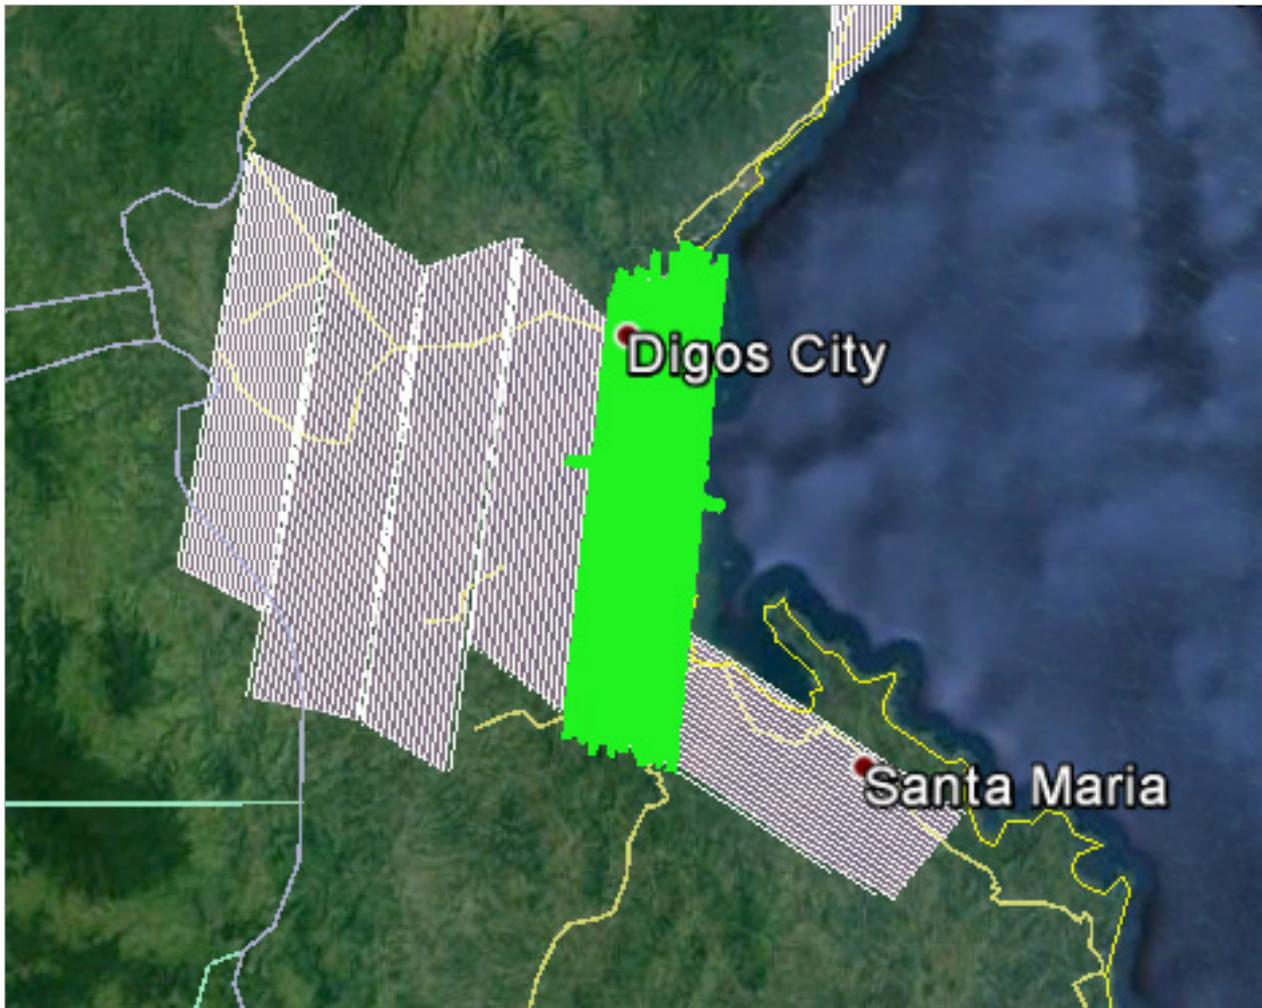
Flight No. : 7406GC
Area: BLK87C
Mission name: 2BLK87BC213A
Parameters:
Altitude: 1000 m;
Scan Frequency: 50 Hz;
Scan Angle: 20 deg;
Overlap: 30 %
Area covered: 193.272 km²

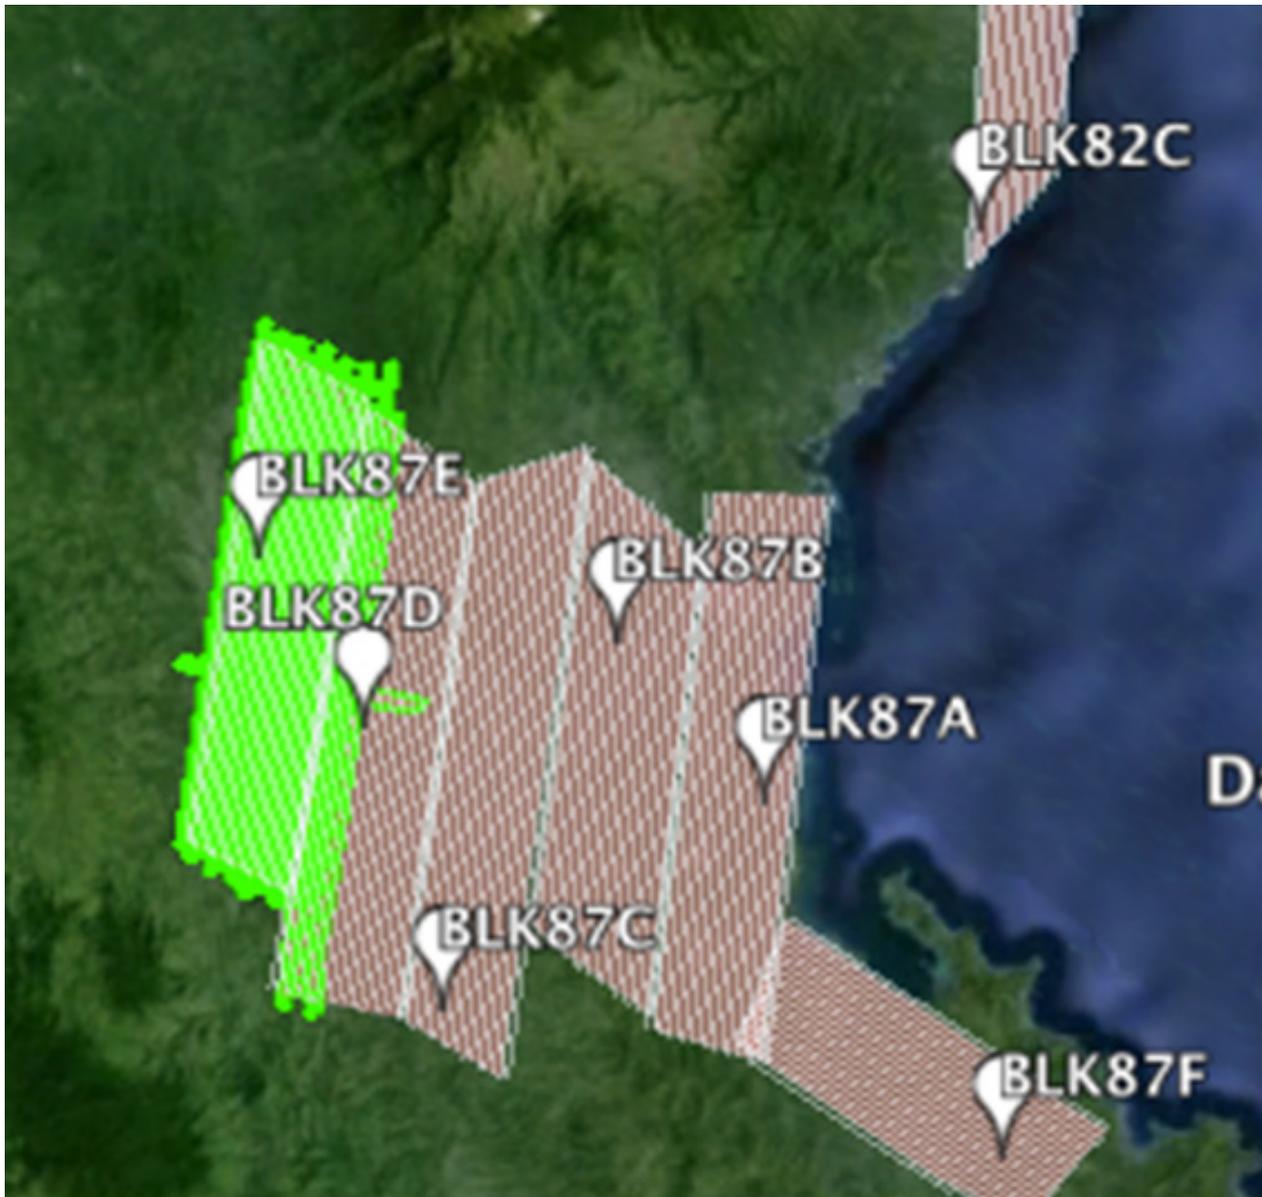
Flight No. : 7412GC
Area: BLK87B
Mission name: 2BLK87CSD216A
Parameters:
Altitude: 1000 m;
Scan Frequency: 50 Hz
Scan Angle: 20 deg;
Overlap: 35 %
Area covered: 70.780 km²

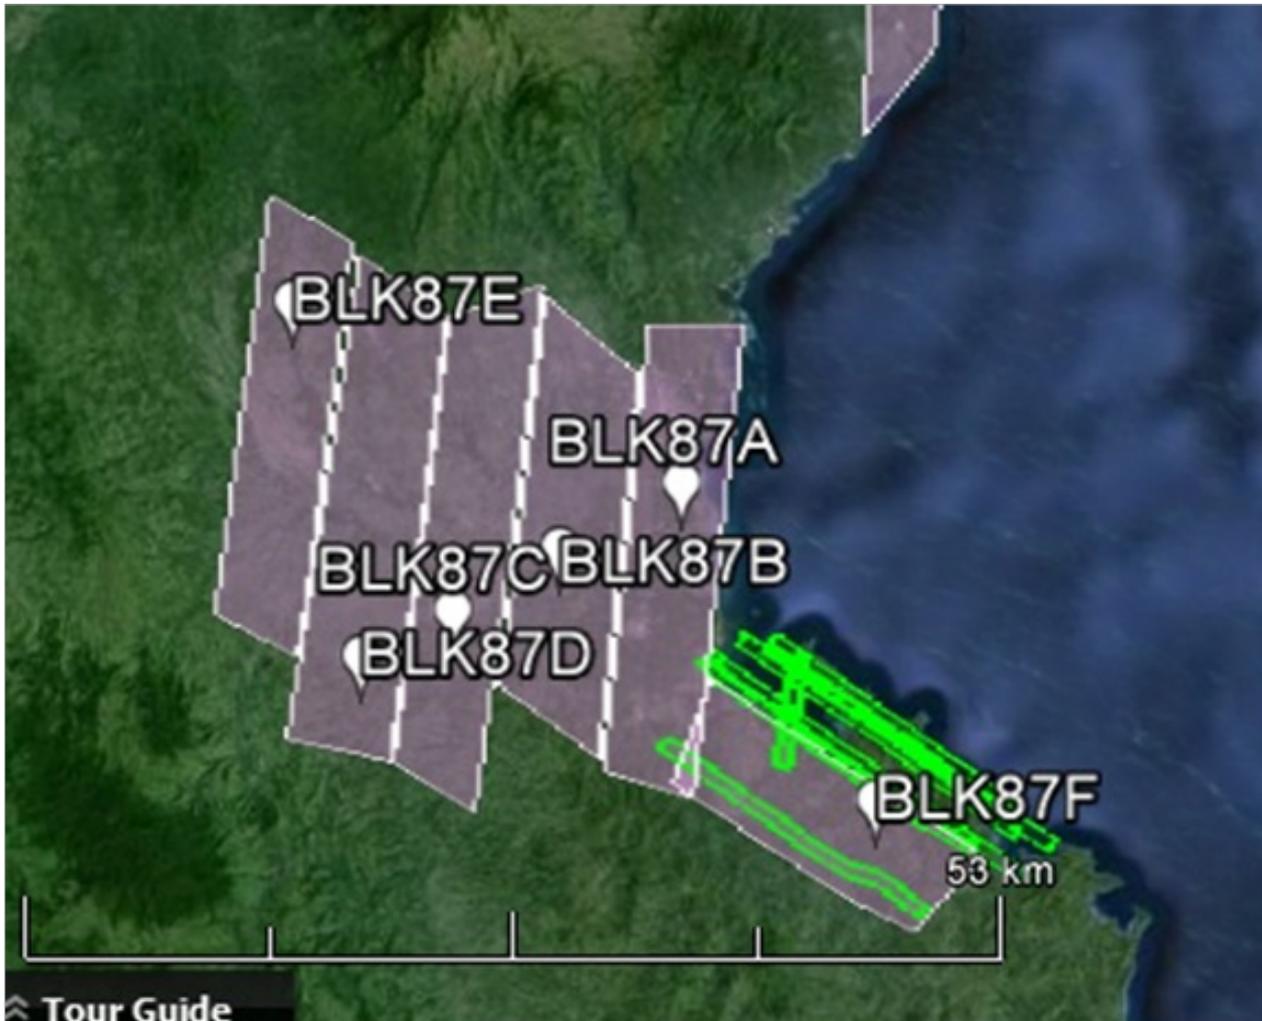
Flight No. : 7216GC
Area: BLK87B, BLK87D, BLK87F
Mission name: 2BLK87F218A
Parameters:
Altitude: 1000 m;
Scan Frequency: 50 Hz
Scan Angle: 20 deg;
Overlap: 35 %
Area covered: 139.714 km²

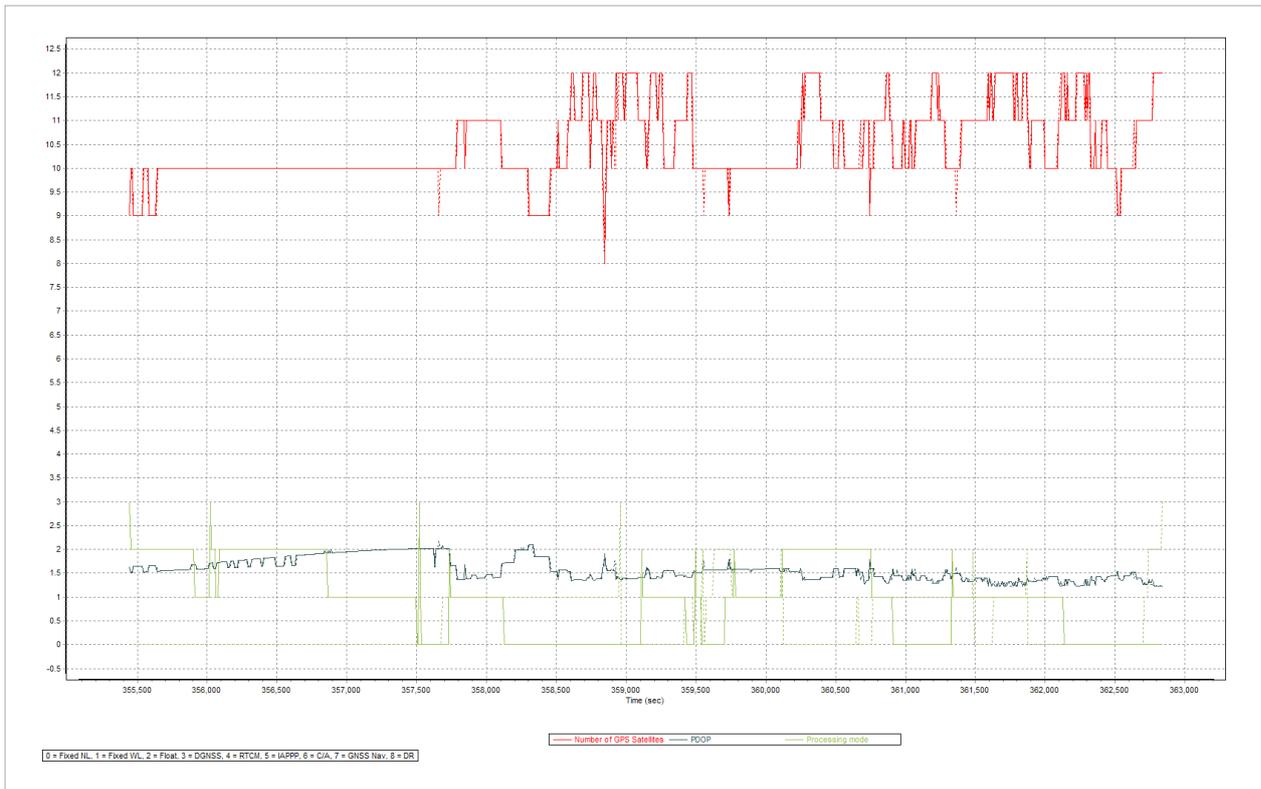
Figure 1.1.1 Solution Status

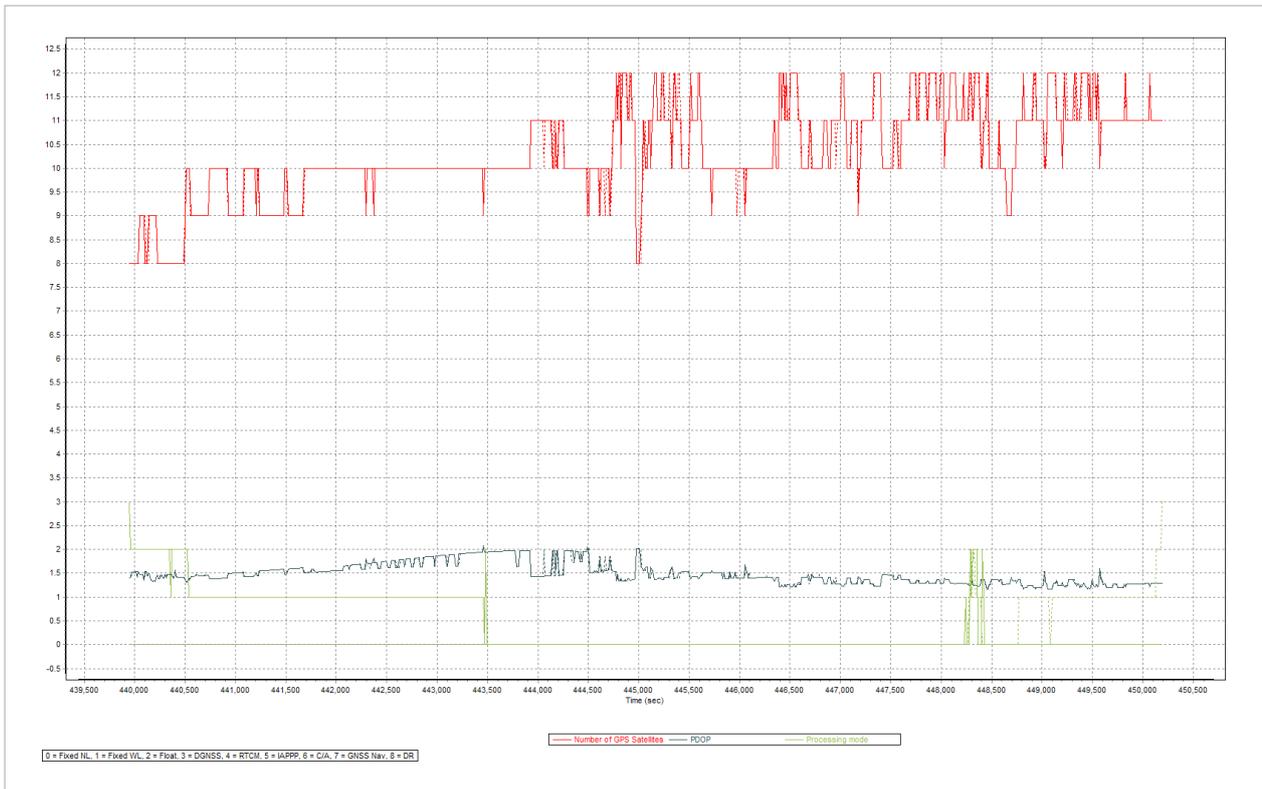
Figure 1.2.1 Solution Status
